Report Type: Work Plan

Site:	Dodd Federal Unit Water Flood					
Company:	COG Operating LLC					
Section, Township and Range	Unit I	Sec 15	T17S	R29E		
Lease Number:	API-30-015-02987					
County:	Eddy County					
GPS:		32.83275° N		104.05684° W		
Surface Owner:	Federal					
Mineral Owner:						
Directions:	In Loco Hills, from the intersection of Hwy 82 and CR 217 travel west on Hwy 82 for 4.3 miles, turn right and travel 100 feet, turn right and travel 0.4 miles, turn left and travel 0.6 miles to site.

Re: Work Plan for the COG Operating LLC., Dodd Federal Unit Water Flood, Unit I, Section 15, Township 17 South, Range 29 East, Eddy County, New Mexico.

COG Spill Assessment
Eddy County, New Mexico

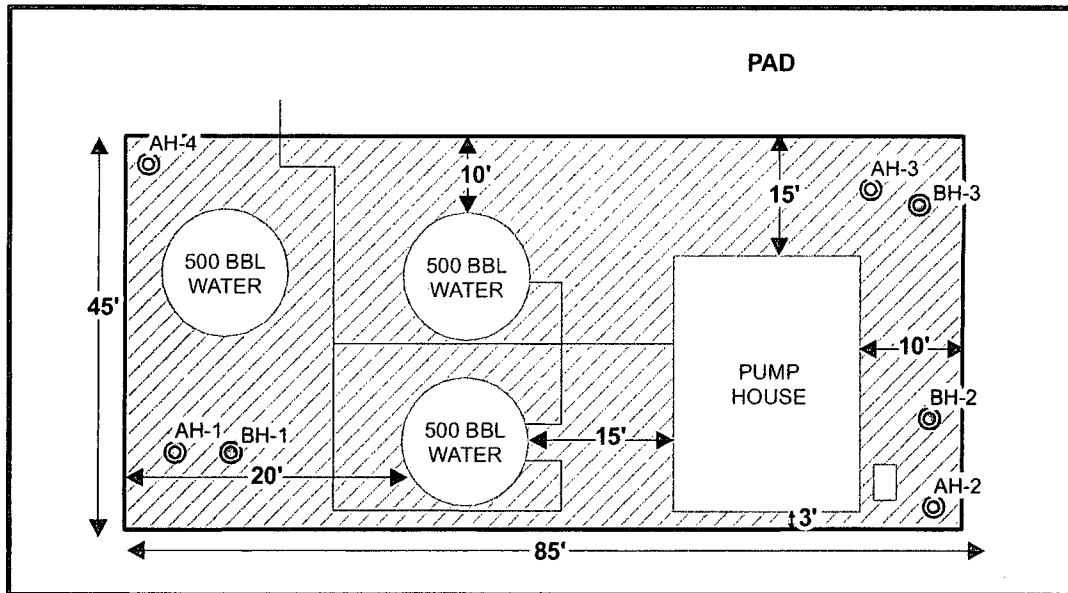
Figure 3

On May 31, 2011, Tetra Tech personnel inspected and sampled the spill area. Four (4) auger holes (AH-1, AH-2, AH-3 and AH-4) were installed using a stainless steel hand auger to assess the impacted soils. Due to the tanks, lines and structures, additional auger holes were not installed at the site. Select samples were analyzed for TPH analysis by EPA method 8015 modified, BTEX by EPA Method 8021B and chloride by EPA method 300.0. Copies of laboratory analysis and chain-of-custody documentation are included in Appendix C. The results of the sampling are summarized in Table 1. The auger hole locations are shown on Figure 3.

Referring to Table 1, all auger holes were below the RRAL for TPH and BTEX. The area of AH-4 showed a shallow chloride impact to the soils, which declined to 237 mg/kg at 2-2.5' below surface. The chloride impact was not vertically defined in auger holes (AH-1, AH-2 and AH-3), with bottom hole samples of 10,100 mg/kg at 1-1.5', 1,560 mg/kg at 9-9.5' and 2,060 mg/kg at 9-9.5', respectively.

On September 23, 2011, Tetra Tech personnel supervised the installation of soil borings (SB-1, SB-2 and SB-3) utilizing an air rotary drilling rig. Soil samples were collected to a depth of 60.0' below surface to define the chloride impact. Referring to Table 1, chloride concentrations declined with depth to <200 mg/kg at 60.0' (SB-1) and <200 mg/kg at 40.0' (SB-2) and <200 mg/kg at 40.0' (SB-3). The soil boring locations are shown on Figure 3.

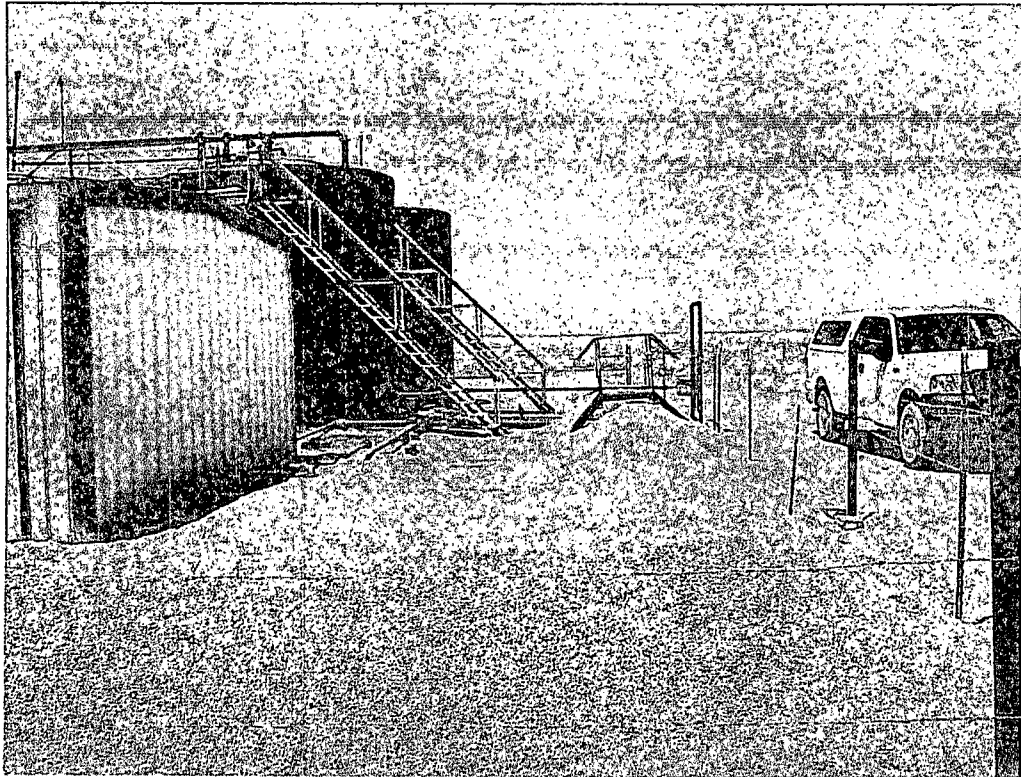
View West – AH-3 and 4

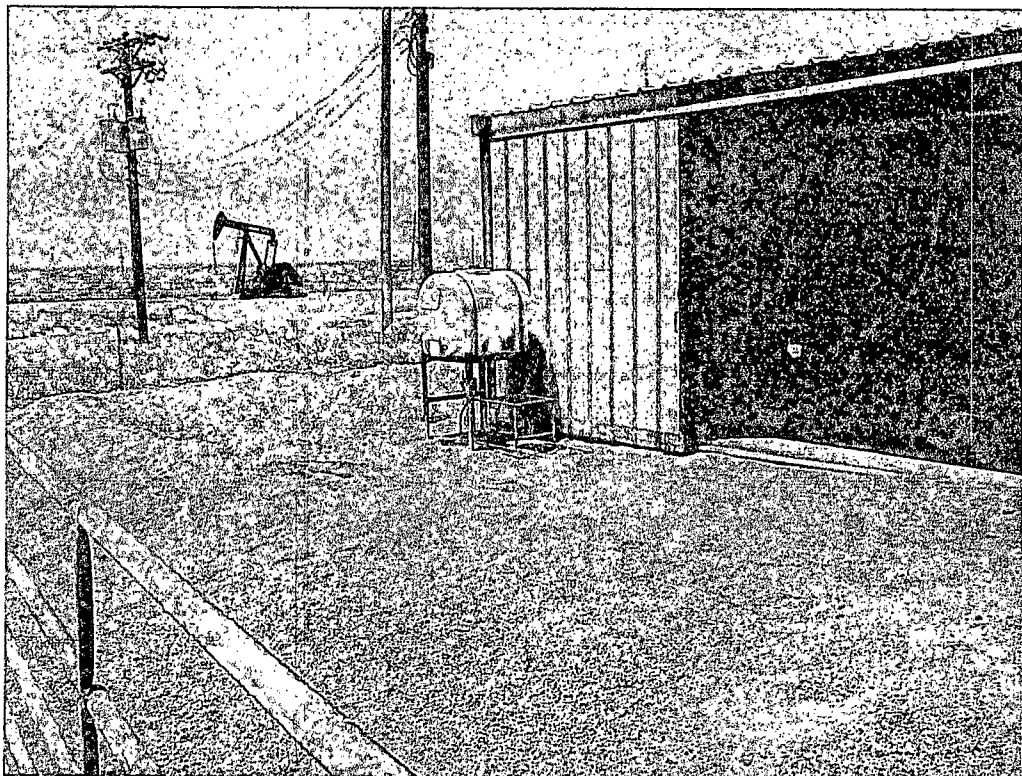
View South – AH-2

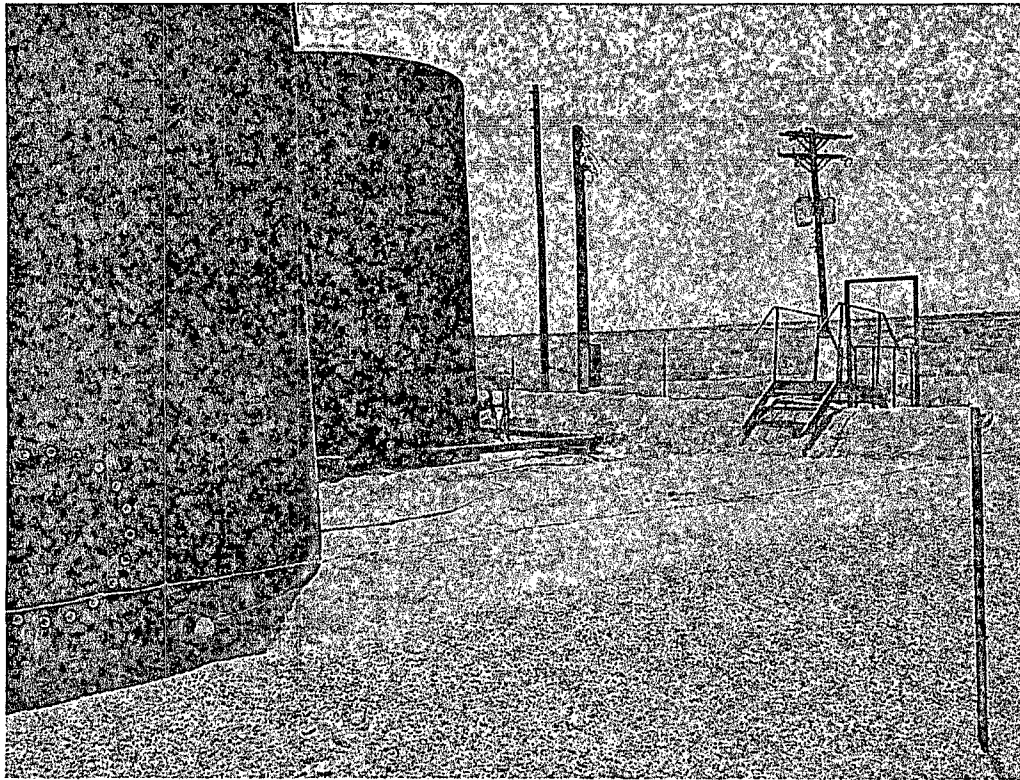
View South East – AH-4
