## Report Type: Work Plan

Site:	Mesilla State #2 Flow line					
Company:	COG Operating LLC					
Section, Township and Range	Unit H	Sec 16	T17S	R30E		
Lease Number:	API-30-015-31366					
County:	Eddy County					
GPS:	32.83502° N			103.96942° W		
Surface Owner:	State					
Mineral Owner:						
Directions:	In Loco Hills, from the intersection of Goat Roper Rd and 82, travel north on Goat Roper for 1.2 miles, turn right (east) and travel for 0.3 miles, turn right (south) and travel for 500', turn left (east) and travel for 500' to site on the south side of the lease road.

**Re: Work Plan for the COG Operating LLC., Mesilla State #2, Unit H,  
Section 16, Township 17 South, Range 30 East, Eddy County,  
New Mexico.**

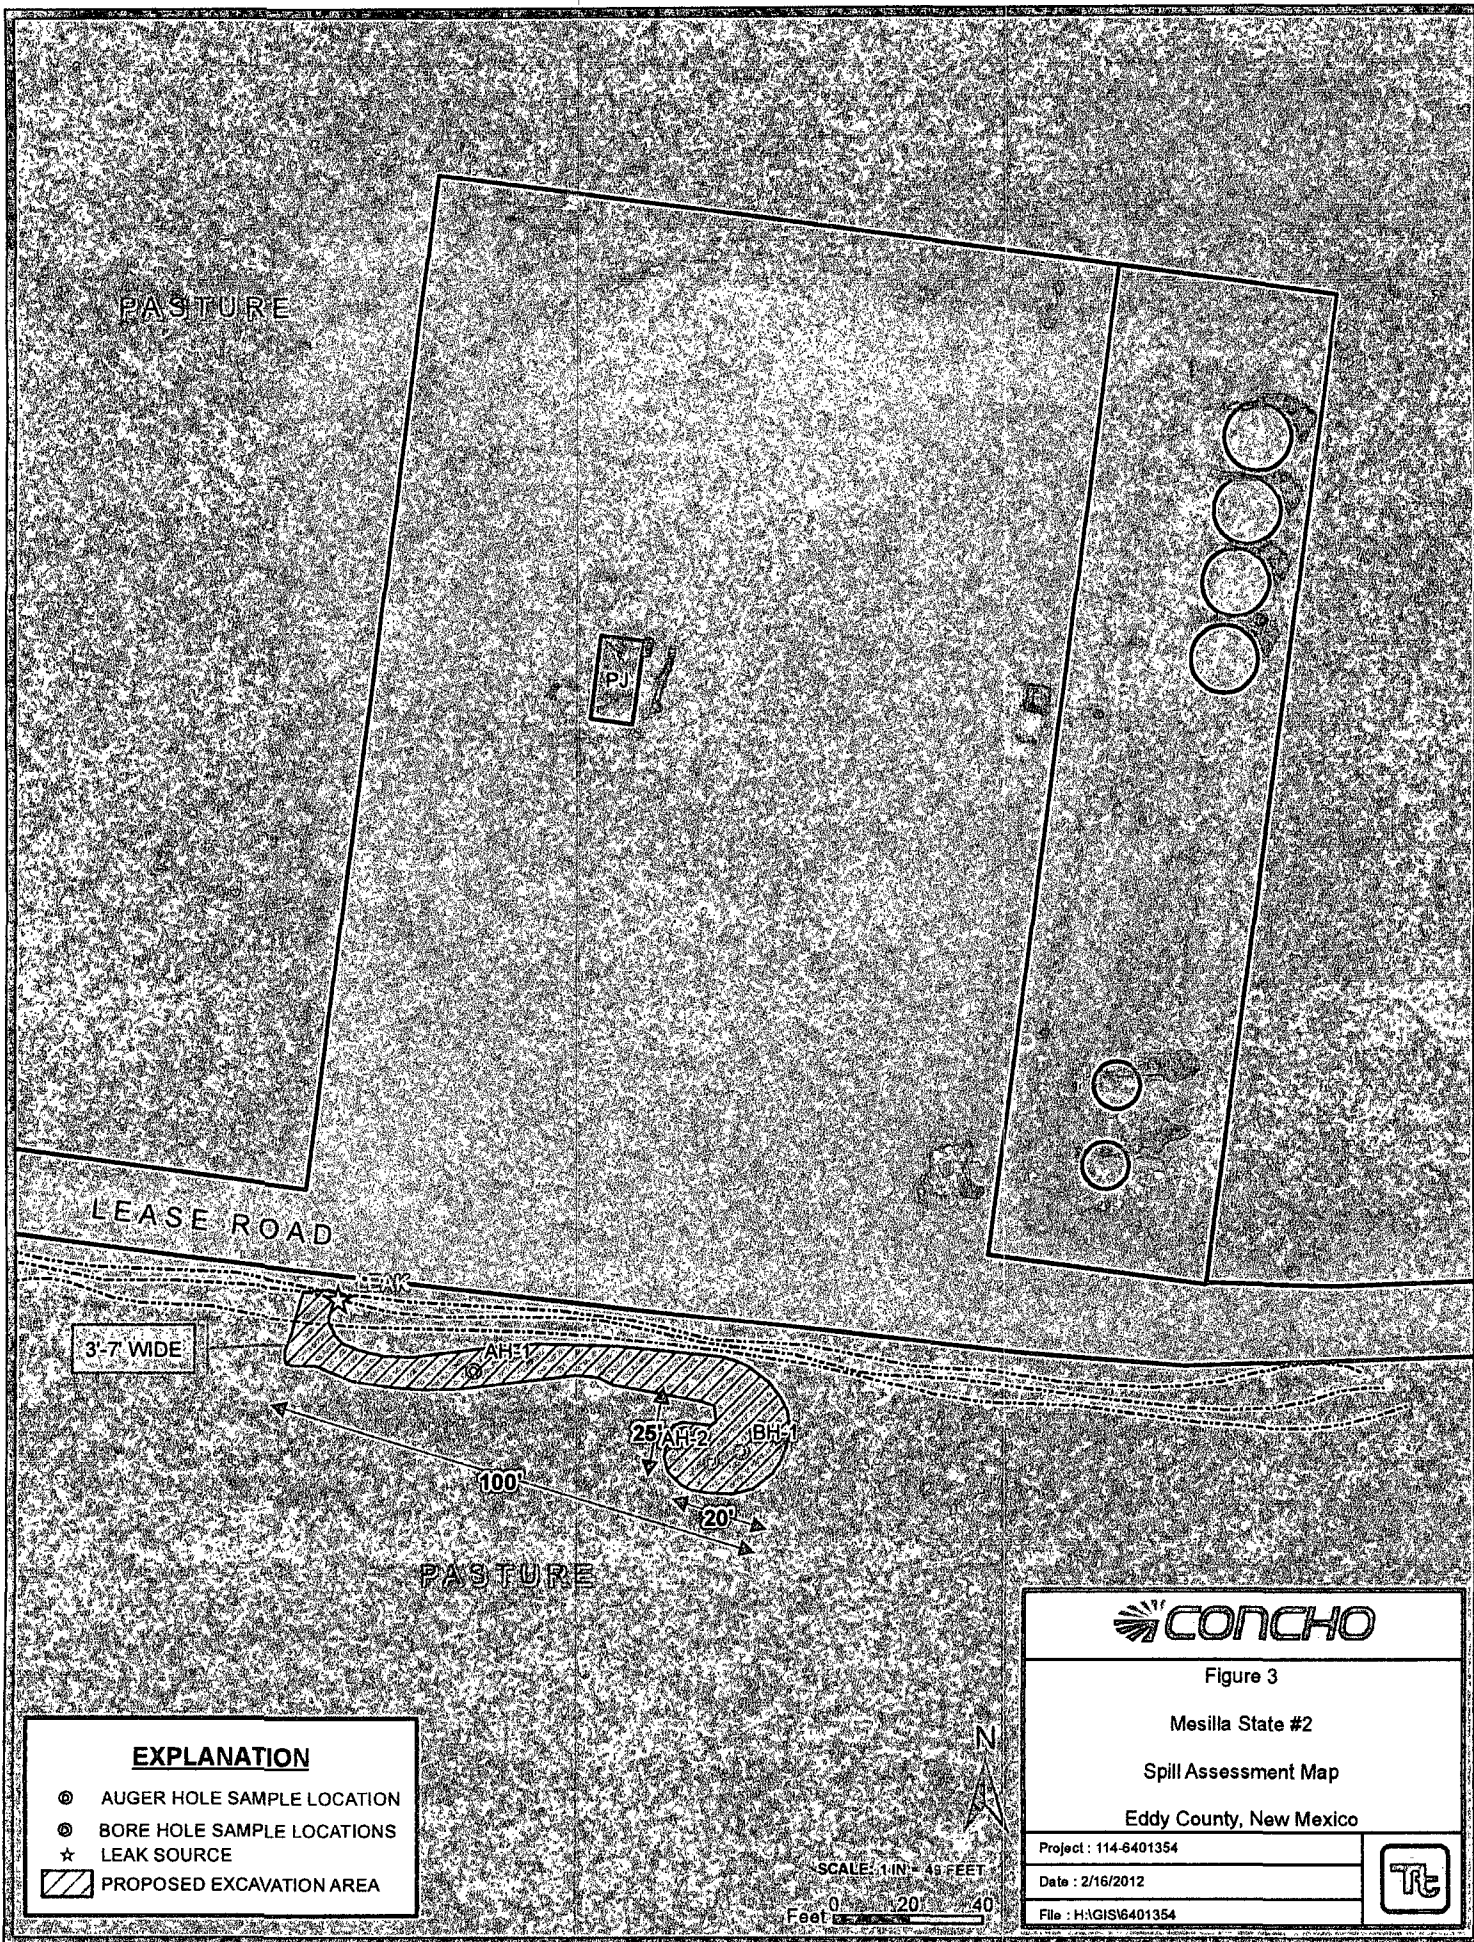
Figure 3

On March 28, 2012, Tetra Tech personnel inspected and sampled the spill area. Two (2) auger holes (AH-1 and AH-2) were installed using a stainless steel hand auger to assess the impacted soils. Selected samples were analyzed for TPH analysis by EPA method 8015 modified, BTEX by EPA Method 8021B and chloride by EPA method 300.0. Copies of laboratory analysis and chain-of-custody documentation are included in Appendix C. The sampling results are summarized in Table 1. The auger hole locations are shown on Figure 3.

Referring to Table 1, auger hole (AH-1) exceeded the RRAL for TPH at 0-1', but declined below the RRAL at 1-1.5' below surface. Auger hole (AH-2) was not defined and exceeded the RRAL for TPH, benzene and total BTEX down to a depth of 2.5-3.0' below surface.

Elevated chloride concentrations were also detected in both auger holes. Auger hole (AH-1) declined with depth and was defined at 4-4.5' below surface. However, AH-2 was not vertically defined and showed a chloride bottom hole sample of 7,030 mg/kg at 2.5-3.0' below surface. Deeper samples were not collected due to a dense formation.

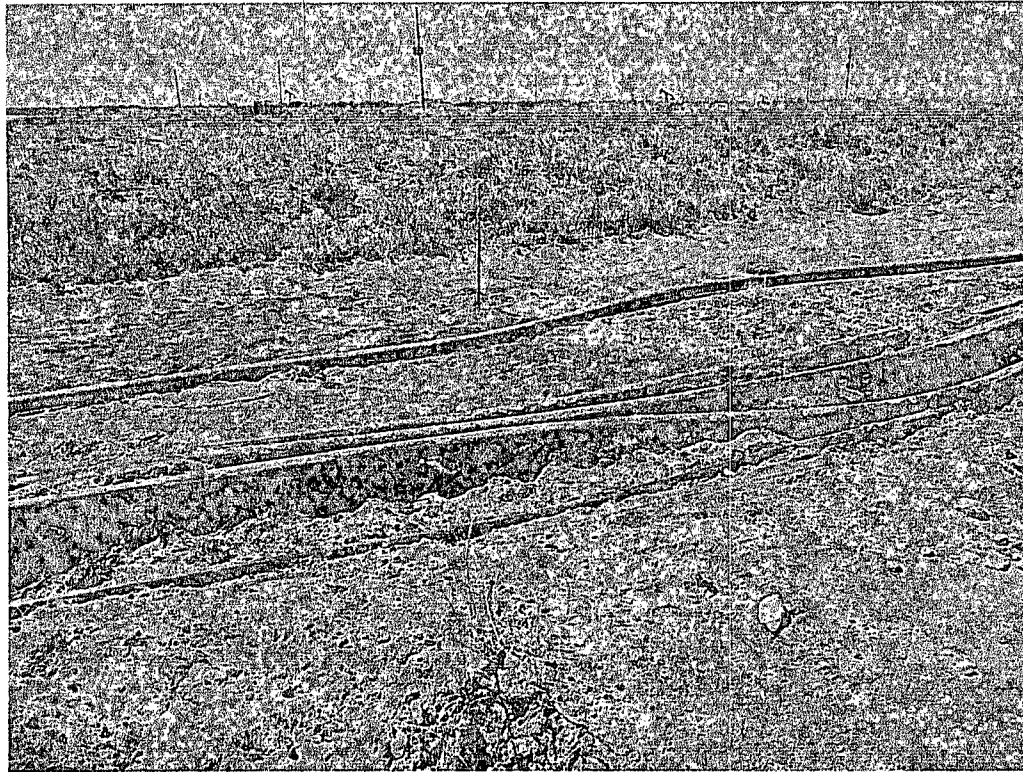
View South – Area of Leak

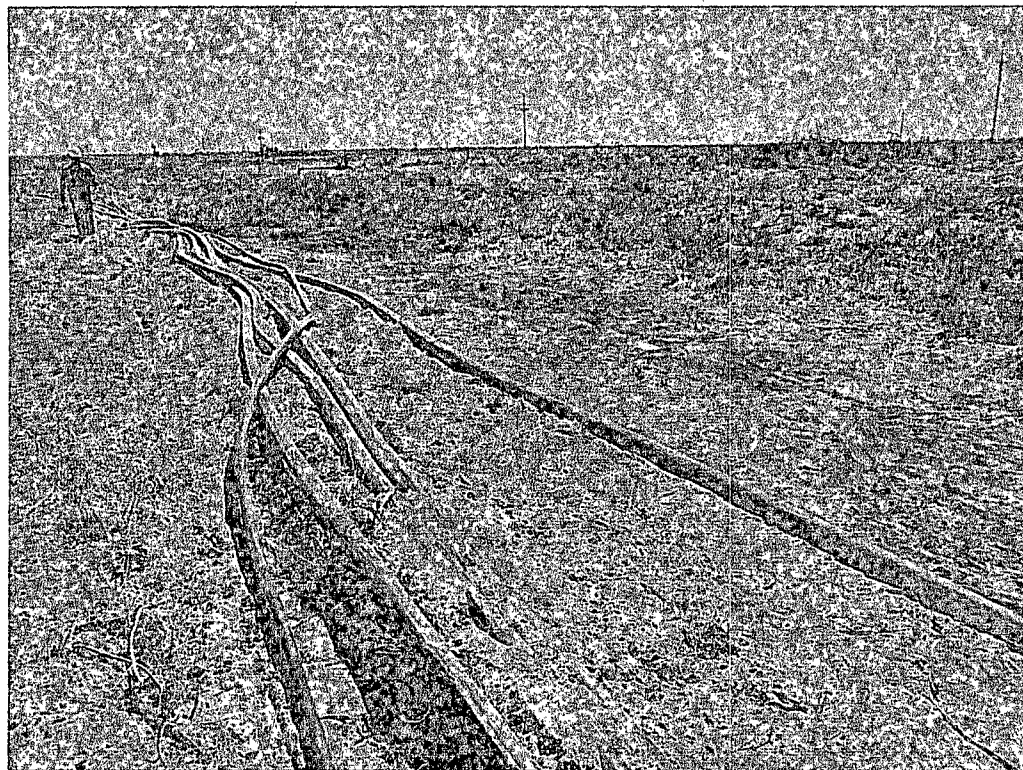
View South East – Area of AH-1

COG proposes removal of impacted material as highlighted (green) in Table 1 and shown on Figure 4. To remove the elevated chloride and hydrocarbon impact exceeding the RRAL, the areas of AH-1 and AH-2 will be excavated to a depth of approximately 2.0' to 3.0' below surface.

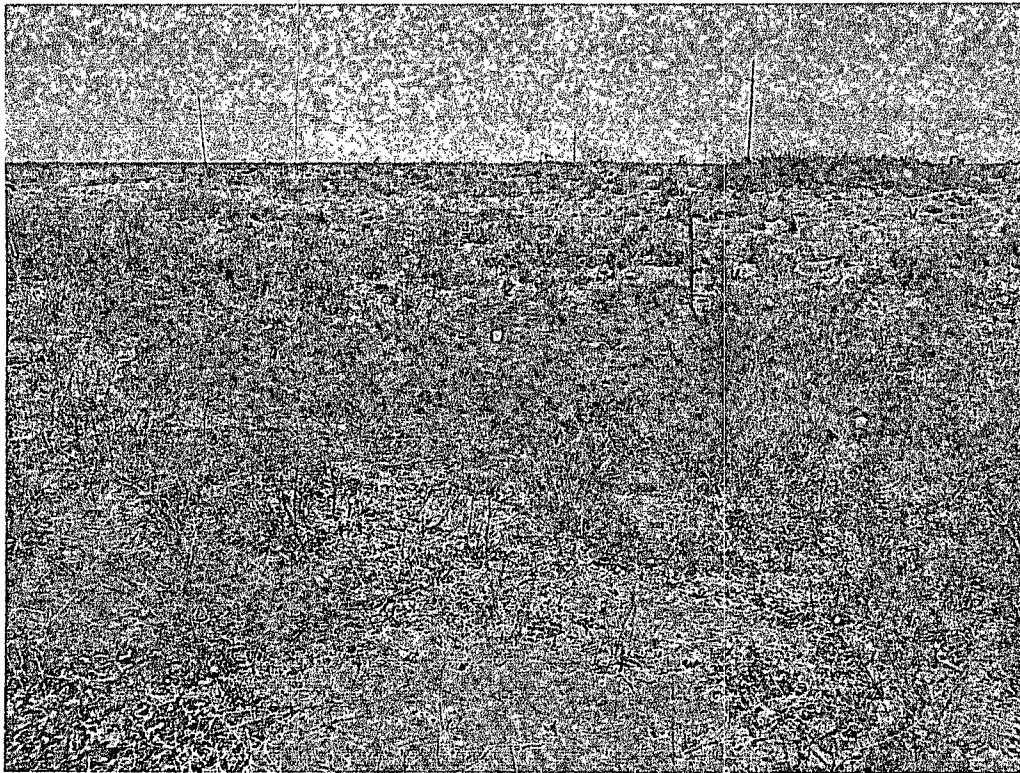
View South – Area of AH-2
