### Release Notification and Corrective Action

**Name of Company** Apache Corporation **873** **Contact** Craig Maxwell  
**Address** 2350 W. Marland Blvd. Hobbs, NM 88240 **Telephone No.** (575) 393-7106  
**Facility Name** Lee Federal Tank Battery **30-015-30268** **Facility Type** Tank Battery

## Internal Incident Report – Spill/Release

**Location:** Lee Federal Battery

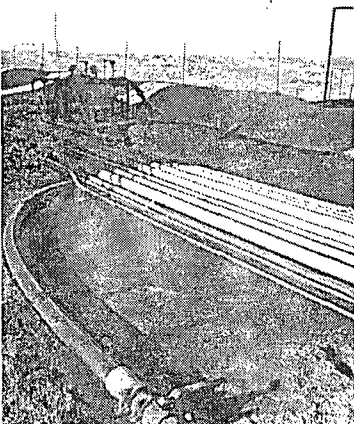
**One Line Summary:** Corrosion in water dump line resulting in hole.

**Full summary:** A hole was found on the water dump line due to corrosion. Approximately 20bbls of produced water was released. Approximately 15bbls of produced water was recovered from inside the containment walls. This facility is not lined. The line was isolated to the two FWKO's and the three production treaters so that water could no longer dump into the corroded water dump line. All wells were shut in. A vacuum truck was dispatched to recover the standing fluid from inside the facility. Corroded line was repaired. The initial assessment will be conducted this morning to determine the extent of the contamination. A remediation plan will be determined once we have the initial assessment completed.

**Root cause of incident:** Corrosion

1. Replacement of the water dump line.
