# SITE INFORMATION

## Report Type: Work Plan

Site:	BKU #146 Flowline					
Company:	COG Operating LLC					
Section, Township and Range	Unit B	Sec. 30	T-17-S	R-30-E		
Lease Number:	API 30-015-04394					
County:	Eddy County					
GPS:	32.81208° N			104.00906° W		
Surface Owner:	Federal					
Mineral Owner:						
Directions:	Intersection of Hwy 82 and CR-216 (west of Loco Hills), south on CR-216 0.6 mi, left on Lacey C 0.6 mi, left 500' to location.

**Re: Work Plan for the COG Operating LLC., BKU #146 Flow line, Unit B, Section 30, Township 17 South, Range 30 East, Eddy County, New Mexico.**

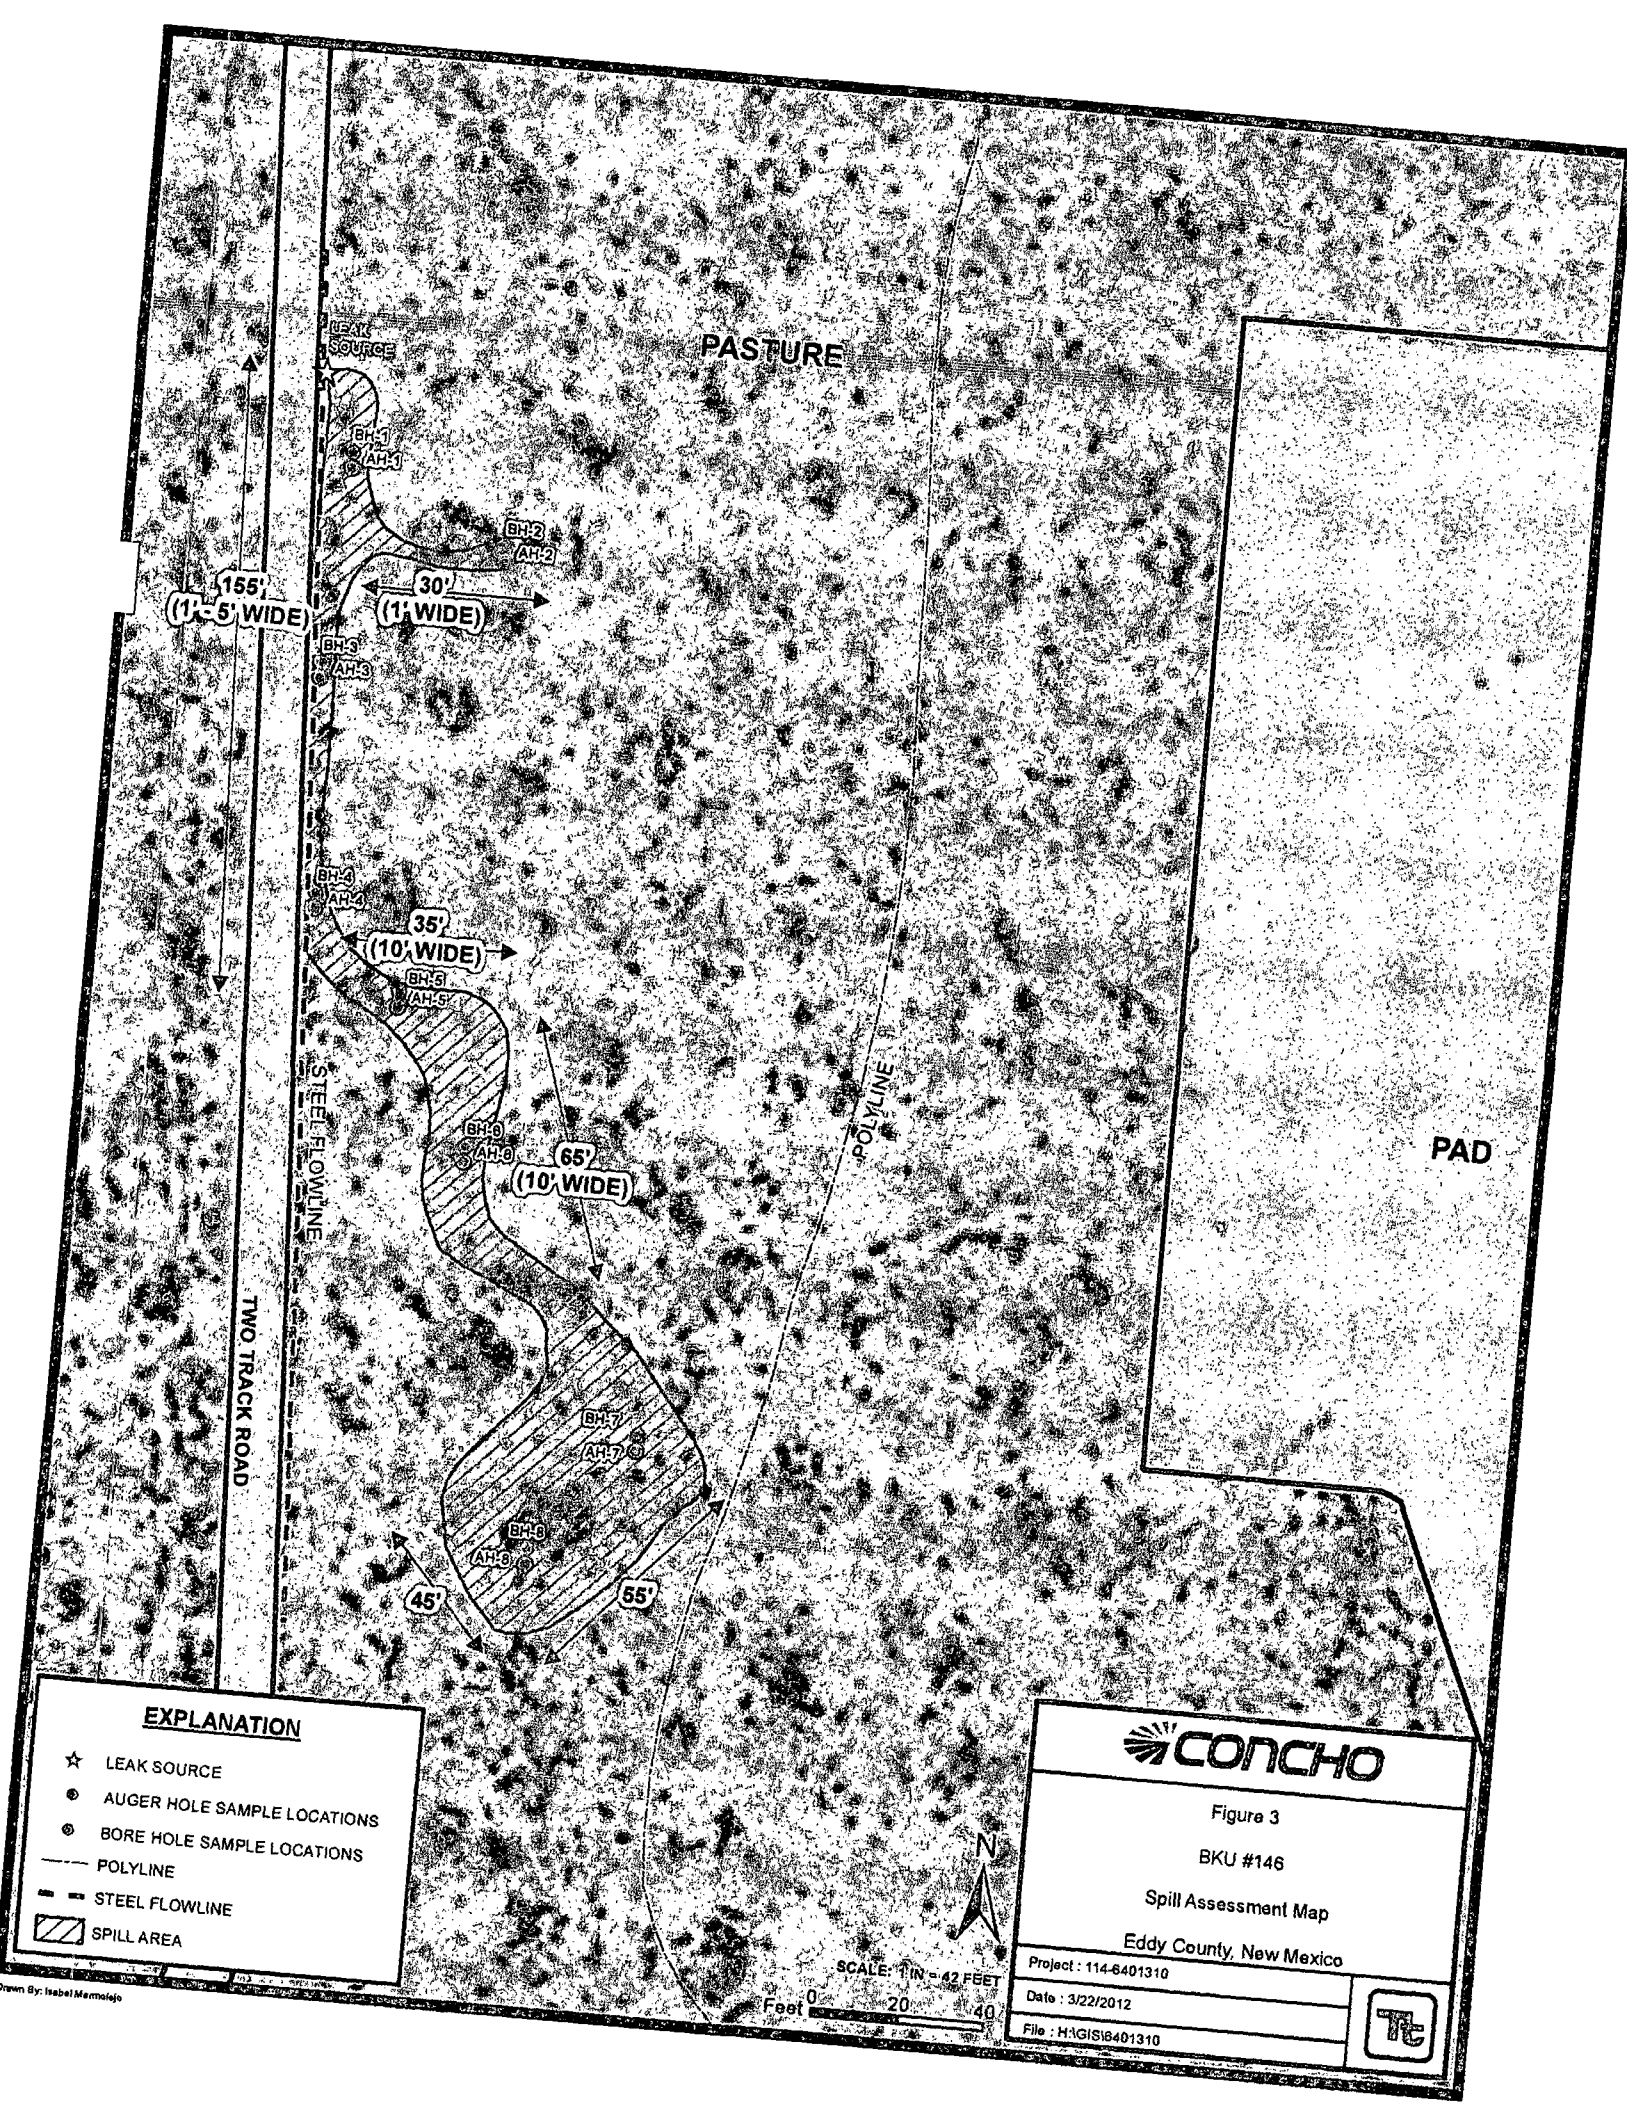
Figure 3

On March 8, 2011, Tetra Tech personnel inspected and sampled the spill area. Eight (8) auger holes (AH-1 through AH-8) were installed using a stainless steel hand auger to assess the impacted soils. Soil samples were collected at 0-1' below surface and deeper samples could not be collected due to a shallow dense caliche. Selected samples were analyzed for TPH analysis by EPA method 8015 modified, BTEX by EPA Method 8021B and chloride by EPA method 300.0. Copies of laboratory reports and chain-of-custody documentation are included in Appendix C. The sampling results are summarized in Table 1. The auger hole locations are shown on Figure 3.

Referring to Table 1, all of the samples were below the RRAL for BTEX and TPH. The chloride impact was not vertically defined, with bottom hole samples ranging from 6,310 mg/kg to 11,000 mg/kg.

Referring to Table 1, chloride concentrations greater than 10,000 mg/kg were detected in all of the boreholes, with concentrations declining below 10,000 mg/kg at 4.0' to 24.0' below surface. The chloride impact was vertically defined in all of the boreholes. The areas of BH-4, BH-5, BH-6 and BH-8 showed a chloride spike at 29-30' below surface and significantly declined at 39-40' below surface.

COG proposes removal of impacted material as highlighted (green) in Table 1 and shown on Figure 4. To remove the elevated chloride concentrations, the areas of AH-2 and AH-4 will be excavated to a depth of approximately 5.0' and 10.0' below surface, respectively. The area of AH-7 will be excavated approximately 20.0' below surface. The remaining areas will be excavated to a depth of approximately 15.0' below surface. Once excavated to the appropriate depths, the excavated areas will be capped with a 40 mil liner at 4.0' to 5.0' below surface and backfilled to grade with clean soil.

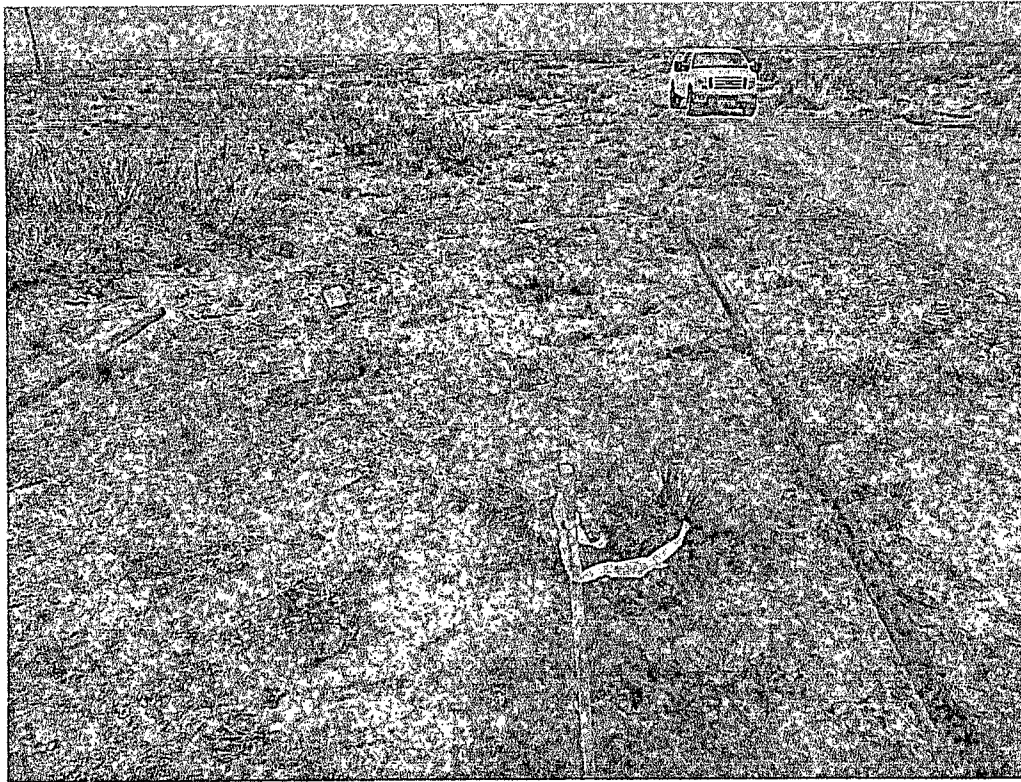
View south – near source and AH-1

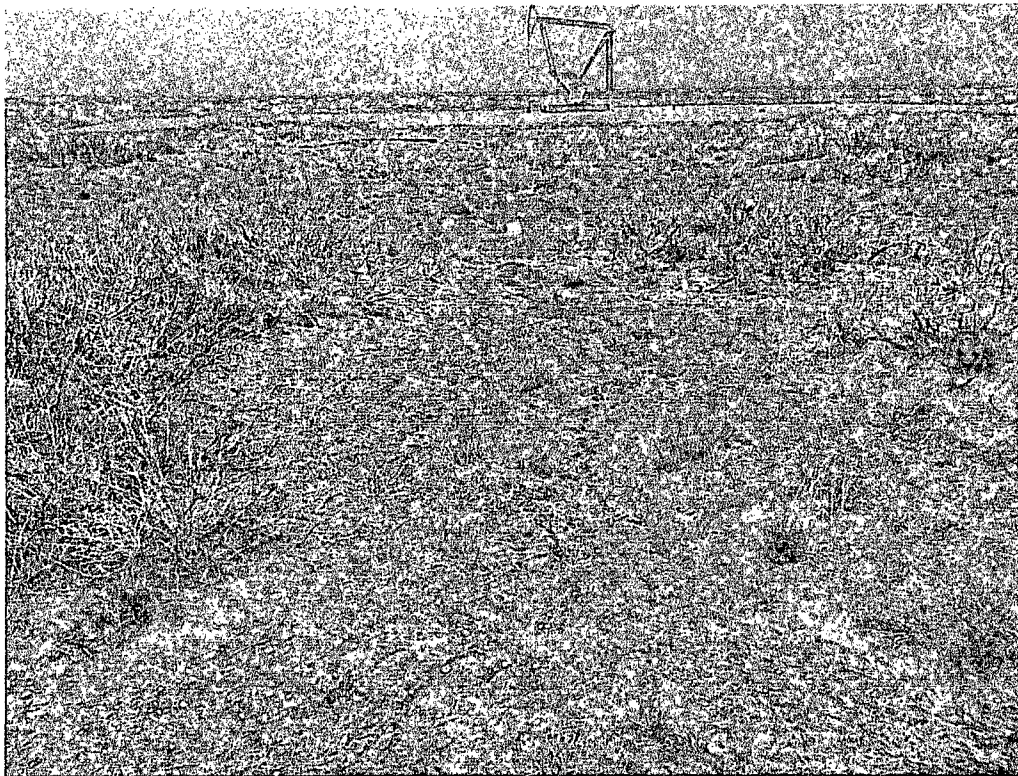
View east- Near AH-2

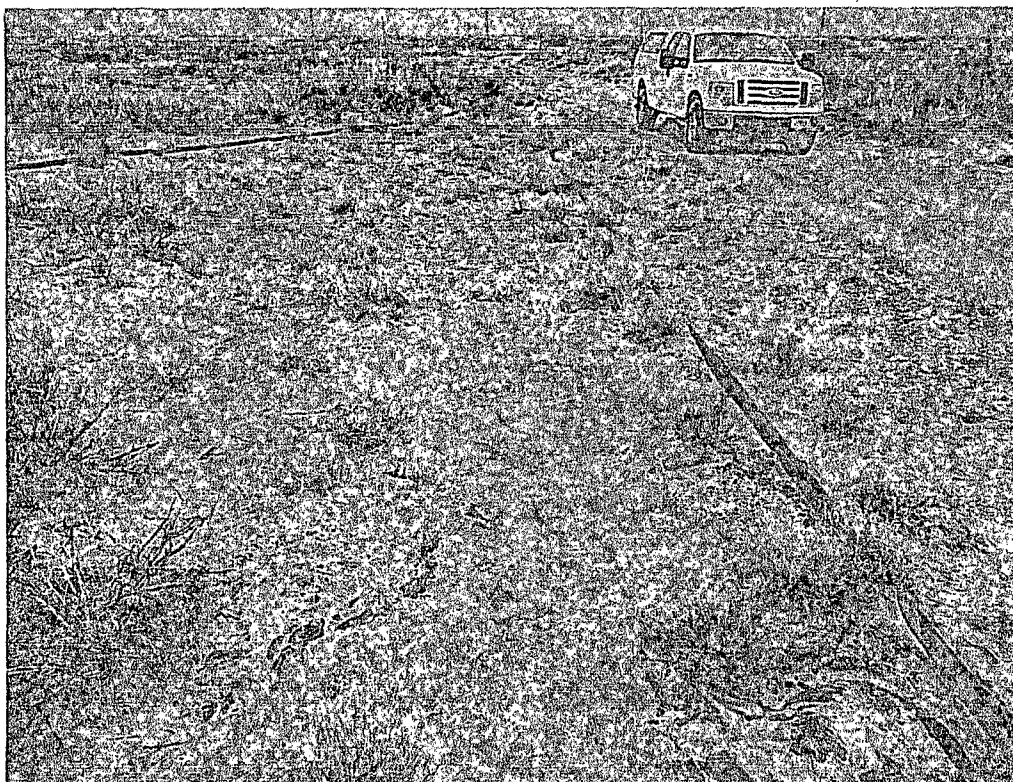
View south – Spill along two track, near AH-3

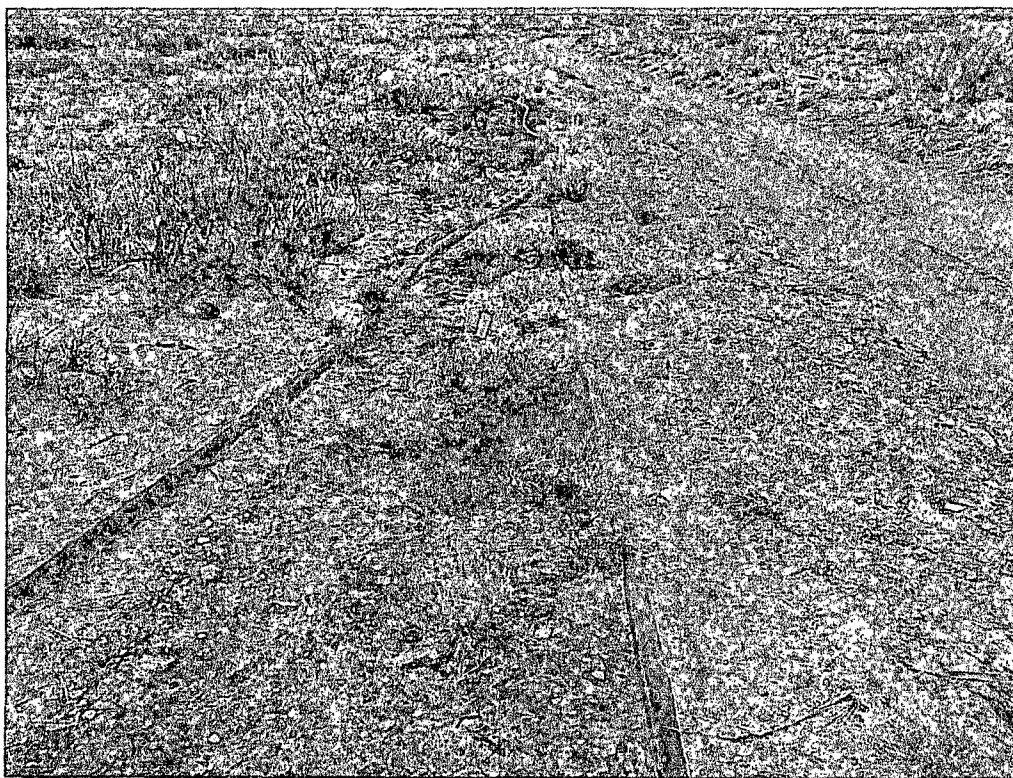
View south – Near AH-4

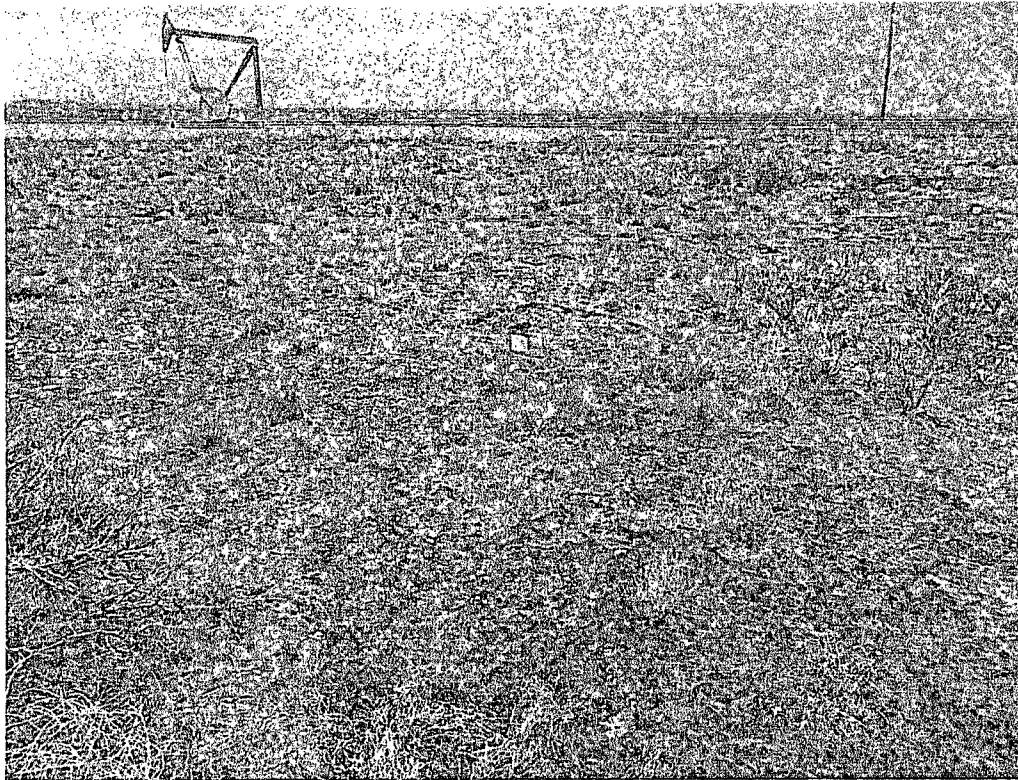
View east – Near AH-5

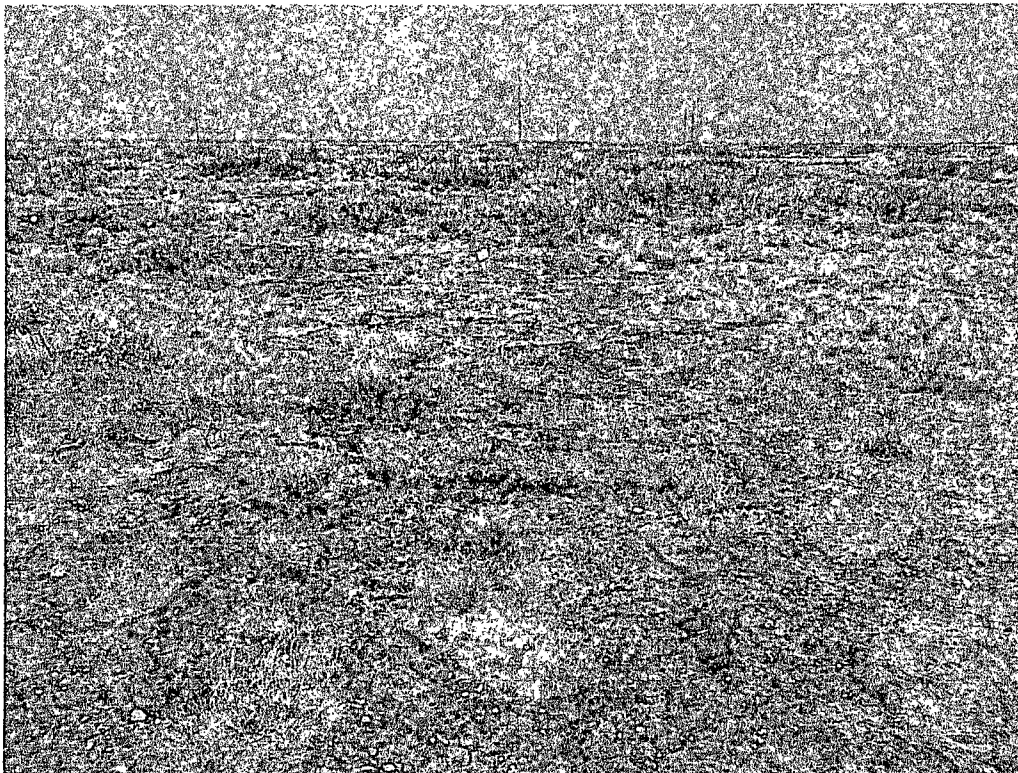
View south – Near AH-6

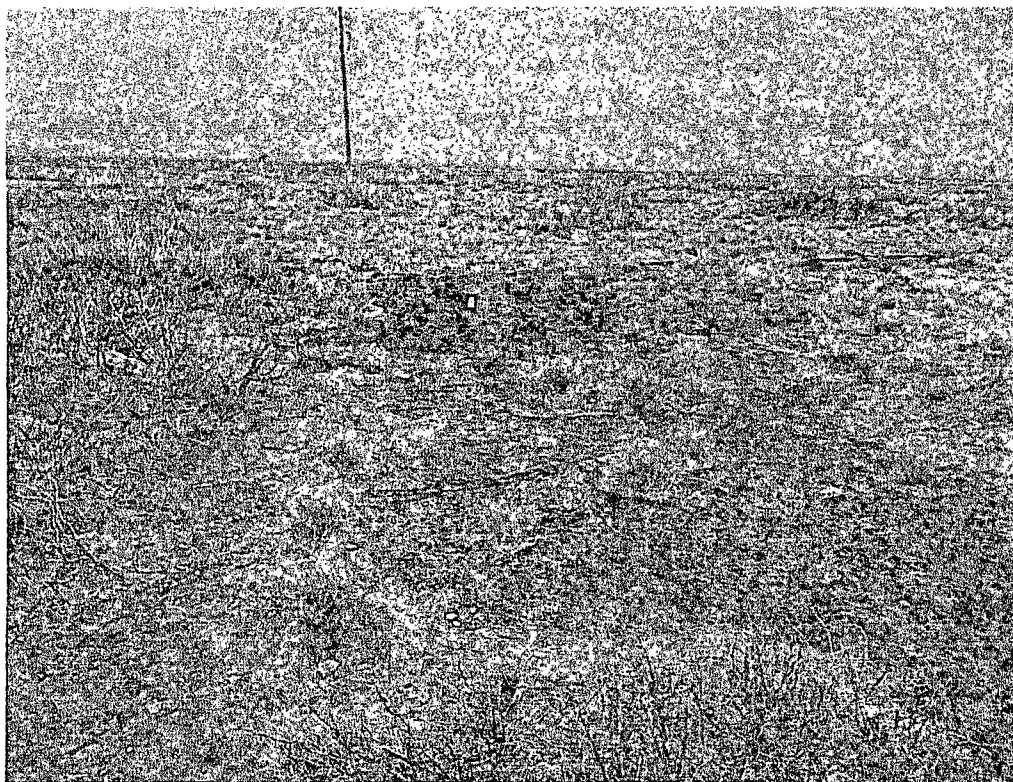
View east – Near AH-7

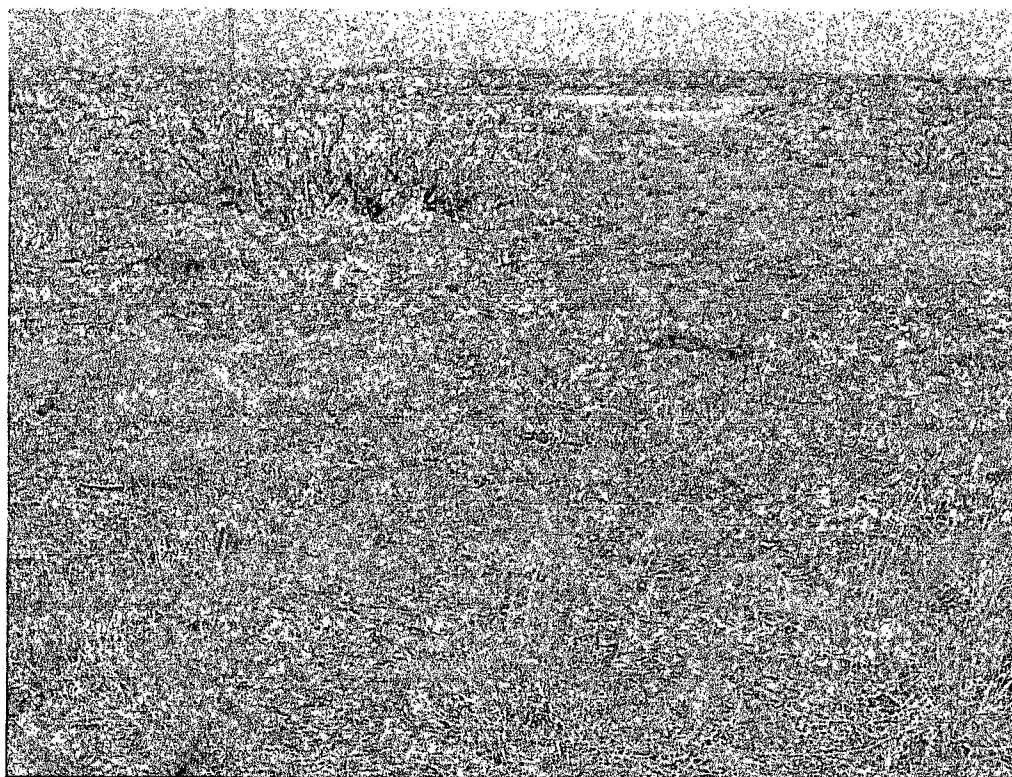
View south – AH-8

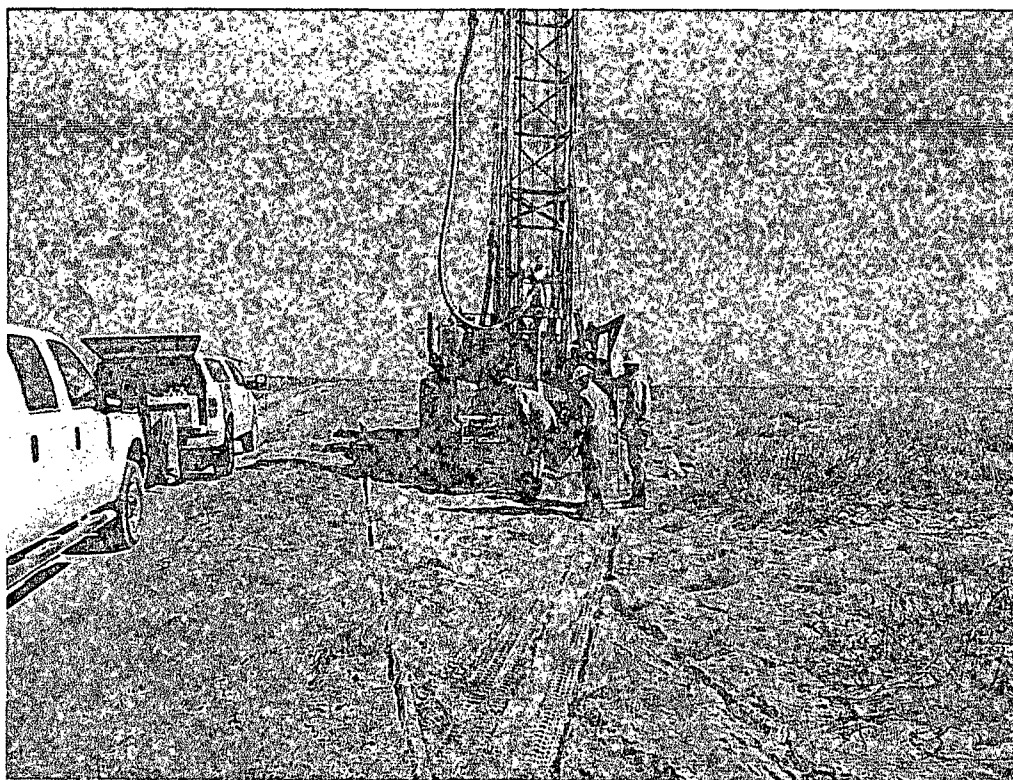
View north – Installing BH-1 near AH-1

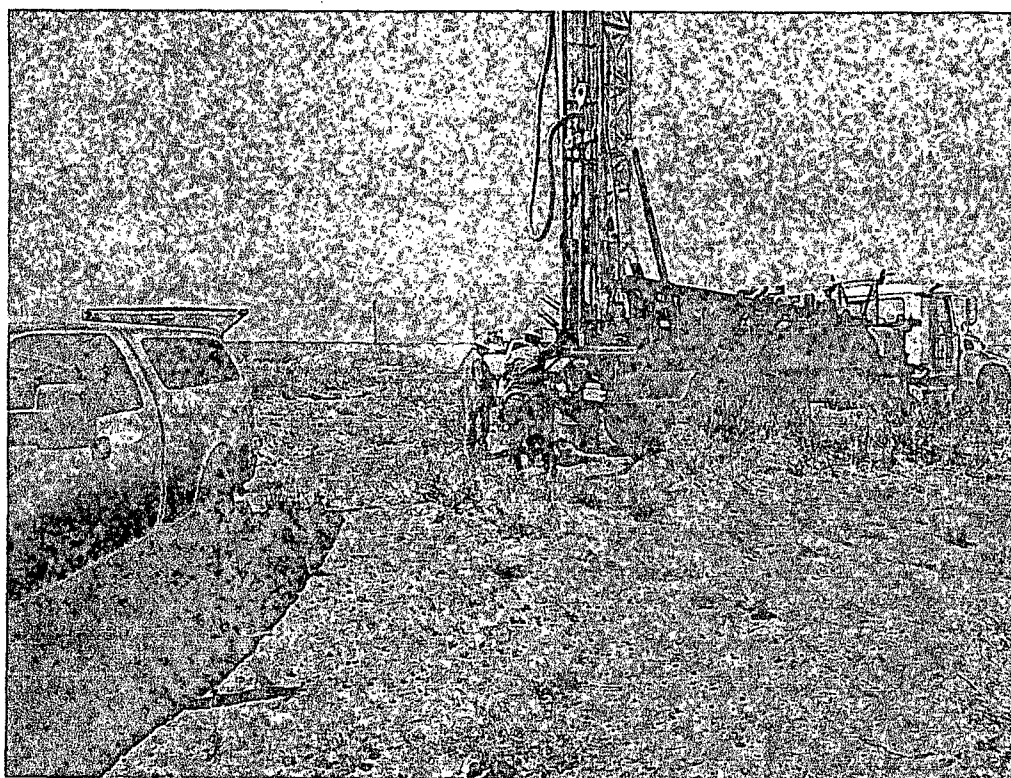
View south – Installing BH-2 near AH-2
