| | Burk Royalty Co., Ltd | Release Report<br>Cruces No. 6<br>API 025-02462<br>Lea County, New Mexico | <b>Site Location</b><br><small>Date created: 03.26.2014<br/>Revised by: J. Van Dyke</small> |

BURK ROYALTY CO., LTD  
CRUCES #6- API 025-02462  
SITE PHOTOS  
February 18, 2014

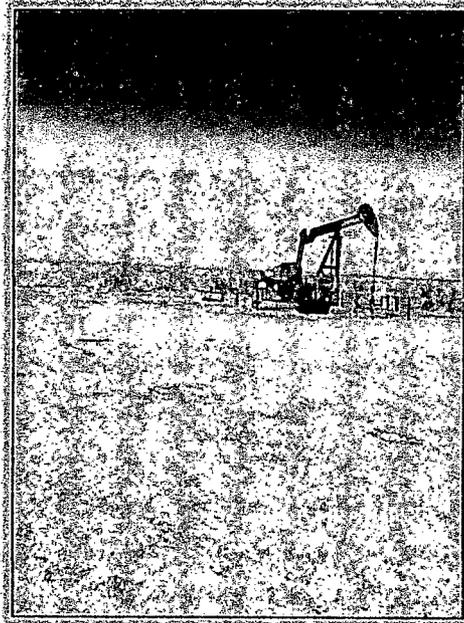
Photo 1.: View of the Cruces # 6 pump-jack taken from release location, approximately 80-feet south of the pump-jack.

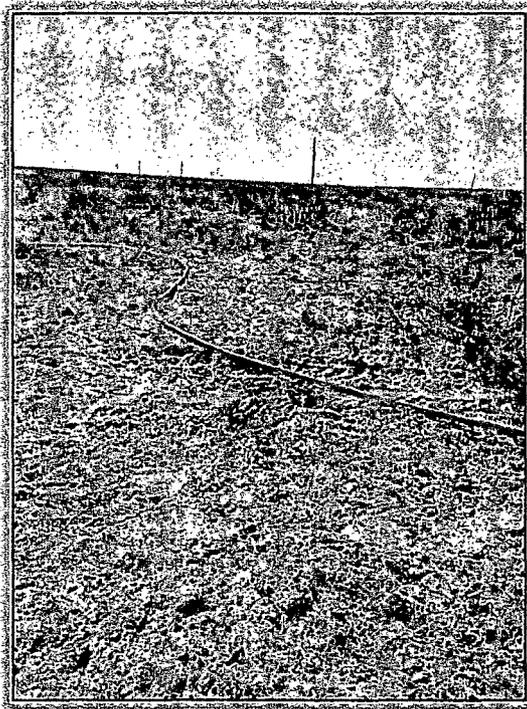
Photo 4.: View facing south, photo showing one of the two surface stains remaining at the time of sampling at the eastern boundary of the release.

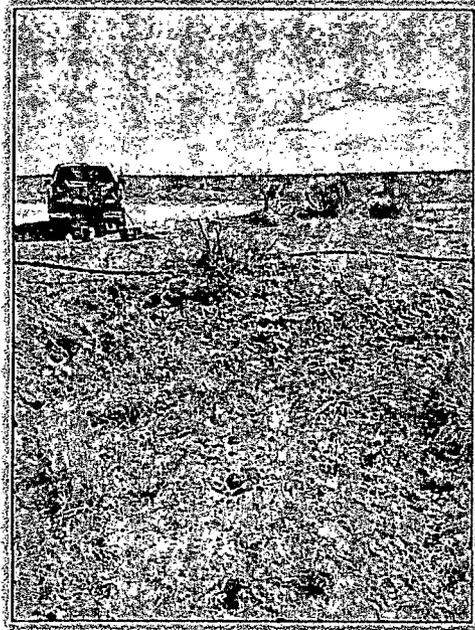
Photo 5.: View of the main footprint of the release from the western side of the release area facing east. Darker soil in the far right and middle of the photo displays the other surface stain at the sample location "Cruces 1".
