R. T. HICKS CONSULTANTS, LTD.

June 2, 2014

RE: Murchison - Hackberry State #1 Release C-141 form

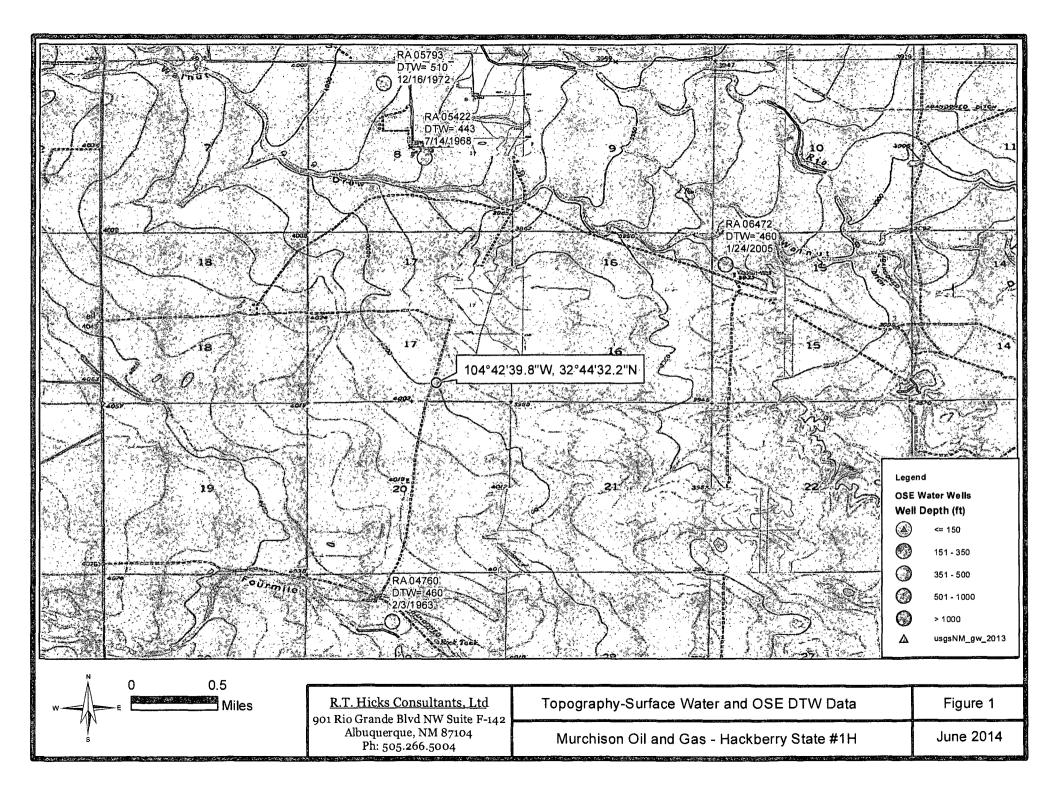
As shown on Figure 1, data from the Office of the State Engineer demonstrate that depth to groundwater exceeds 100 feet and the distance to mapped surface water bodies is nearly ½ mile. The nearest known water well is more than 1 mile distant. Our understanding of how regulated constituents migrate from the source
