Rele	ease Notific	cation	and Co	rrective A	ction					
NAB14	41021	945				OPERA:	TOR		🛚 Initi	al Report		Final Rep	
Name of Co	mpany: BO	OPCO, L.P.		240737		Contact: To	ny Savoie						
				bad, N.M. 8822			No. 575-887-732						
Facility Na	ne: Poker I	Lake Unit 2	74 Tank	Battery		Facility Typ	e: Exploration a	and Proc	duction			******	
Surface Ow	ner: Federa	al	Mineral (Owner: F	Federal			API No	. 30-015-3	35138			
				LOCA	ATION	OF REI	LEASE						
Unit Letter	Section	Township	1 0 1			South Line	Feet from the		East/West Line County				
О	12	24S	29E	360	Sout	outh 2310			East Eddy

FIELD SPILL REPORT

DATE: September 3, 2014

LOCATION OF SPILL SITE: PLU 274 API 30-015-35138 UL O, Sec 12, Twns. 25S, R 29E

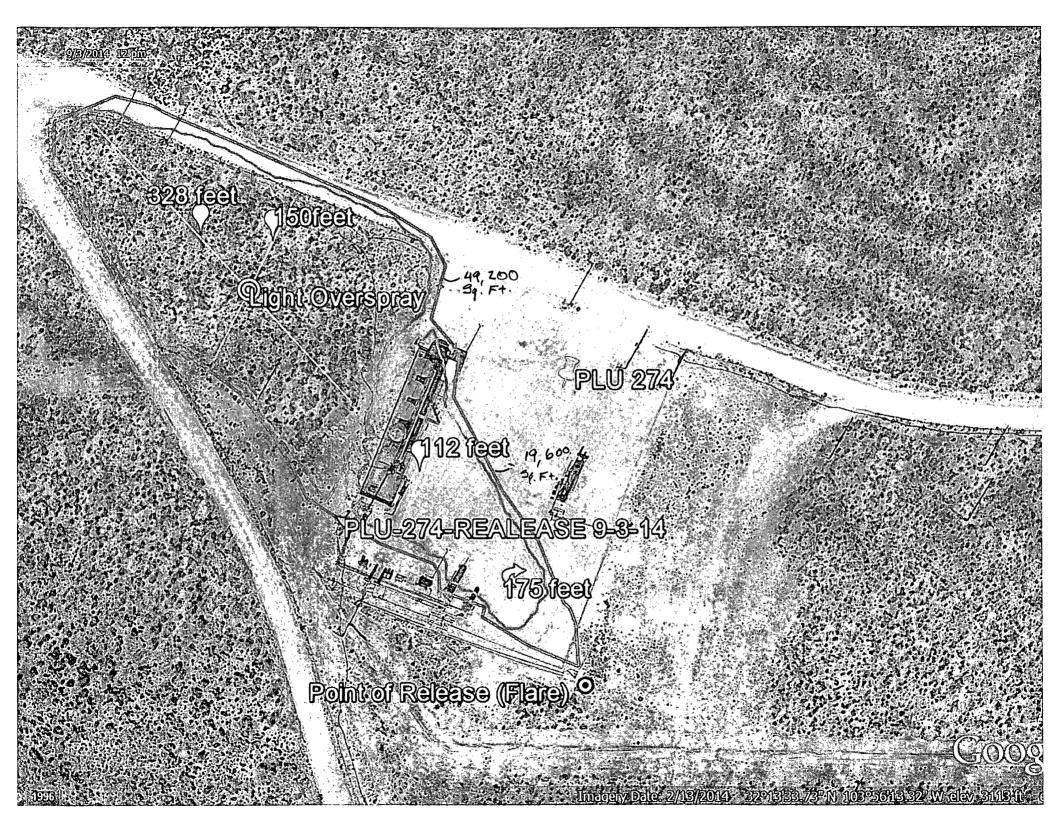
PICTURE ATTACHMENT:

DESCRIPTION (What happened?): Discovery 0940 9/3/14

FWKO float failed sending fluid out the flare line, wind was blowing from SE to NW

EH&S was called to site to review, repairs underway
