Release Notification and Corrective Action

Name of Company: BOPCO, L.P.		OPERATOR	<input checked="" type="checkbox"/> Initial Report <input type="checkbox"/> Final Report
Address: 522 W. Mermod, Suite 704 Carlsbad, N.M. 88220		Contact: Tony Savoie	
Facility Name: BEU-DI-9 #34H (Frac spill at the JRU-29 SWD)		Telephone No. 575-887-7329	
		Facility Type: Exploration and Production	
Surface Owner: State	Mineral Owner: State	API No. 30-015-27735

## FIELD SPILL REPORT

LOCATION OF SPILL SITE: BEU DI-9 #34H Frac spill @ JRU 29(API 30-015-27735) UL "K" 36-22-30

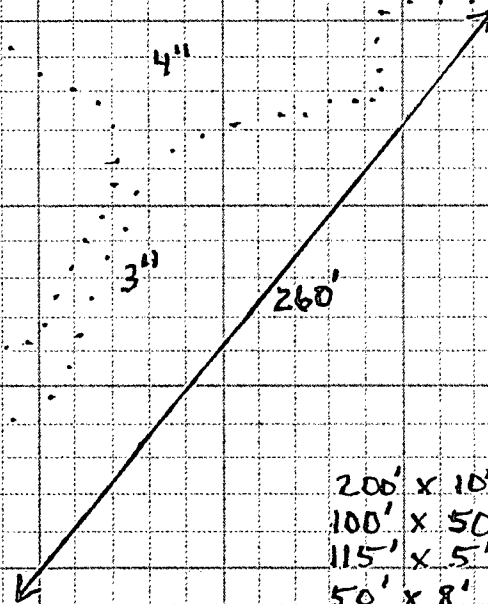
BEU D19 #34H Frac Spill (9-30-2014)

$$\begin{aligned} 200' \times 10' \times 2'' &= 2.97 \text{ bbls} \\ 100' \times 50' \times 4'' &= 14.84 \text{ bbls} \\ 115' \times 5' \times 3'' &= 1.28 \text{ bbls} \\ 50' \times 8' \times 8'' &= 2.37 \text{ bbls} \end{aligned}$$

21.46 bbls

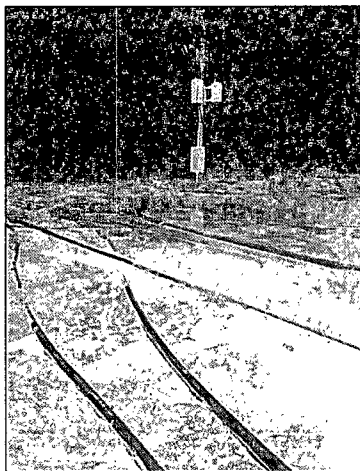
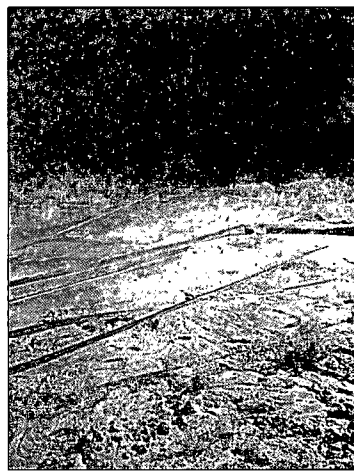
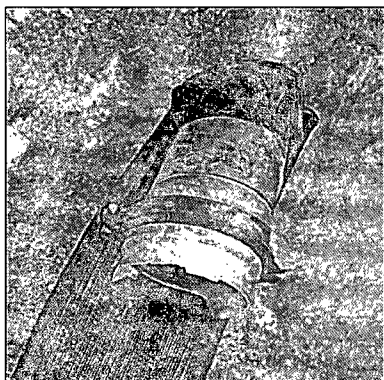
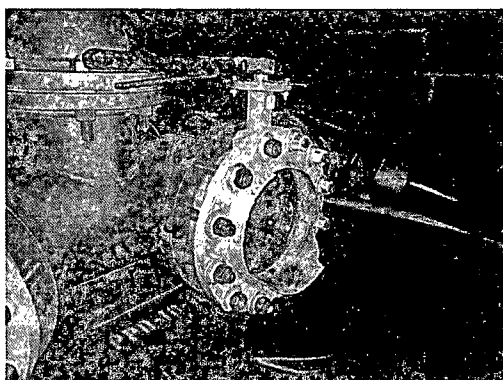
### PICTURE ATTACHMENT:

PW transfer release due to lay flat hose flange failure at the transfer pump. Release occurred during the BEU DI 9 #34H frac. The transfer pump was located at the JRU #29 SWD. The PW went off the So West corner of the pad into the pasture.

When conditions were safe, the leak was isolated and the flange was replaced. EH&S was notified at 11:46 PM 9/30/14 via email. Test were ran on-site to determine PW loss. Impacted area was determined to be approxiamtely 12,476 sq. ft. of pasture. ✓
