Release Notification and Corrective Action

Name of Company: BOPCO, L.P. 2100731	Contact: Tony Savoie
Address: 522 W. Mermod, Suite 704 Carlsbad, N.M. 88220	Telephone No. 575-887-7329
Facility Name: Poker Lake Unit 347H	Facility Type: Exploration and Production

FIELD SPILL REPORT

LOCATION OF SPILL SITE: PLU 347H API 30-015-38668 (UL "C" 11-25S-30E) 540 FNL & 1440 FWL

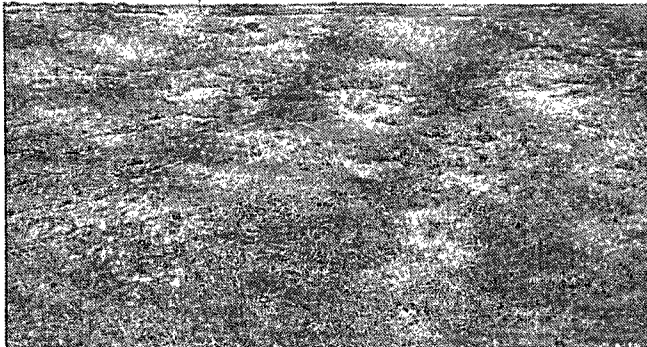
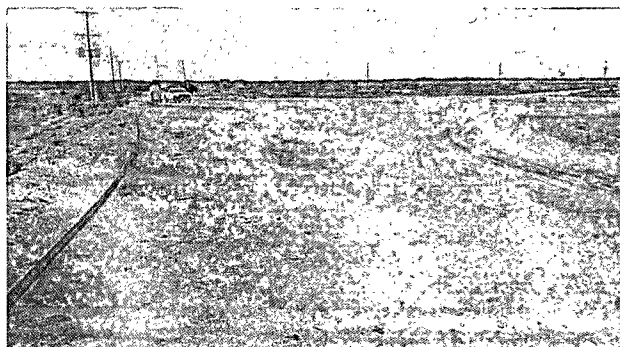
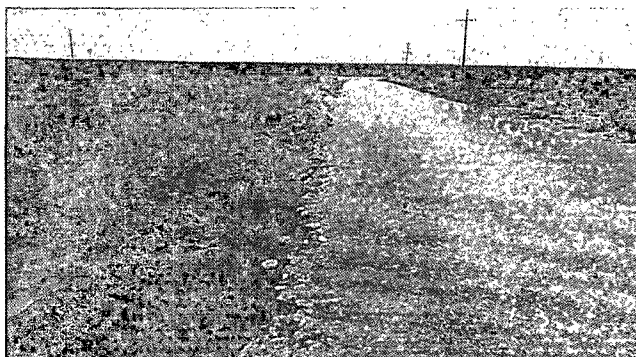
PICTURE ATTACHMENT:

A hammer union on tubing side of the well head caused the leak. The leak covered an area of about 80,900 sq ft, of which 53,700 was in the pasture to the west and south of the site. Estimating a depth of one inch throughout the site, near 60 bbls oil remains in the soil.

Union repaired. Vac truck recovered 40 bbls total fluid (5 of which was oil) not sure yet how much was rain water or produced water.
