### Release Notification and Corrective Action

Name of Company: BOPCO, L.P. <b>2107137</b>	Contact: Tony Savoie
Address: 522 W. Mermod, Suite 704 Carlsbad, N.M. 88220	Telephone No. 575-887-7329
Facility Name: Poker Lake Unit 428H Tank Battery	Facility Type: Exploration and Production

**2RP-2528**

## FIELD SPILL REPORT

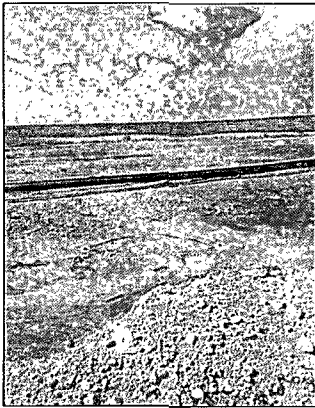
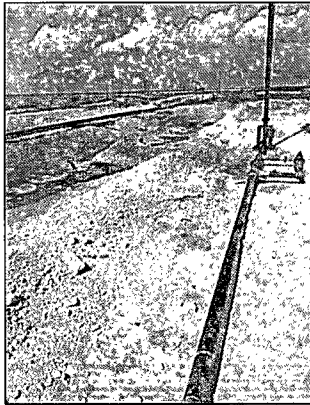
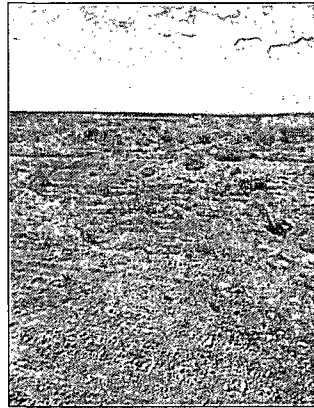
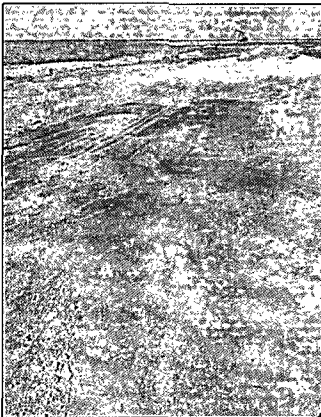
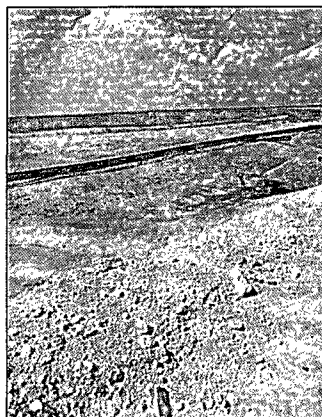
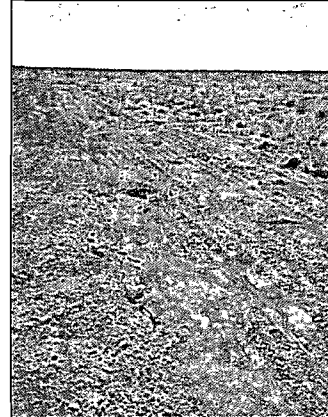
PLU-428 Flare

Pasture was misted with oil when fluid released from flare line.

No fluid recovered. EPI washed down the misted area with micro-blaze on 9/26/14
