**Release Notification and Corrective Action**

Name of Company: BOPCO, L.P. <i>2100737</i>	Contact: Tony Savoie
Address: 522 W. Mermod, Suite 704 Carlsbad, N.M. 88220	Telephone No. 575-887-7329
Facility Name: James Ranch Unit #120H	Facility Type: Exploration and Production

## FIELD SPILL REPORT

LOCATION OF SPILL SITE: JRU 120 Flowline (API-30-015-38116)

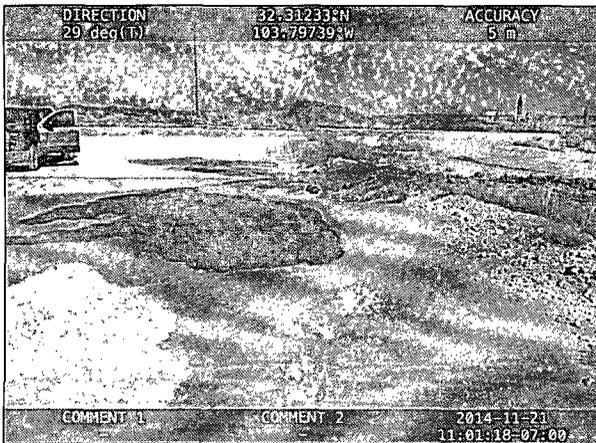
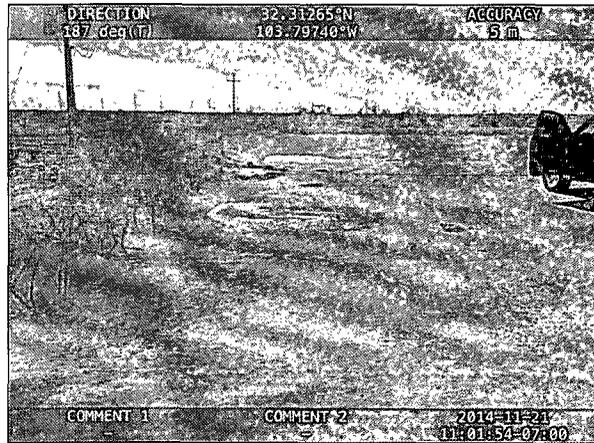
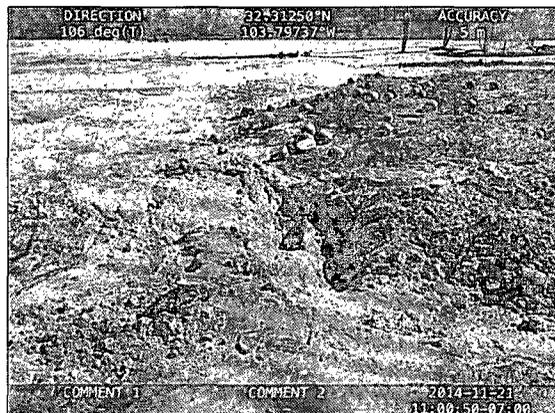
**PICTURE ATTACHMENT:**

Describe Area Affected and Cleanup Action Taken.* The spill impacted approximately 1475 sq.ft. of caliche well pad. The oil and water had soaked into the ground. The saturated soil was scraped up with a backhoe and stockpiled on-site pending removal during the final site remediation. The impacted area will be cleaned up in accordance to the NMOCD and BLM remediation guidelines.

External corrosion on flowline. All stayed on well pad.

CSM backhoe on site scraping up saturated soil. Will stockpile on site pending final remediation.
