Release Notification and Corrective Action

NAB1501255875		OPERATOR	<input checked="" type="checkbox"/> Initial Report	<input type="checkbox"/> Final Report
Name of Company: BOPCO, L.P.		Contact: Tony Savoie		
Address: 522 W. Mermod, Suite 704 Carlsbad, N.M. 88220		Telephone No. 575-887-7329		
Facility Name: JRU-29 SWD Tank Battery, on the Pad with the producing well.		Facility Type: Exploration and Production		
Surface Owner: State of N.M.		Mineral Owner: State of N.M.		API No. 30-015-27735

FIELD SPILL REPORT

Release information for the JRU-29 SWD

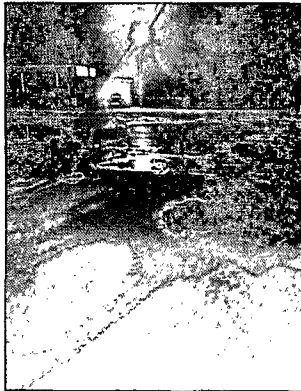
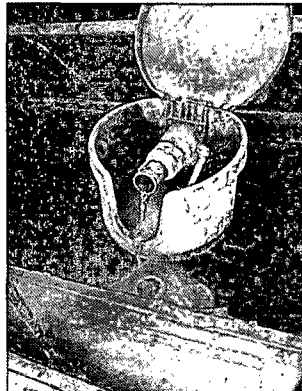
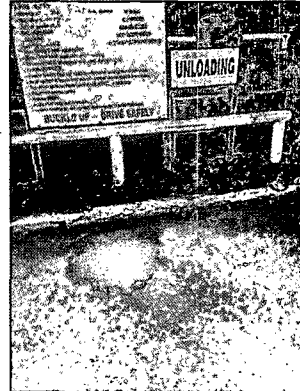
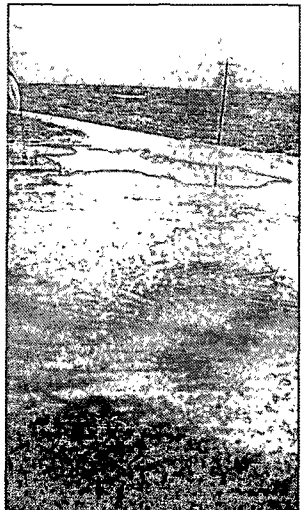
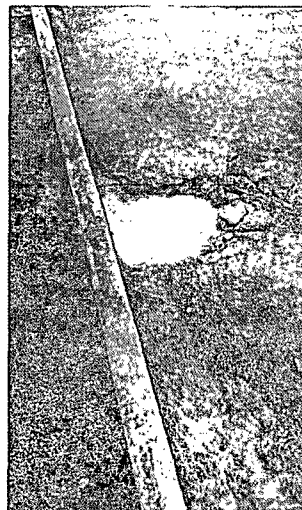
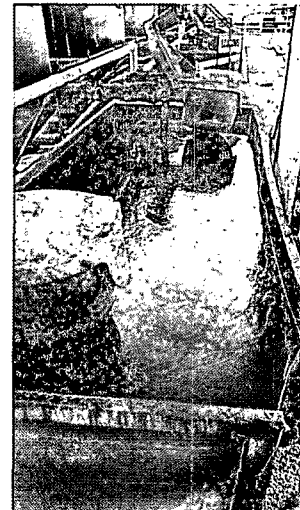
PICTURE ATTACHMENT:

Describe Area Affected and Cleanup Action Taken.* The spill impacted approximately 14,500 sq.ft. of Tank Battery/well pad. A vacuum truck recovered approximately 3 bbls of fluid upon discovery. The pad area had a significant rain event after the release and prior to EH&S site review. The spill area will be cleaned up in accordance to the NMOCD remediation guidelines.		
I hereby certify that the information given above is true and complete to the best of my knowledge and understand that pursuant to NMOCD rules and regulations all operators are required to report and/or file certain release notifications and perform corrective actions for releases which may endanger public health or the environment. The acceptance of a C-141 report by the NMOCD marked as "Final Report" does not relieve the operator of liability should their operations have failed to adequately investigate and remediate contamination that pose a threat to ground water, surface water, human health or the environment. In addition, NMOCD acceptance of a C-141 report does not relieve the operator of responsibility for compliance with any other federal, state, or local laws and/or regulations.

Truck driver failed to control fluids while unloading PW at the facility

Truck was dispatched to recover fluids on the ground. Recovered 3 bbls Produced Water. Spill investigation ongoing. Soil remediation plan being developed for contaminated soil.
