FIELD SPILL REPORT

DATE: January 3, 2015

LOCATION OF SPILL SITE: PLU-CVX-JV-PC #006H API 30-015-36636 ULP, Sec 33, Twns. 24S, R 30E

"aka" Pierce Canyon 33 Federal #1H

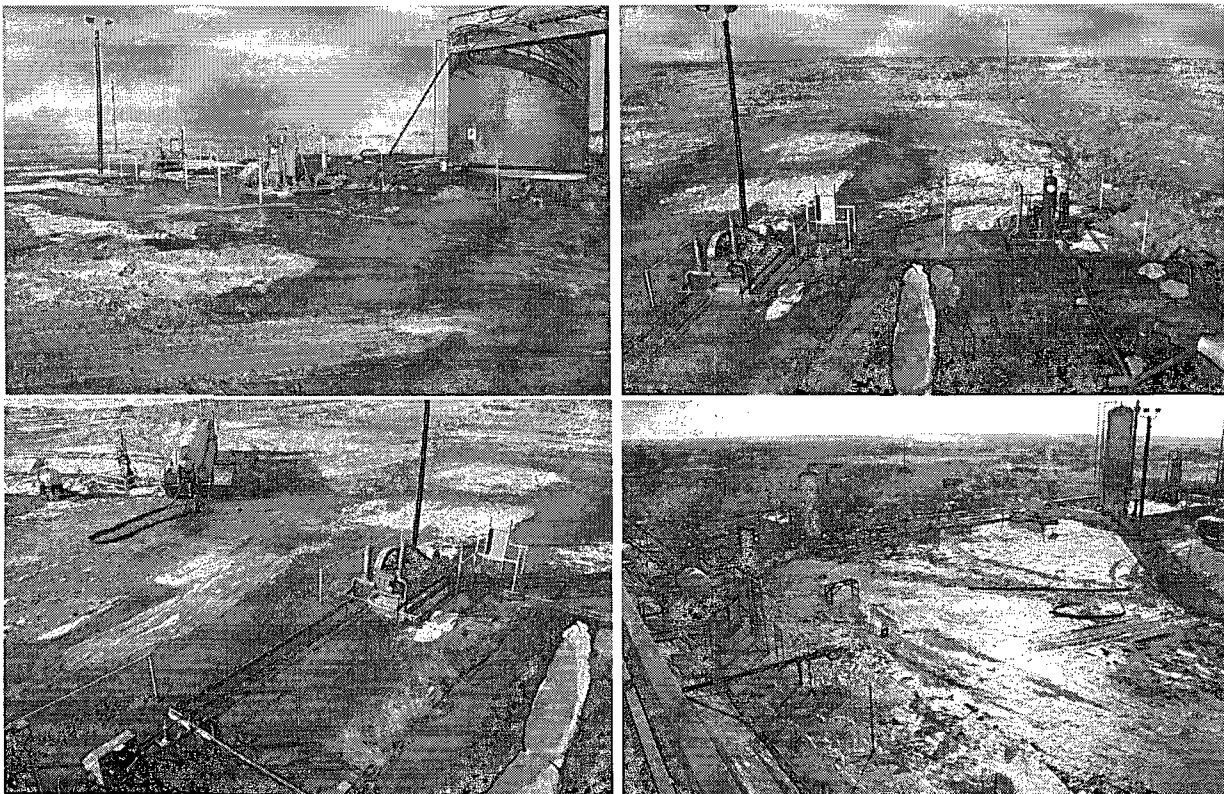
PICTURE ATTACHMENT:

A 1" valve on the truck load line and lact unit suction header failed. EHS was notified at 3 p.m. and the agencies were notified at 3:24 p.m. 1/3/15

The vacuum truck was unable to pick up oil on 1/3/15 due to frozen conditions. Returned on 1/4/15 with a crew and was able to squeegee and recover most of the free standing fluid. EH&S reviewed the site at 9 a.m. It was reported that about 45 bbls total fluid was recovered, a little over half was rain-water . Photographed and determined oil loss in soil. (Photos 1/4/14 at 9:06 am)
