Release Notification and Corrective Action

Name of Company: BOPCO, L.P.	Contact: Tony Savoie
Address: 522 W. Mermod, Suite 704 Carlsbad, N.M. 88220	Telephone No. 575-887-7329
Facility Name: PLU-CVX-JV-RR #006H	Facility Type: Exploration and Production

FIELD SPILL REPORT

LOCATION OF SPILL SITE: Frac Activities at the PLU-CVX-JV-RR #006H (API 30-015-40580)

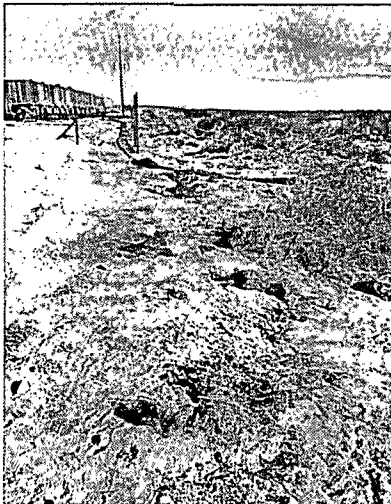
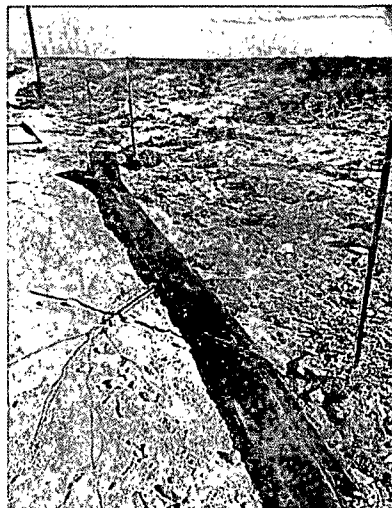
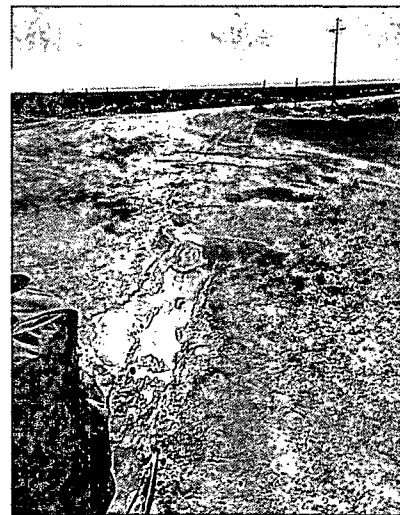
PICTURE ATTACHMENT:

Release associated with the lay flat hose. Looks like fluid was released while rolling up / moving the lay flat.
