Report Type: Work Plan

Site:	Santa Elena 19 Federal #001H
Company:	COG Operating LLC
Section, Township and Range	Unit E Sec 19 T16S R30E
Lease Number:	(API#) 30-015-40567
County:	Eddy County
GPS:	32.91029° N 104.01885° W
Surface Owner:	Federal
Mineral Owner:	
Directions:	From Loco Hills travel north on CR 217 for approx. 3.73 miles. Turn left traveling west 2.9 miles and turn right (north). Continue traveling north 5.2 miles and turn back to the east. Travel 1.4 miles to the location on the left.

**Re: Work Plan for the COG Operating LLC., Santa Elena 19 Federal #001H,
Unit E, Section 19, Township 16 South, Range 30 East, Eddy County,
New Mexico.**

Spill Assessment Map

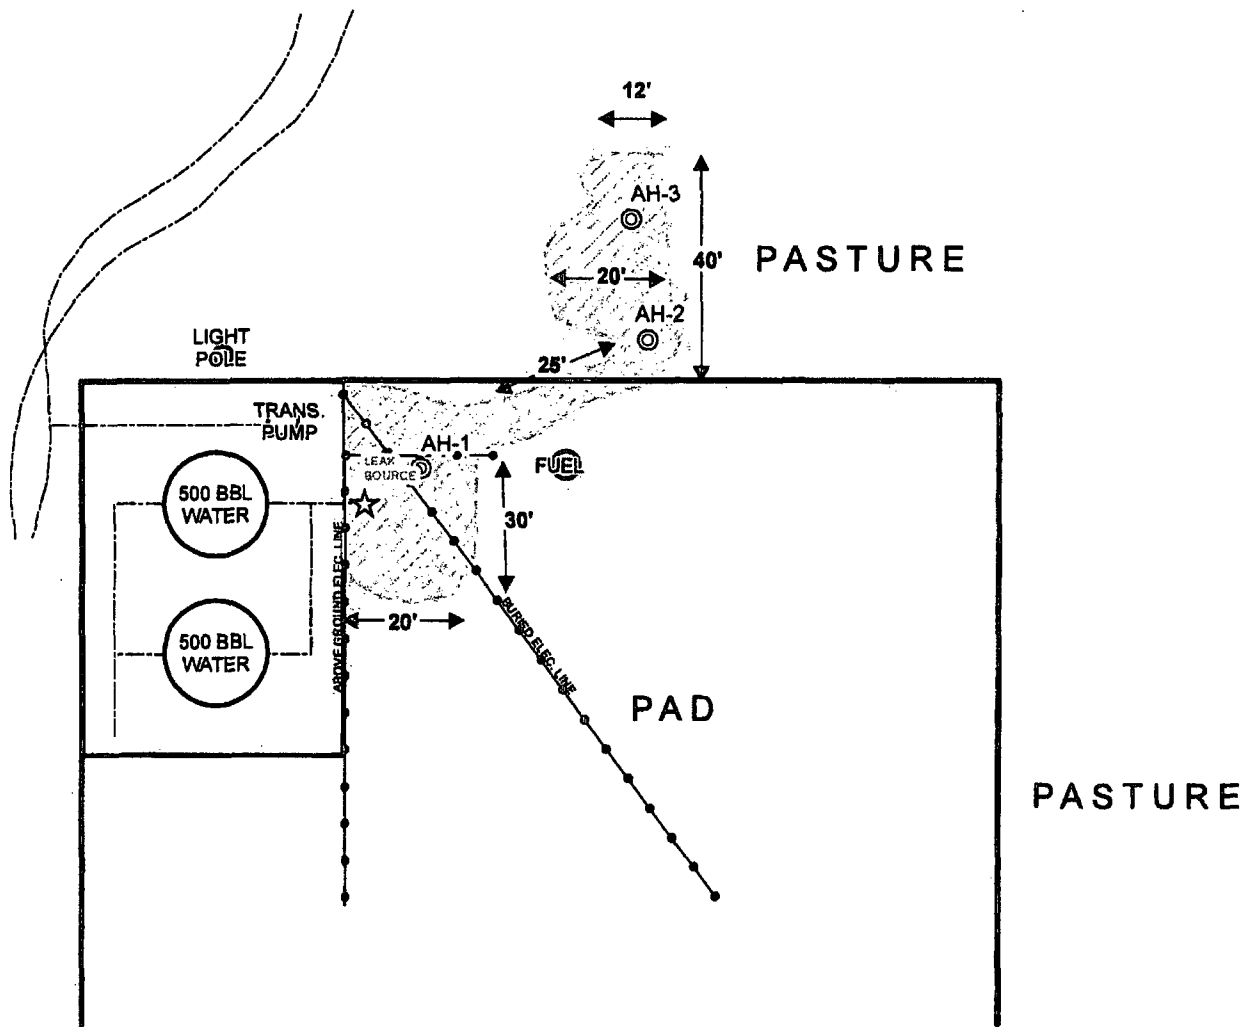
Figure 3

Referring to Table 1, all of the auger hole samples were below the RRAL for TPH and BTEX. Auger hole (AH-1) did not show a chloride impact to the area. A shallow chloride impact was detected in the areas of AH-2 and AH-3, which showed elevated chloride concentrations in the shallow soils and declined significantly at 5-5.5' and 4-4.5' of 68.3 mg/kg and <20.0 mg/kg, respectively.
