Release Notification and Corrective Action

Name of Company: BOPCO, L.P. <i>260737</i>	Contact: Tony Savoie
Address: 522 W. Mermod, Suite 704 Carlsbad, N.M. 88220	Telephone No. 575-887-7329
Facility Name: PLU-85	Facility Type: Exploration and Production

FIELD SPILL REPORT

LOCATION OF SPILL SITE: PLU 085 (API 30-015-27911)

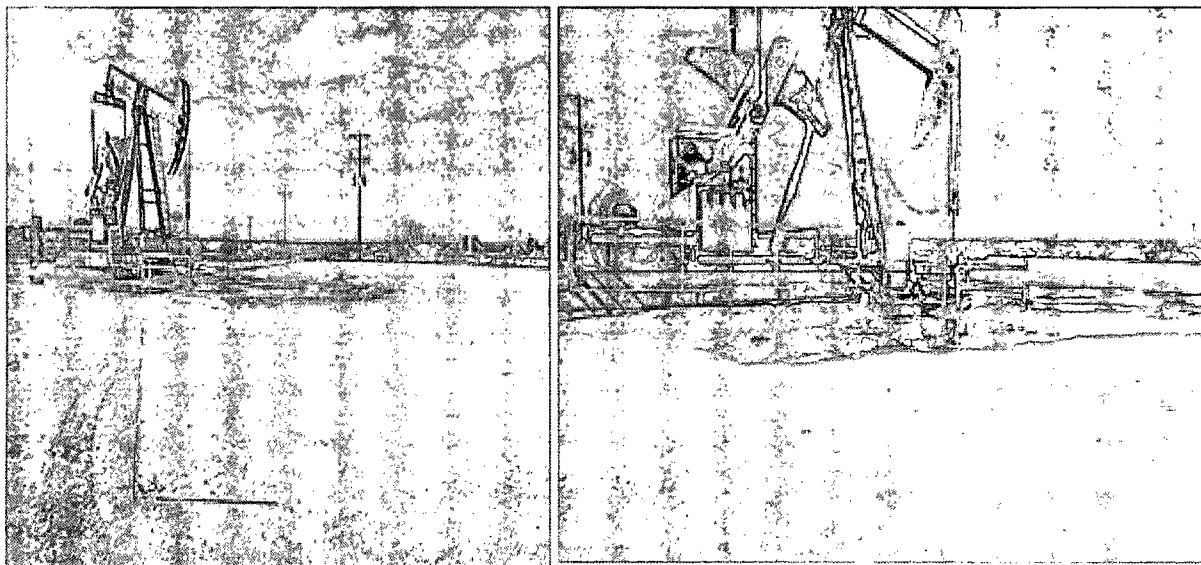
High Pressure hose on the kill switch ruptured due to weathering of hose.

Site was reviewed on 3/23/15. Vacuum truck was able to recover 0.5 bbl of crude oil and approximately 4 bbls of produced water. Hose to be replaced.

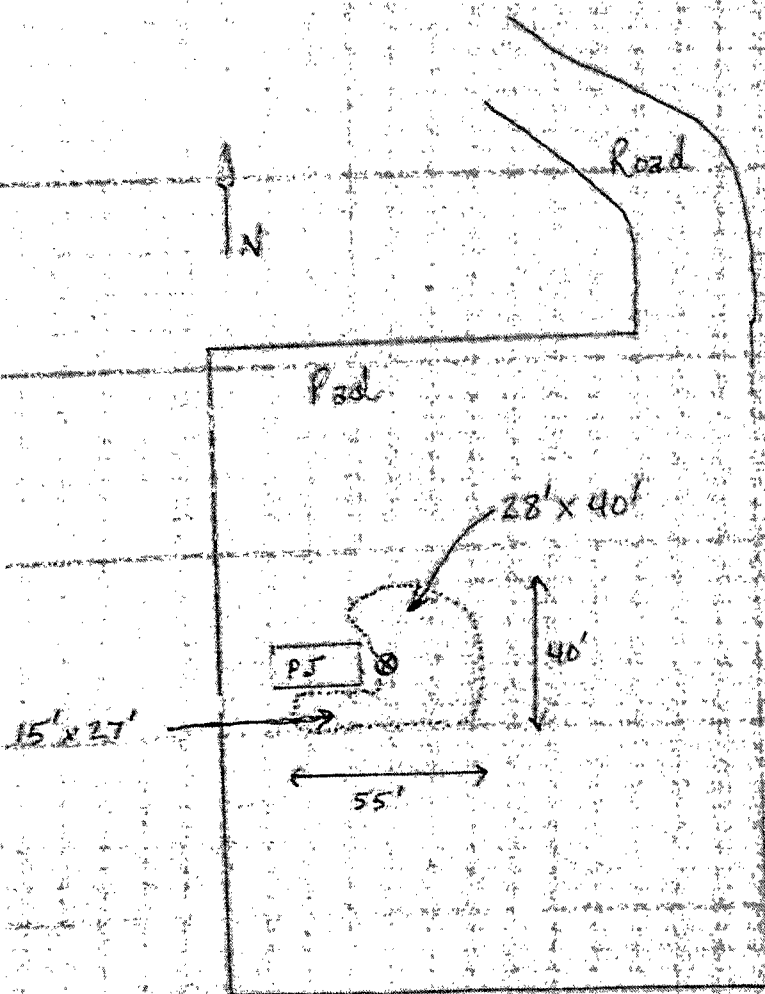
FLU #085

HP hose on the kill switch ruptured due to weathering. Was recovered 1/2 bbl oil and 4 bbls PLW. Detected 1525 # of pad. HP hose will be replaced with SS tubing.

Oil

$$28' \times 40' \times \frac{1}{4}'' = \boxed{0.21 \text{ bbls}}$$

PLW

$$28' \times 40' \times \frac{3}{4}'' = 2.49$$

$$15' \times 27' \times 1'' = 0.30$$

$$\boxed{2.79 \text{ bbls}}$$
