Report Type: Work Plan

Site:	Foster Eddy #9 (flow line)					
Company:	COG Operating LLC					
Section, Township and Range	Unit J	Sec. 17	T-17-S	R-31-E		
Lease Number:	API-30-015-26273					
County:	Eddy County					
GPS:	32.83314° N			103.88694° W		
Surface Owner:	Federal					
Mineral Owner:						
Directions:	Intersection of NM 82 and 529 travel west on 82 0.9 miles, turn right 0.9 miles, left 0.3 miles, right 0.1 miles to location on left.

Re: Assessment and Work Plan for the COG Operating LLC., Foster Eddy #9 (Flow line), Section 17, Township 17 South, Range 31 East, Eddy County, New Mexico.

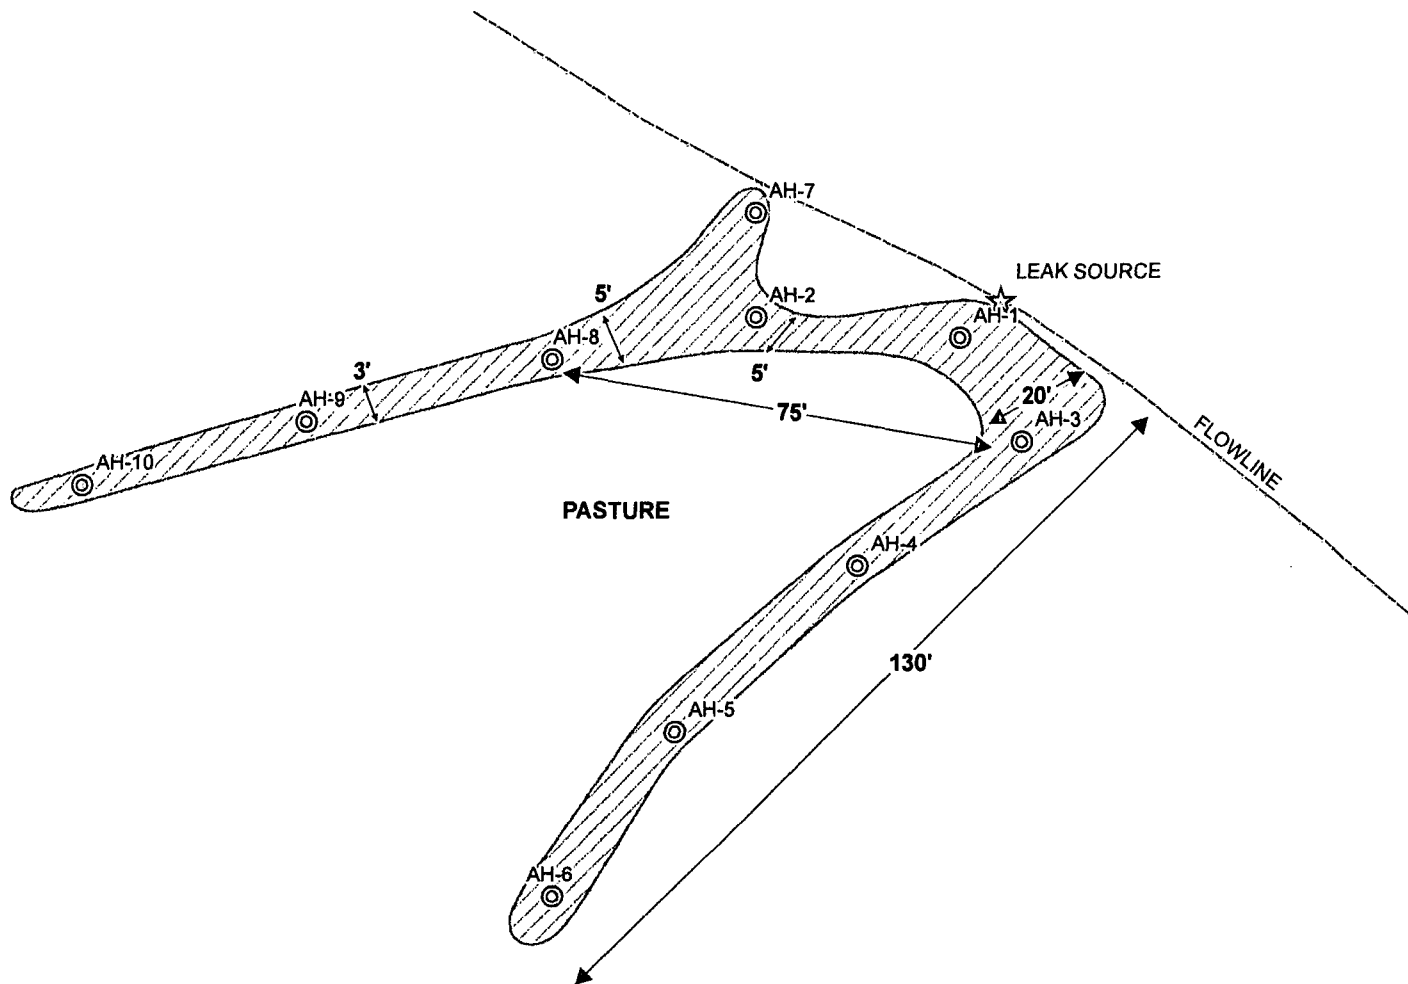
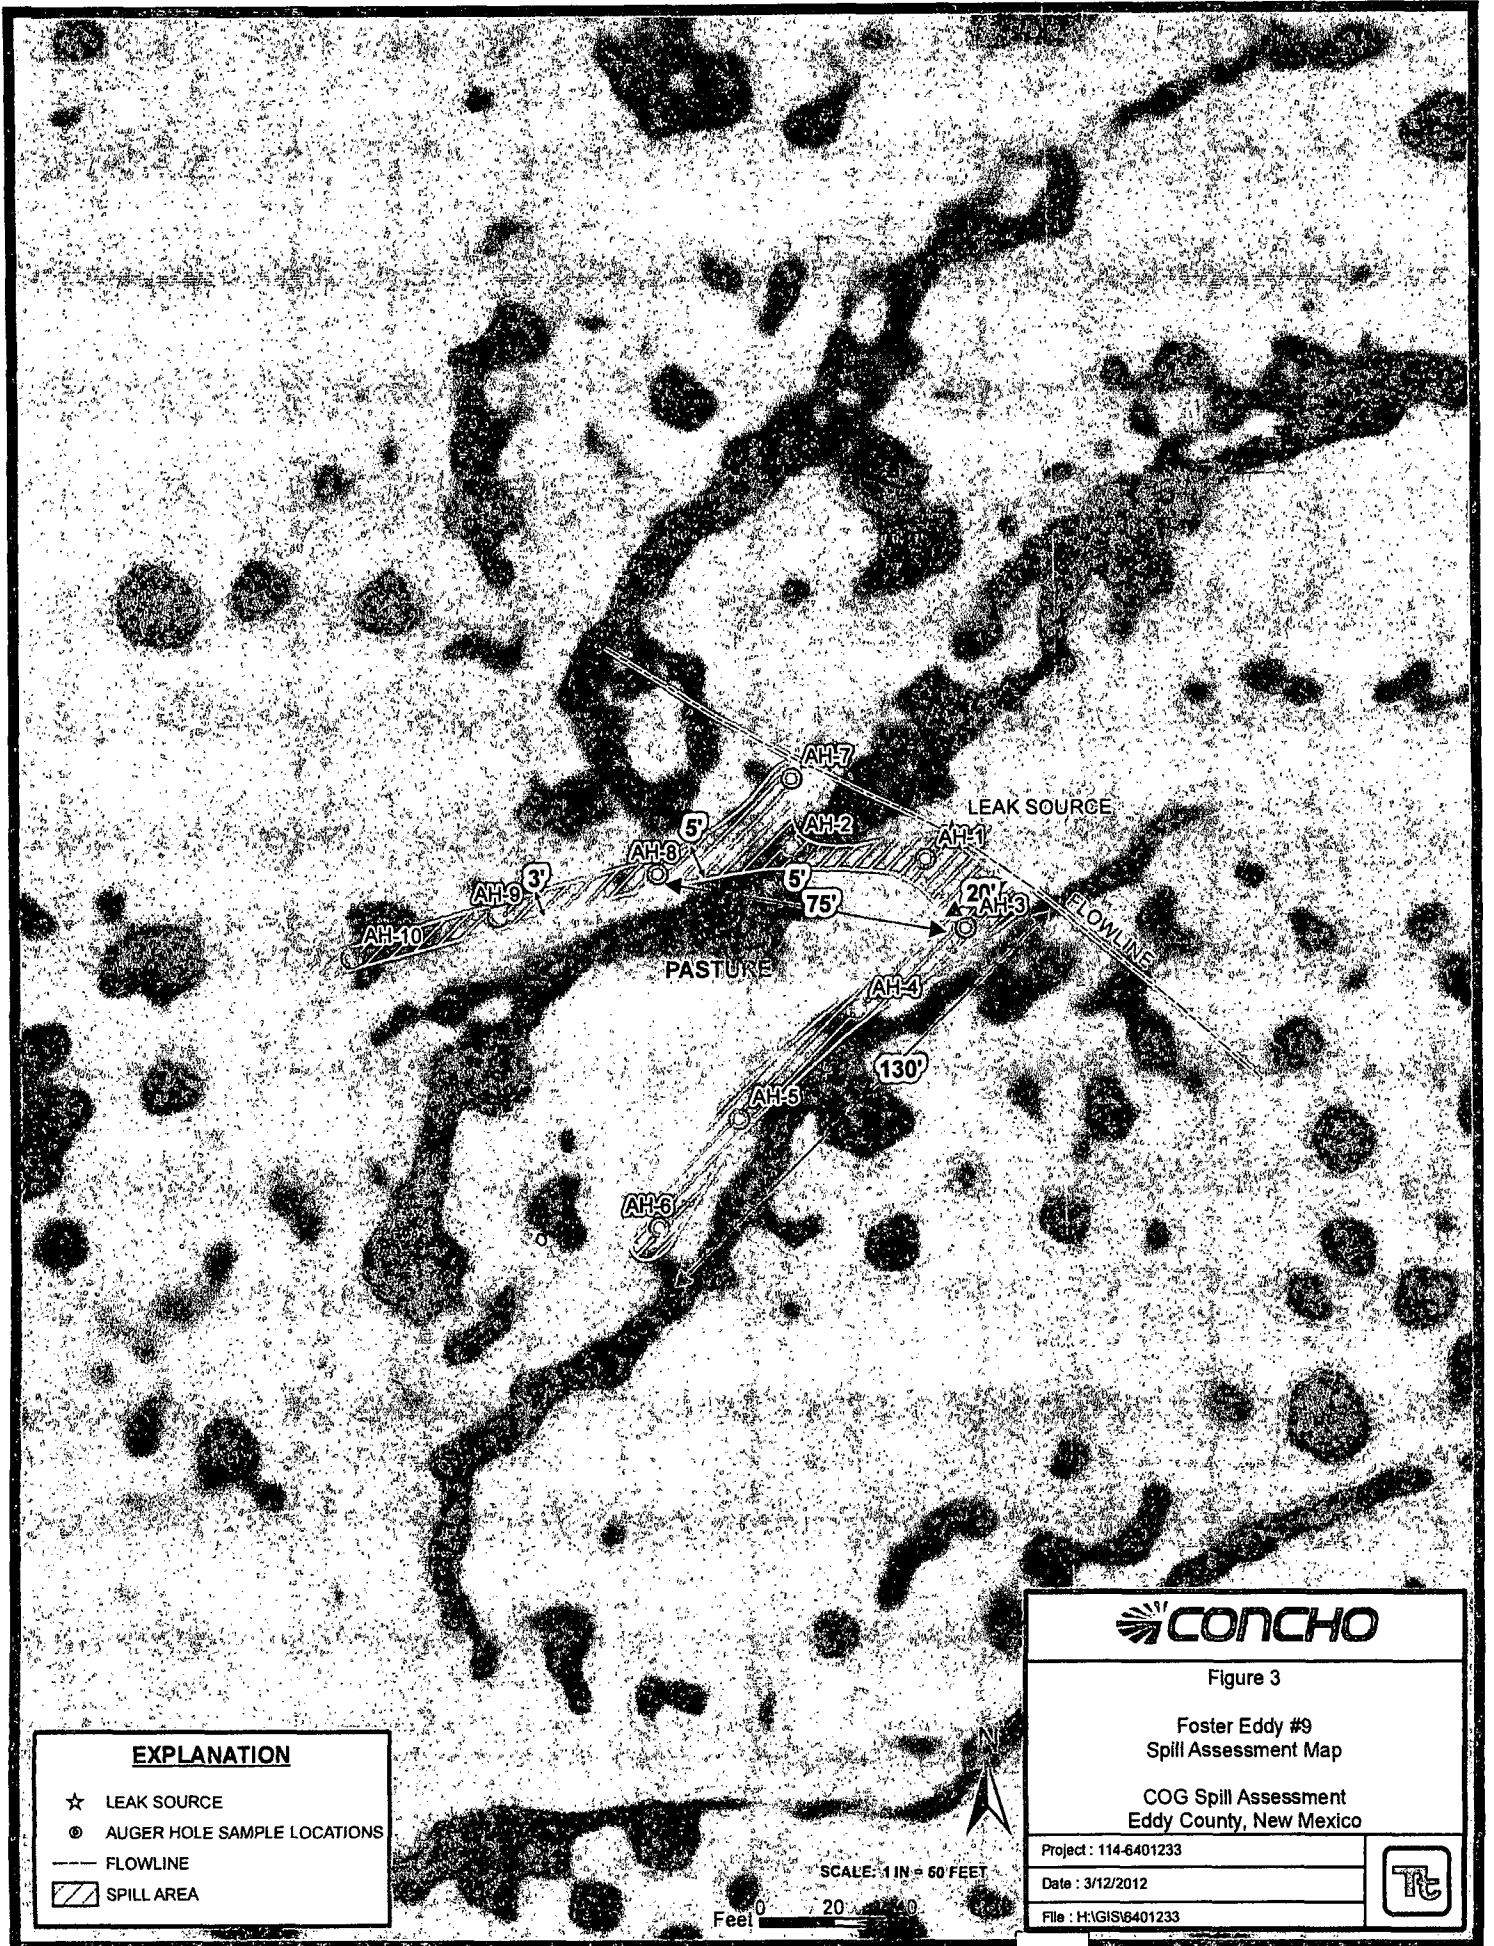
Figure 3

The spill initiated from the polyline located on high ground near a native dry arroyo/wash. The spill migrated into the bottom of the dry arroyo/wash area and flowed in two directions. The impact of the spill measured an approximate length of 130', with a width of 3' to 5' in both spill paths. The spill areas are shown on Figures 3. The initial Form C-141 is enclosed in Appendix A.

On February 8, 2012, Tetra Tech personnel inspected and sampled the spill area. A total of ten (10) auger holes (AH-1 through AH-10) were installed using a stainless steel hand auger to assess the impacted area. Selected samples were analyzed for TPH analysis by EPA method 8015 modified, BTEX by EPA Method 8021B and chloride by EPA method 300.0. Copies of laboratory analysis and chain-of-custody documentation are included in Appendix C. The sampling results are summarized in Table 1. The auger hole locations are shown on Figure 3.

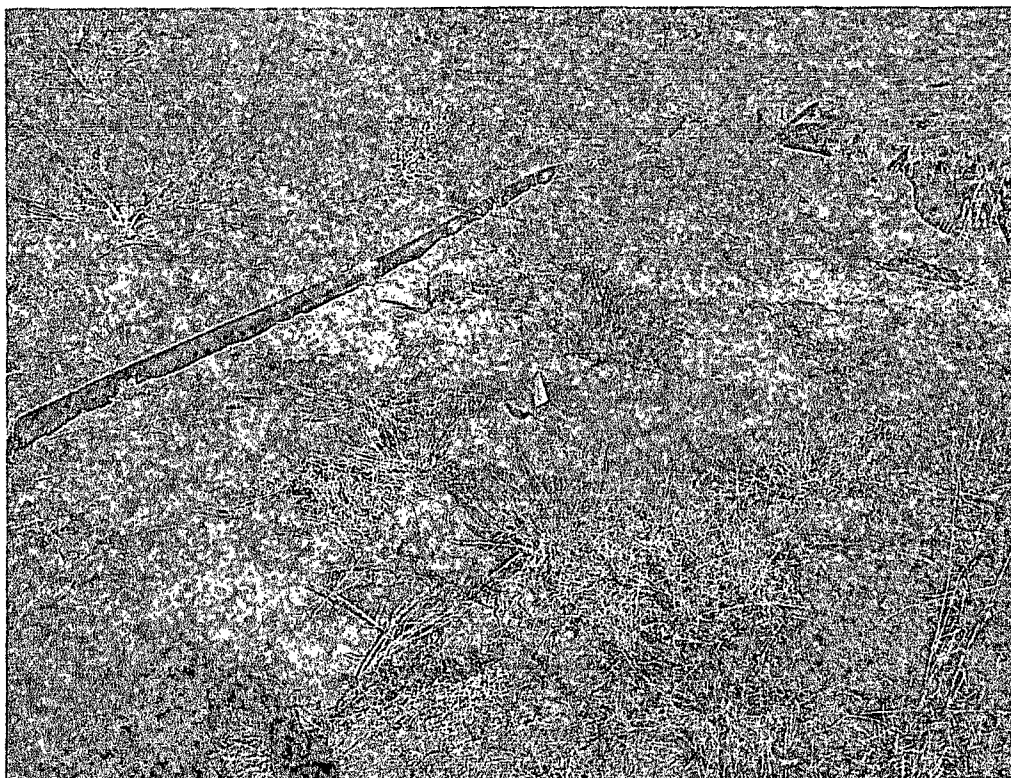
View north east near source and AH-1

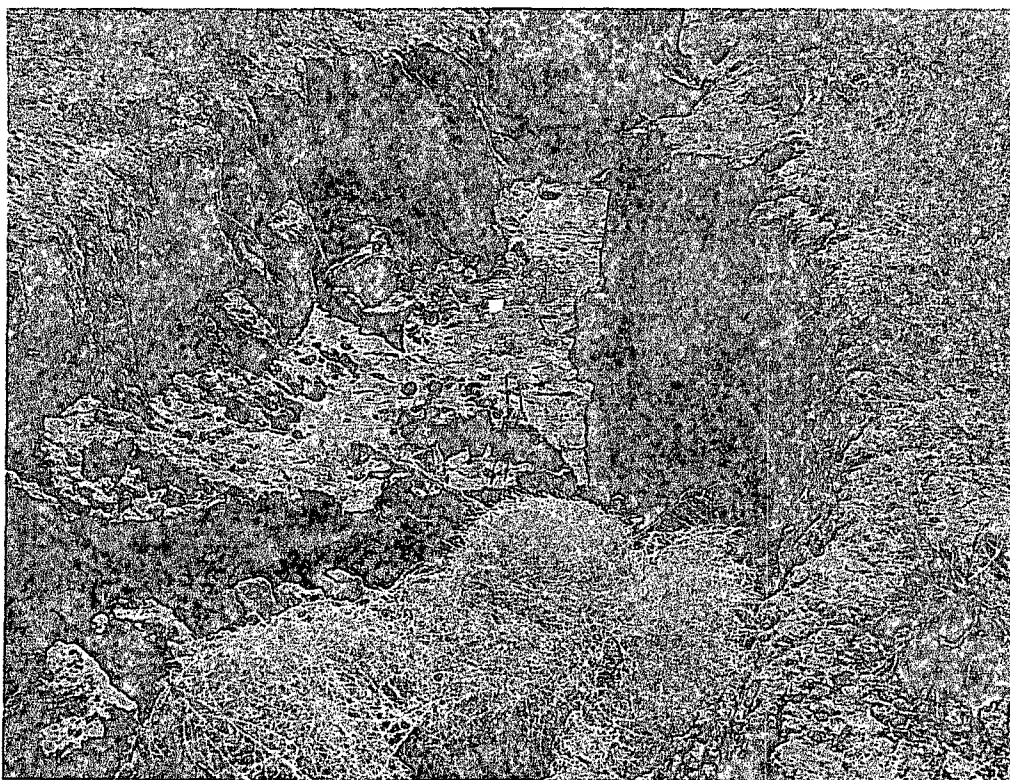
View south west along arroyo/wash near AH-4

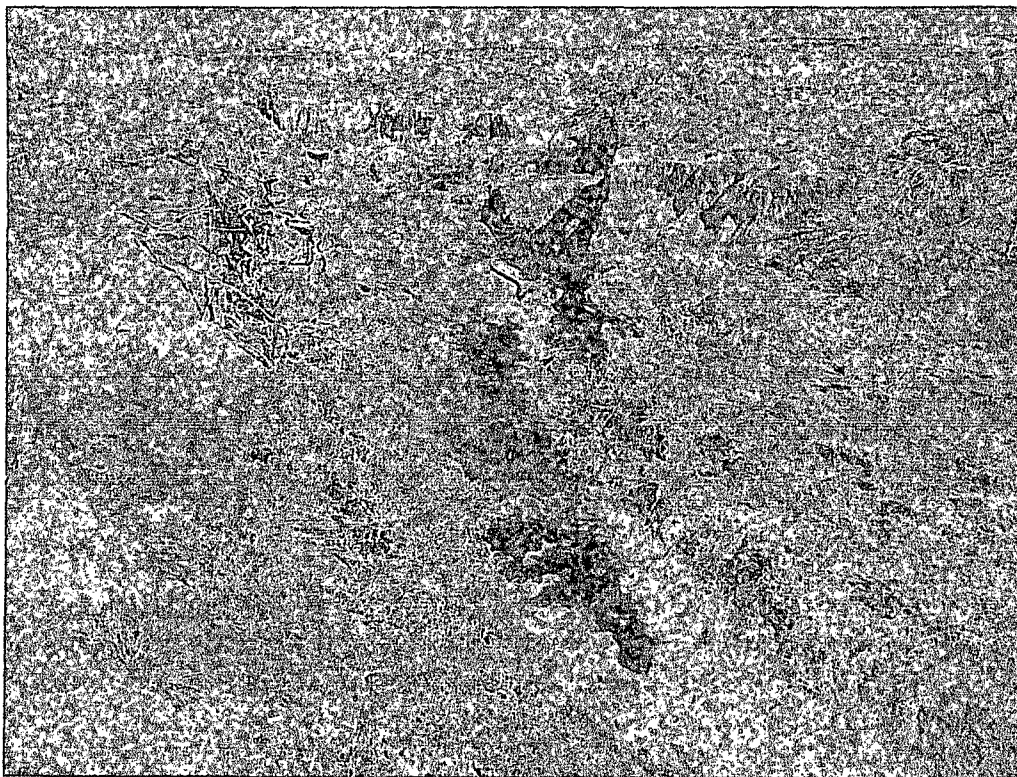
Referring to Table 1, all of the auger holes were below the RRAL for TPH and BTEX, with the exception AH-10. Auger hole (AH-10) showed TPH concentrations of 12,800 mg/kg at 0-1' which declined below the RRAL at 1-1.5' below surface to 4,280 mg/kg. In addition, the benzene and total BTEX concentrations exceeded the RRAL in the surface soils and declined below the RRAL at 2.0' and 3.0', respectively.

View north east – edge of spill path near AH-10
