## **Cedar Lake 8" Main Line**

(Release Date 8/11/11)

### **ENVIRONMENTAL SITE INVESTIGATION**

### **CLOSURE REPORT**

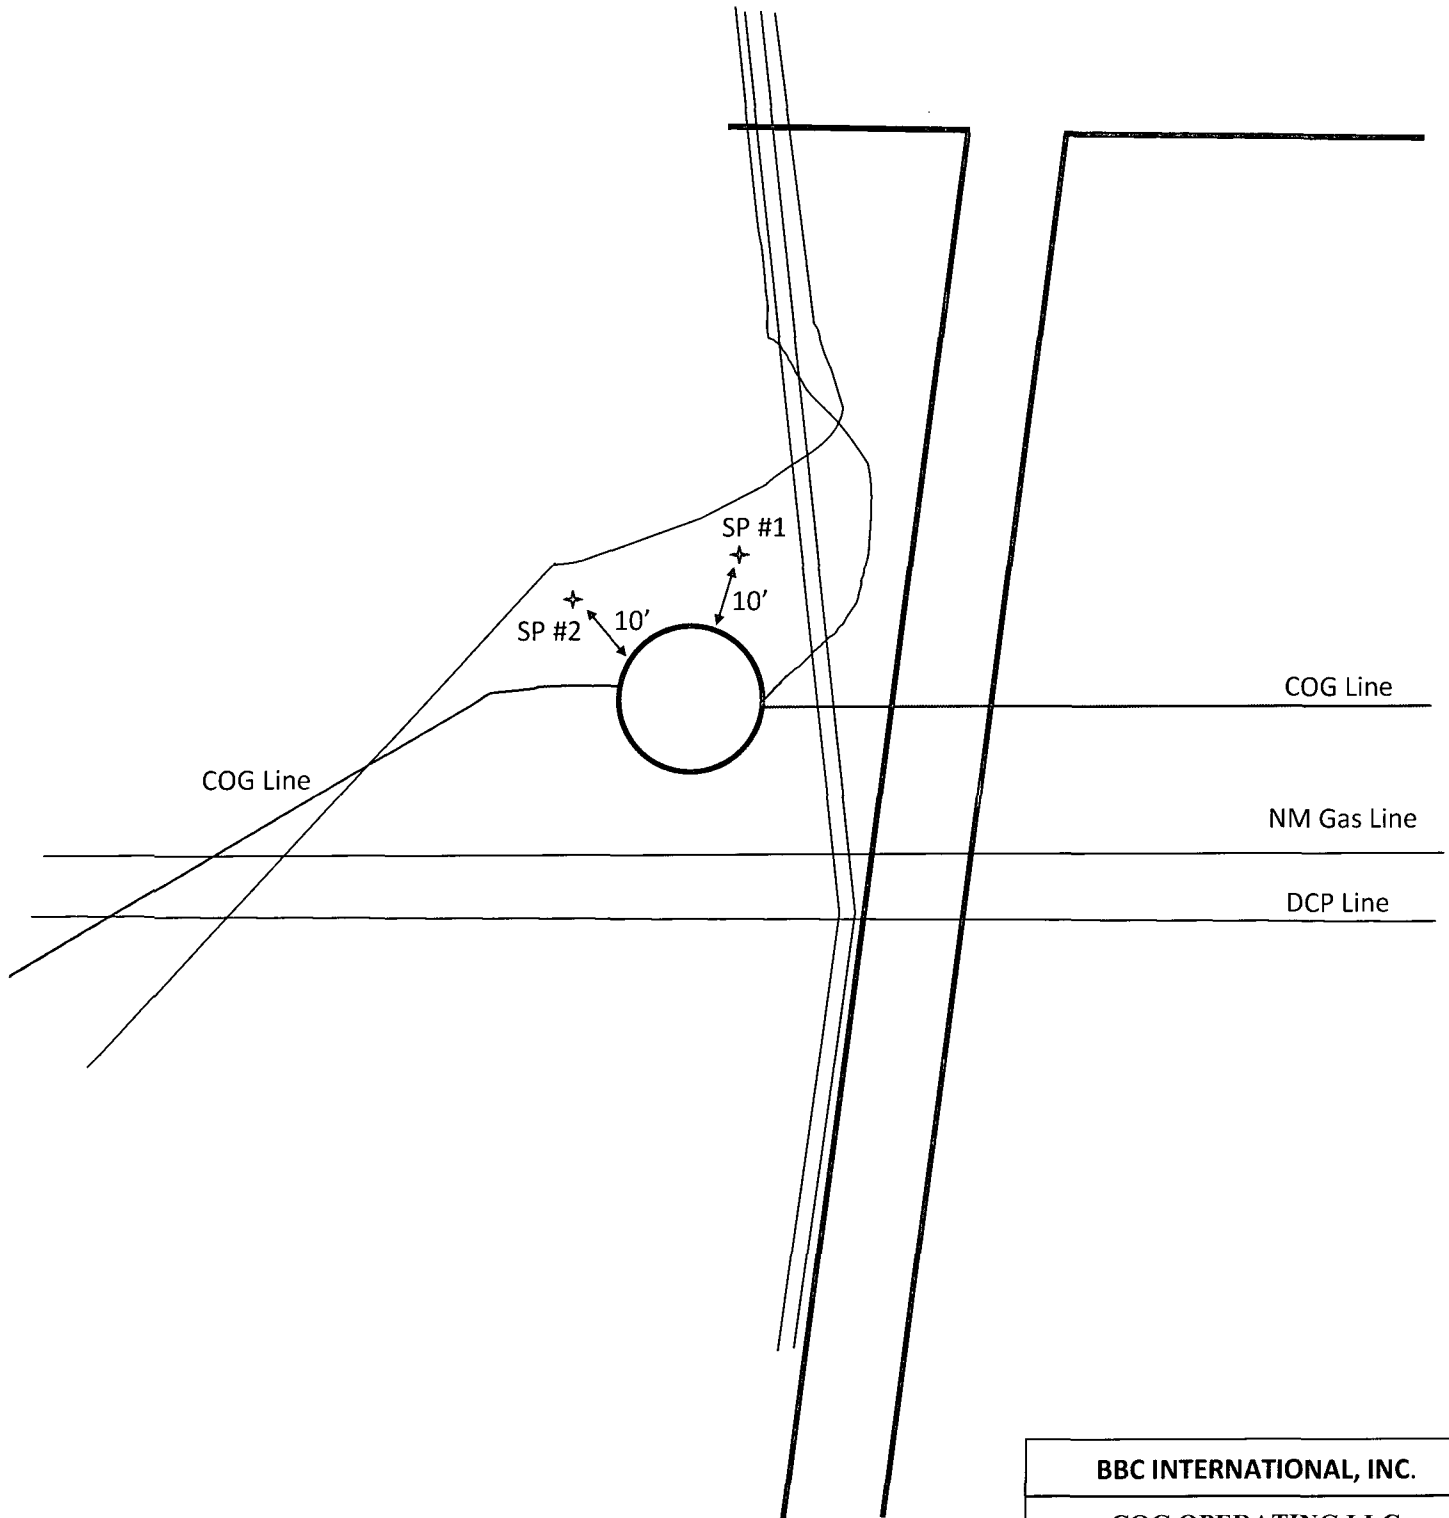
## Site Diagram

A diagram of the leak area including the sample points can be reviewed in Appendix I of this report. The surface soil is red sand. There is no water source within 1,000 feet of the site. There is no surface water within 1,000 feet of the site. Based on data from the Eddy County Groundwater Trend Map, the depth to groundwater in Section 20, Township 17 South, and Range 31 East is 350'. The initial C-141 is at the end of this report in Appendix III.

On August 18, 2011, BBC personnel conducted a delineation of the site. Two sample points were advanced in the leak area using hand auger to a total depth of 2 feet. Three samples were taken from SP1 one at surface, one at one foot, and one at 2 feet. Two samples were taken from SP2 one at surface, and one at one foot. The samples were taken to Cardinal Laboratories for chloride analysis. Laboratory analysis for SP1 @ surface is 32 ppm chloride. Laboratory analysis for SP1 @ 1' is 32 ppm chloride. Laboratory analysis for SP1 @ 2' is 32 ppm chloride. Laboratory analysis for SP2 @ surface is 320 ppm chloride. Laboratory analysis for SP2 @ 1' is 48 ppm chloride. The results of the analysis are located in Appendix II of this report. The sample point locations can be viewed on the site diagram in Appendix I of this report.
