Report Type: Work Plan

Site:	White Star Federal Flow line	
Company:	COG Operating LLC	
Section, Township and Range	Unit H Sec. 29 T-17S R-29E	
Lease Number:	NMNM-14840	
County:	Eddy County	
GPS:	32.80639° N	104.08904° W
Surface Owner:	Federal	
Mineral Owner:		
Directions:	From the intersection of Hwy 82 and Hagerman Cutoff (Loco Hills, NM) travel west on 82 (5.3 mi), turn left (0.2 mi), right (0.9 mi) to location on left.

Re: Work Plan for the COG Operating LLC., White Star Flow line, Unit H, Section 29, Township 17 South, Range 29 East, Eddy County, New Mexico.

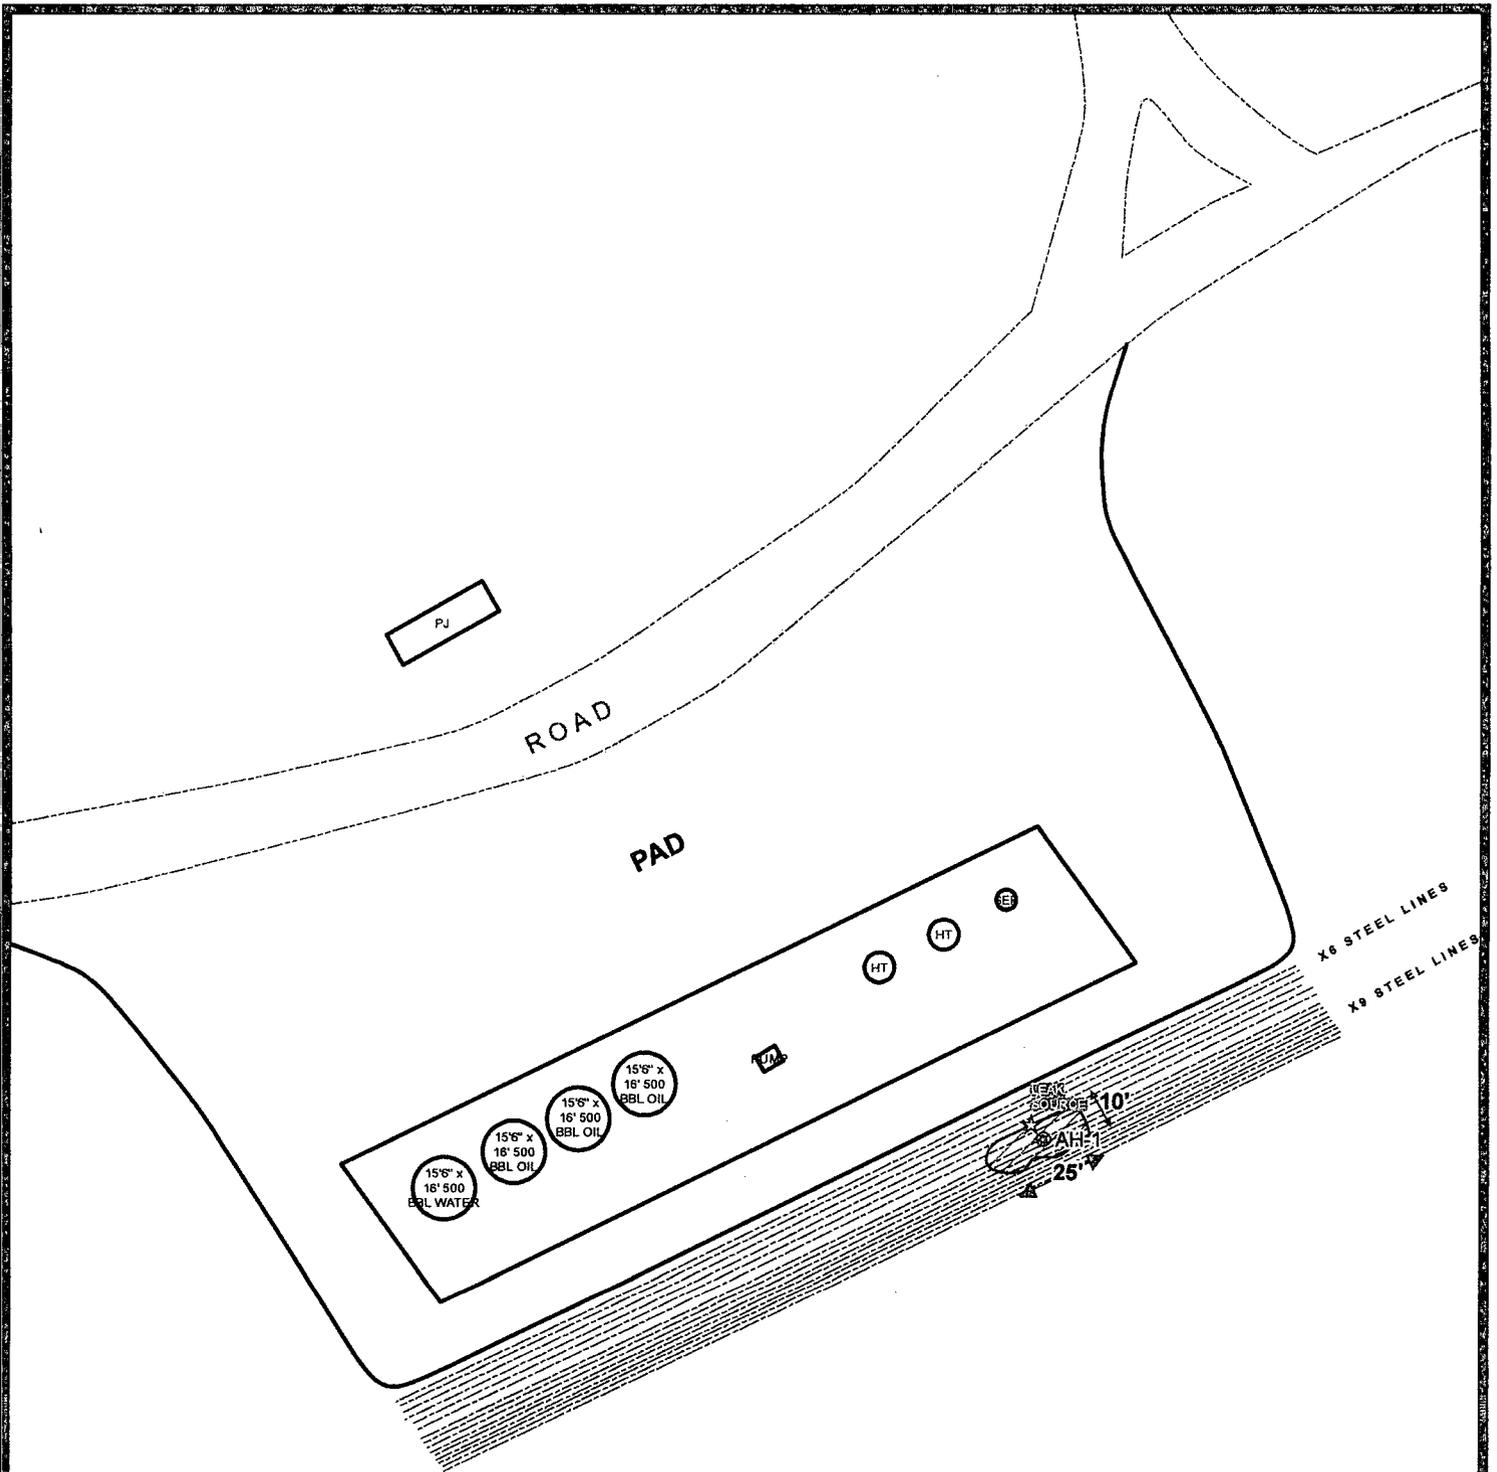
Figure 3	
White Star Federal	
Spill Assessment Map	
Eddy County, New Mexico	
Project : 114-6400888	
Date : 8/14/2012	
File : H:\GIS\6400888

On April 20, 2011, Tetra Tech personnel inspected and sampled the spill area. One auger hole (AH-1) was installed using a stainless steel hand auger to assess the impacted soils. Selected samples were analyzed for TPH analysis by EPA method 8015 modified, BTEX by EPA Method 8021B and chloride by EPA method 300.0. Copies of laboratory analysis and chain-of-custody documentation are included in Appendix C. The results of the sampling are summarized in Table 1. The auger hole location is shown on Figure 3.

Referring to Table 1, the surface sample of AH-1 (0-1') exceeded the RRAL for TPH and BTEX. The remaining deeper samples of AH-1 were below the RRAL for TPH and BTEX. Elevated chloride concentrations were in the subsurface soils and showed a bottom auger hole analysis of 2,450 mg/kg at 7-7.5' below surface. The chloride impact was not vertically defined.

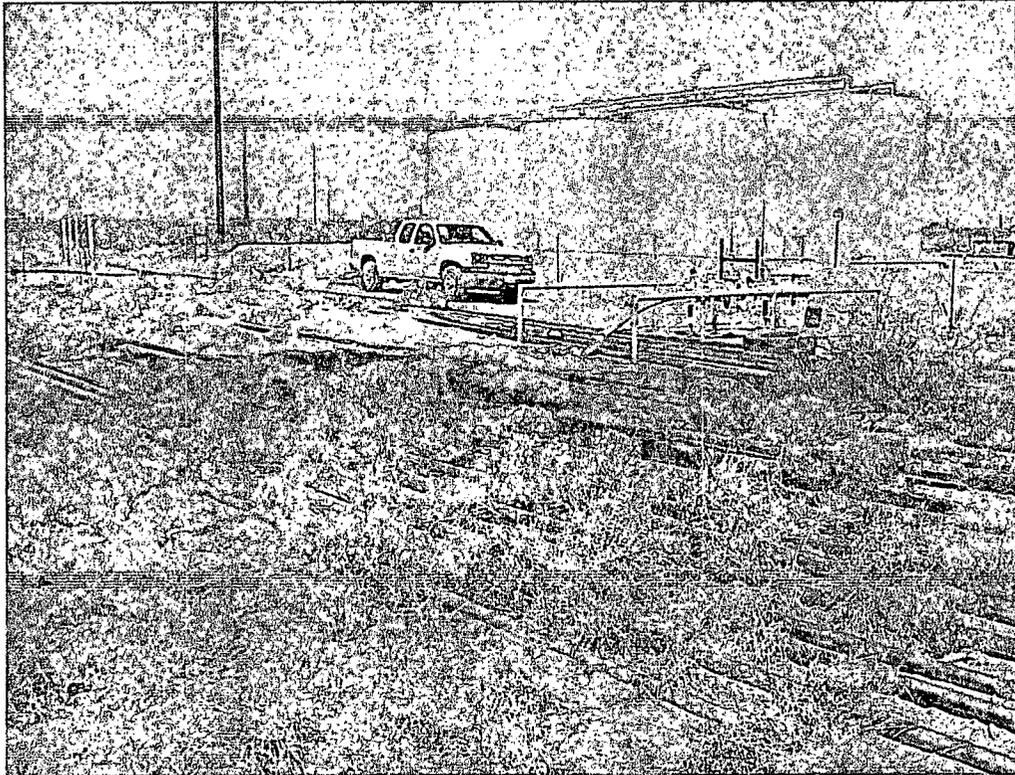
View north of spill (April 20, 2011)

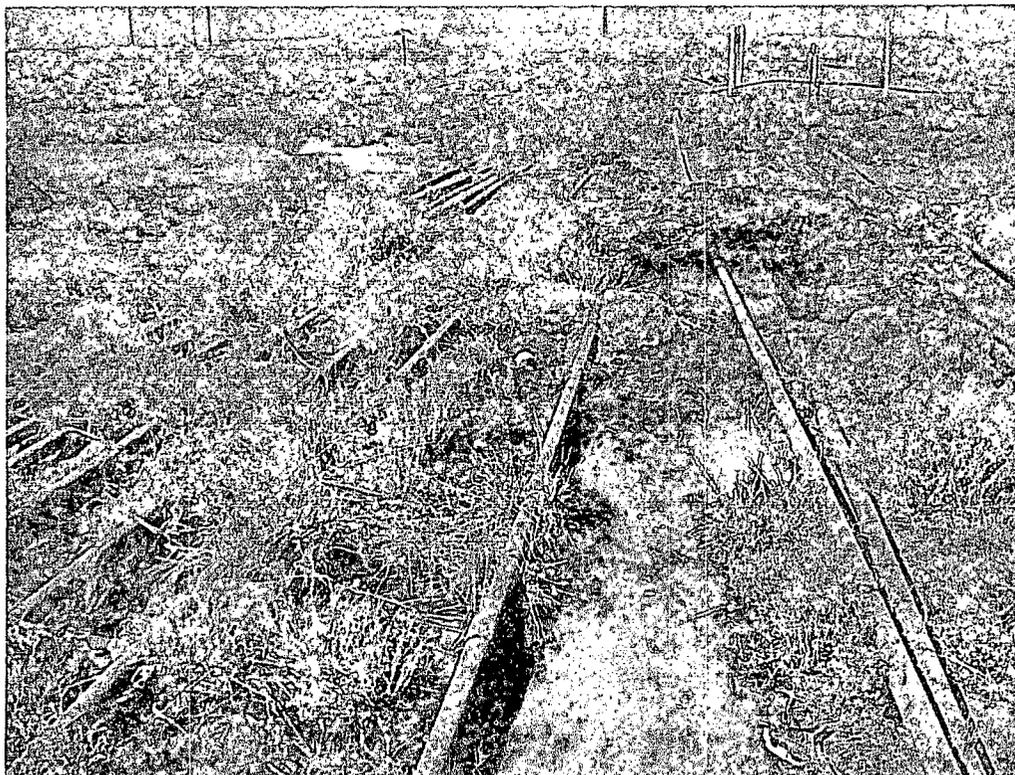
Based on the location of the spill, the proposed excavation areas or depths may not be achieved due to oil and gas equipment, structures or lines which may not be feasible or practicable to be removed due to safety concerns. As such, Tetra Tech will excavate the soils to the maximum extent practicable. If the impacted soil is not accessible, the soil will be deferred until the abandonment of the facility.

Limited access due to steel lines (April 20, 2011)
