Report Type: Closure Report

Site:	Mesilla State #3 Tank Battery		
Company:	COG Operating LLC		
Section, Township and Range	T-17S R-30E Sec. 16 Unit H		
Lease Number:	B-2103		
County:	Eddy County		
GPS:	32.83727° N	103.96921° W	
Surface Owner:	State		
Mineral Owner:			
Directions:	From the intersection of Hwy 529 and Goat Roper Road (Loco Hills, NM), travel North 0.7 miles, turn right 0.5 miles, turn left 0.3 miles to location.

**Re: Closure Report for the COG Operating LLC., Mesilla State #3 ,
Unit H, Section 16, Township 17 South, Range 30 East, Eddy
County, New Mexico.**

COG Operating LLC
Mesilla State #3 Tank Battery
Eddy County, New Mexico

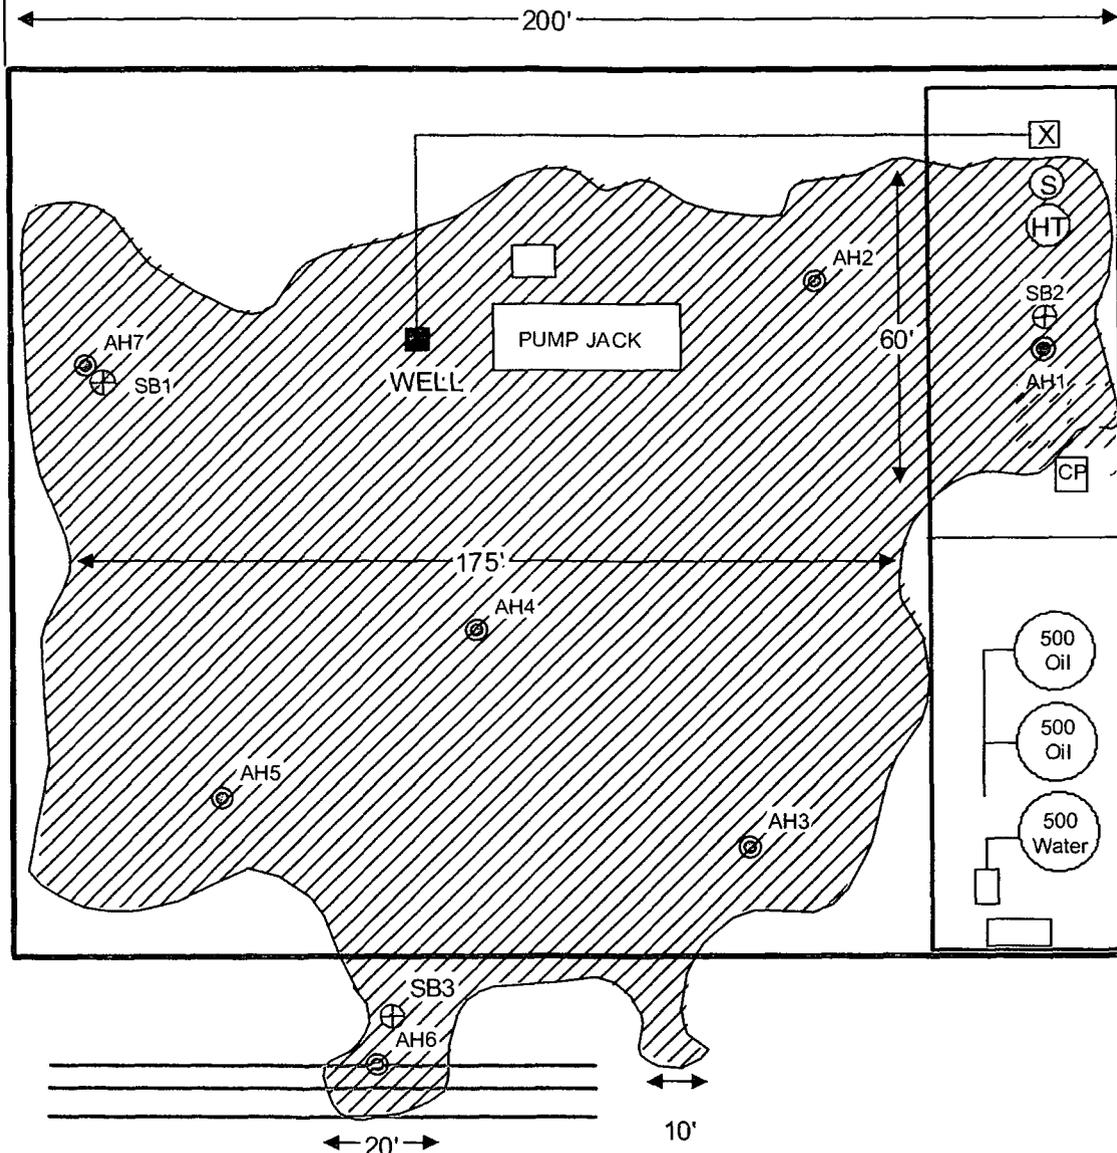
Figure 3
Mesilla State #3
Site Assessment Map
Eddy County, New Mexico

On September 22, 2010, Tetra Tech personnel inspected and sampled the spill area. A total of seven (7) auger holes (AH-1 through AH-7) were installed using a stainless steel hand auger to assess the impacted soils. Select samples were analyzed for TPH analysis by EPA method 8015 modified, BTEX by EPA Method 8021B and chloride by EPA method 300.0. Copies of laboratory analysis and chain-of-custody documentation are included in Appendix B. The results of the sampling are summarized in Table 1. The auger hole locations are shown on Figure 3.

Referring to Table 1, all of the submitted samples were below the RRAL for TPH and BTEX. Auger holes (AH-2, AH-4 and AH-5) had slight chloride concentrations at the surface (0-1') of 327 mg/kg, 206 mg/kg and 818 mg/kg, respectively. The chloride concentrations declined below reporting limit of <200 at 1-1.5' below surface. The remaining auger holes were not vertically defined, with bottom hole chloride concentrations of 3,910 mg/kg at 1-1.5' (AH-1), 9,580 mg/kg at 6-6.5' (AH-6), and 1,510 mg/kg at 5-5.5' (AH-7).

On December 1, 2010, Tetra Tech personnel supervised the installation of three soil borings (SB-1, SB-2 and SB-3) utilizing an air rotary drilling rig. Soil samples were collected to define the impact of the chloride concentrations in the vicinity of AH-1, AH-6 and AH-7. Referring to Table 1, elevated chloride concentrations significantly declined with depth at 7' (SB-1), 3' (SB-2) and 40' (SB-3). The soil boring locations are shown on Figure 3.

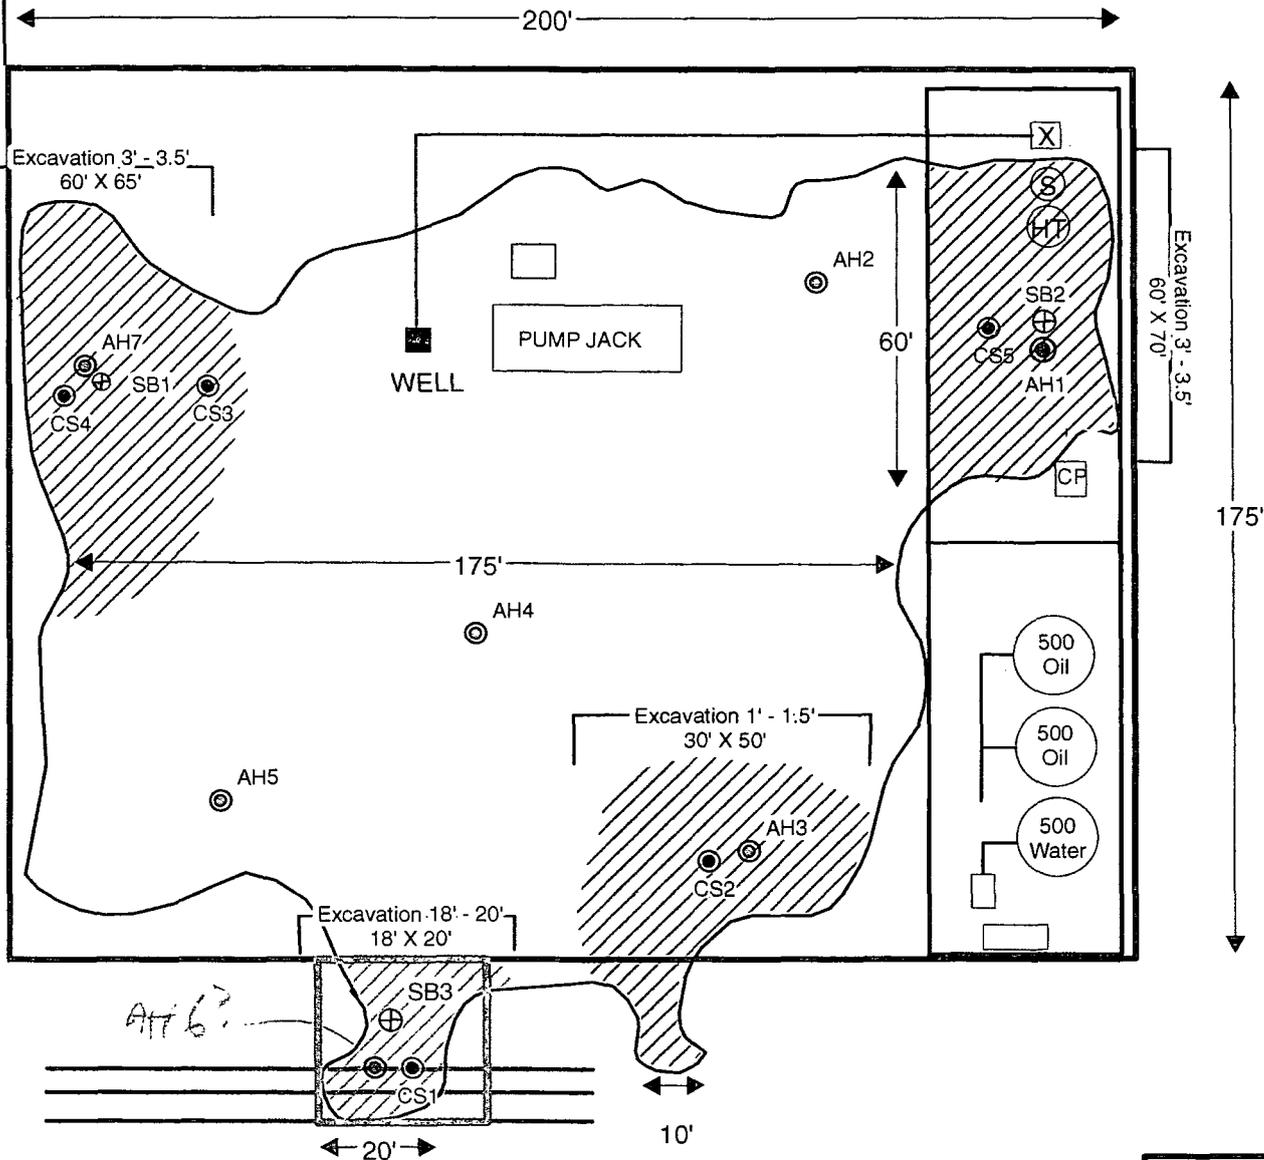
Figure 4
Mesilla State #3
Excavation Map
Eddy County, New Mexico

Once excavated, Tetra Tech collected bottom hole confirmation samples (CS-1 through CS-5), as shown on Figure 4. The confirmation sample results are summarized in Table 1. Based on the results, NMOCD requested the bottom of the excavation near CS-1 be lined to cap the area. A 40 mil liner was installed at 4' below surface and backfilled with clean material to grade. A copy of the C-141 (Final) is included in Appendix A.

Tetra Tech personnel supervised the excavation of the site from February 22 through 24, 2011. The soil remediation was performed according to the approved work plan. The excavations included four separate areas within the tank battery and pad location. The locations, approximate dimensions, and excavation depths are shown on Figure 4.
