Occidental Permian Limited Partnership

RE: Remediation Plan

South Hobbs Unit 8" Injection Trunkline from Central T/B to Injection Building #1

UL'K', Sec. 4, T-19-S, R-38-E

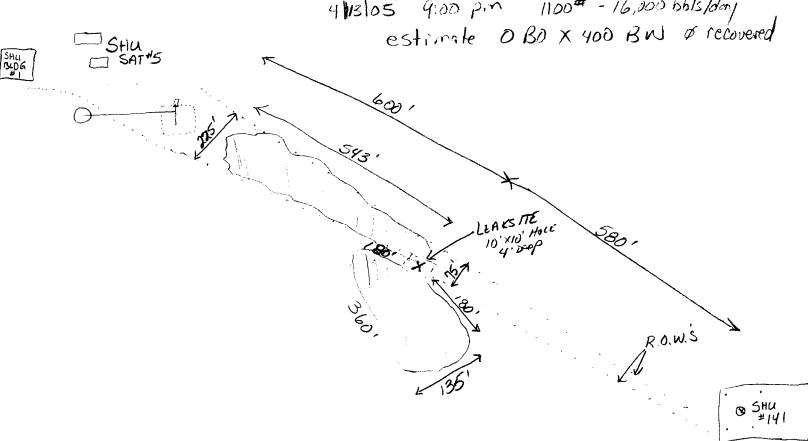
SPILL MAP

N 32°41'12.80" W 103°09' 18,10" (NAD83) PLEASE DRAW SKETCH OF SPILL AND INDICATE WHERE SPILL ORIGINATED.

South HOBBS Unit INSECTION SYSTEM

8"Coment I. ARC Steel to Building #1

4 113105 9:00 pm 1100# - 16,000 bbls/day

estimate OBOX 400 BW & recovered
