February 12, 2004

**Re: Closure Report for D. F. Fergason Tank Battery, U. L. H (SE/4, NE/4), Section 30, Township 18 South, Range 39 East, Lea County New Mexico**

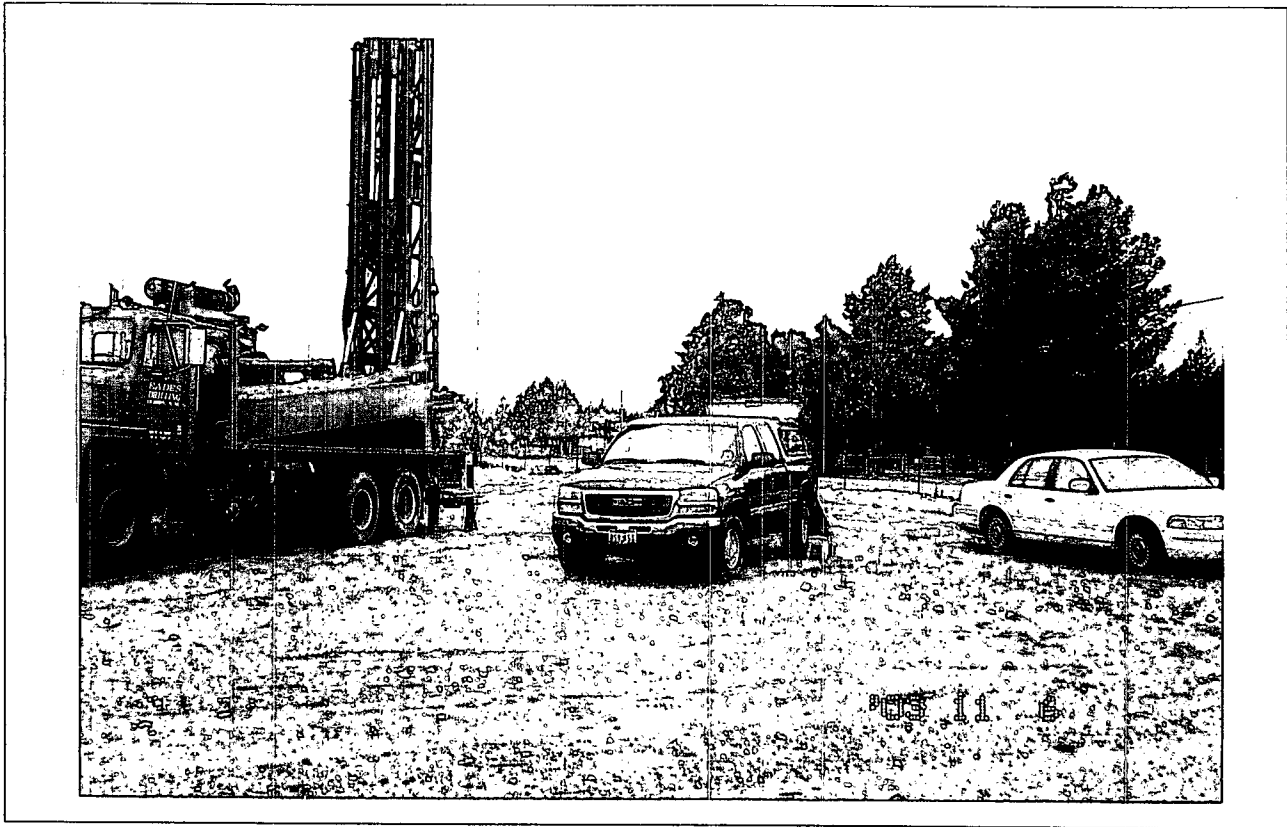
**1. Tank Battery Boring Location (Looking North)**

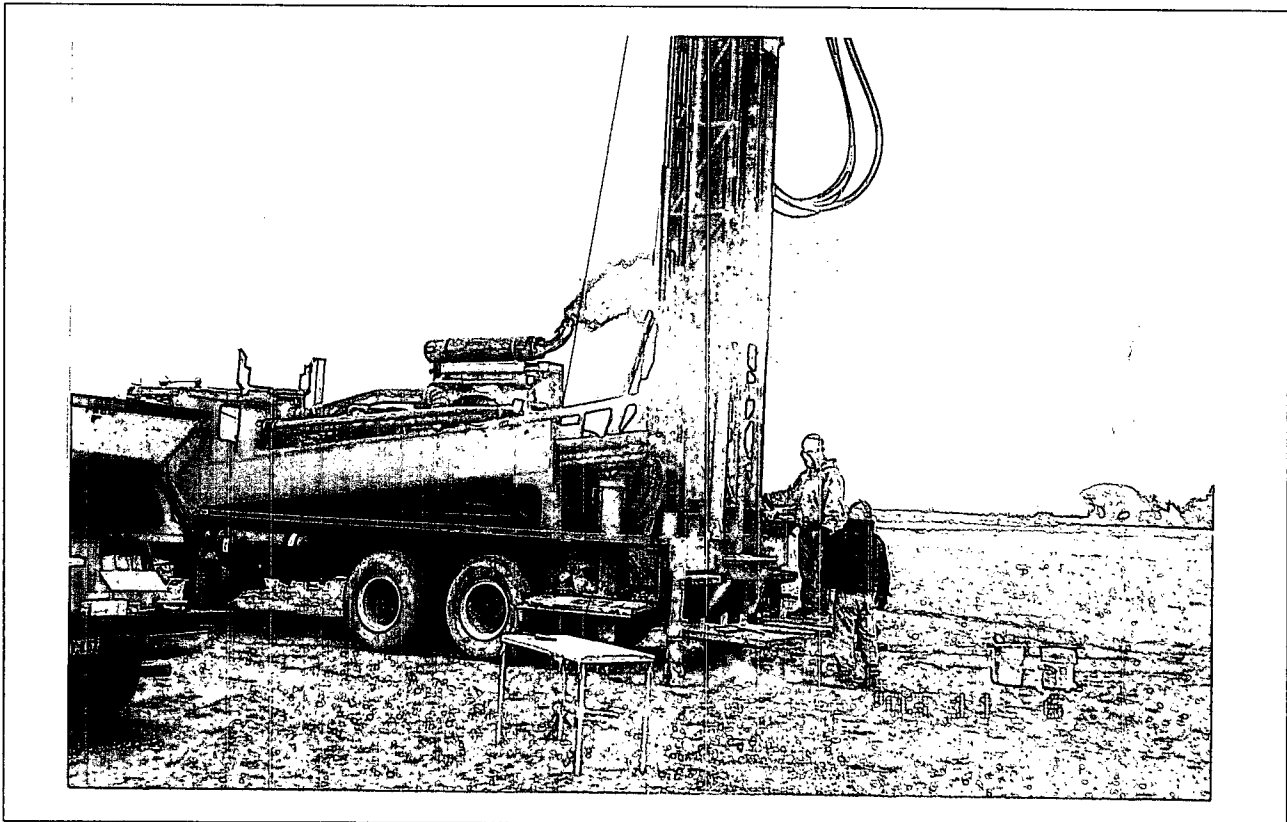
**2. Tank Battery Boring Location (Looking Southwest)**

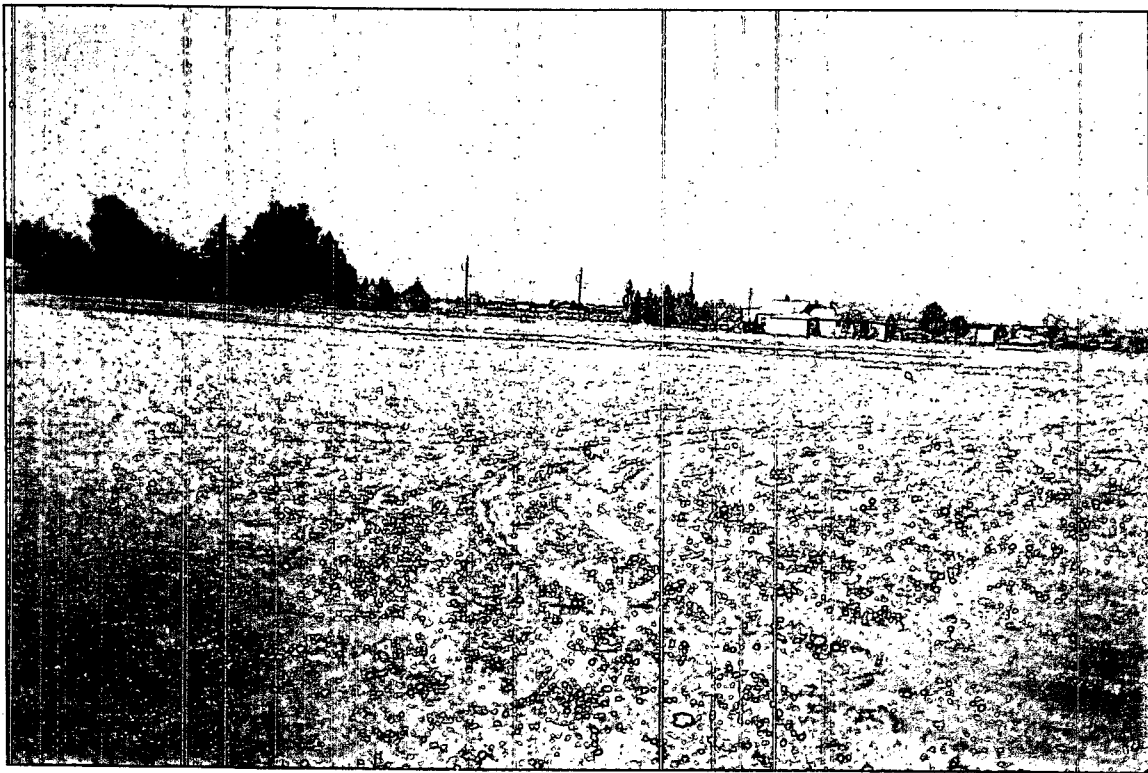
**3. Tank Battery Location – After Remediation (Looking Northwest)**

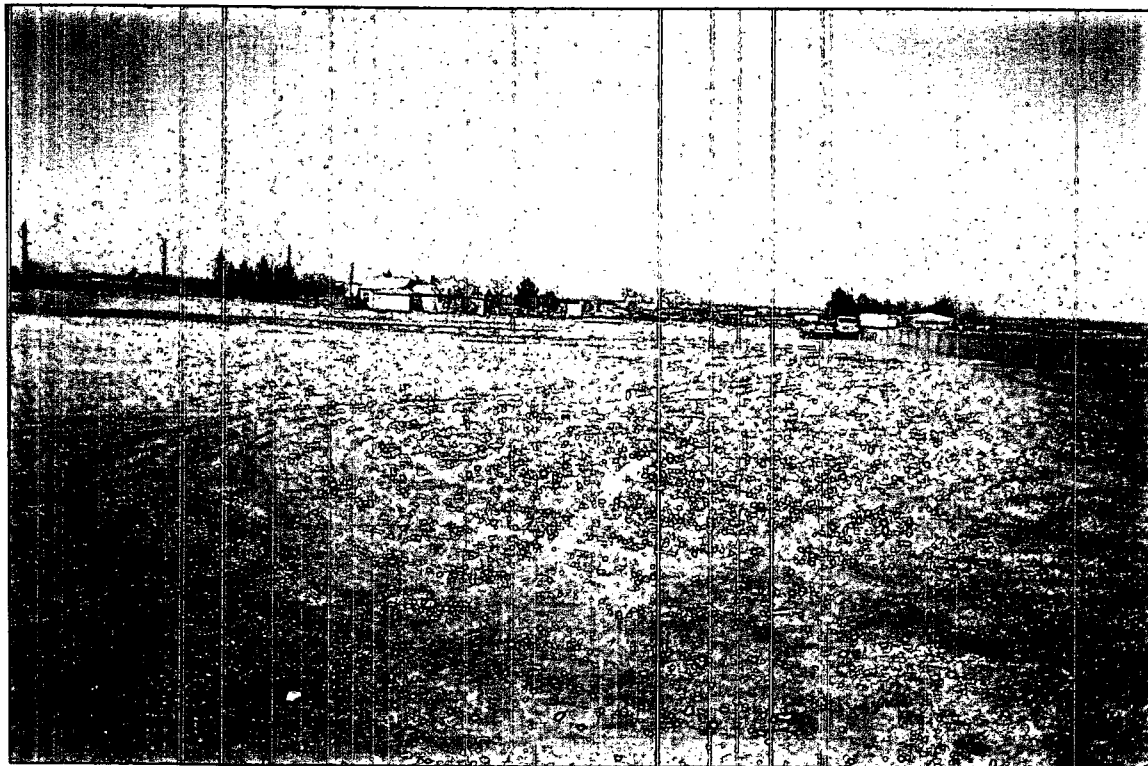
**4. Tank Battery Location – After Remediation (Looking North)**

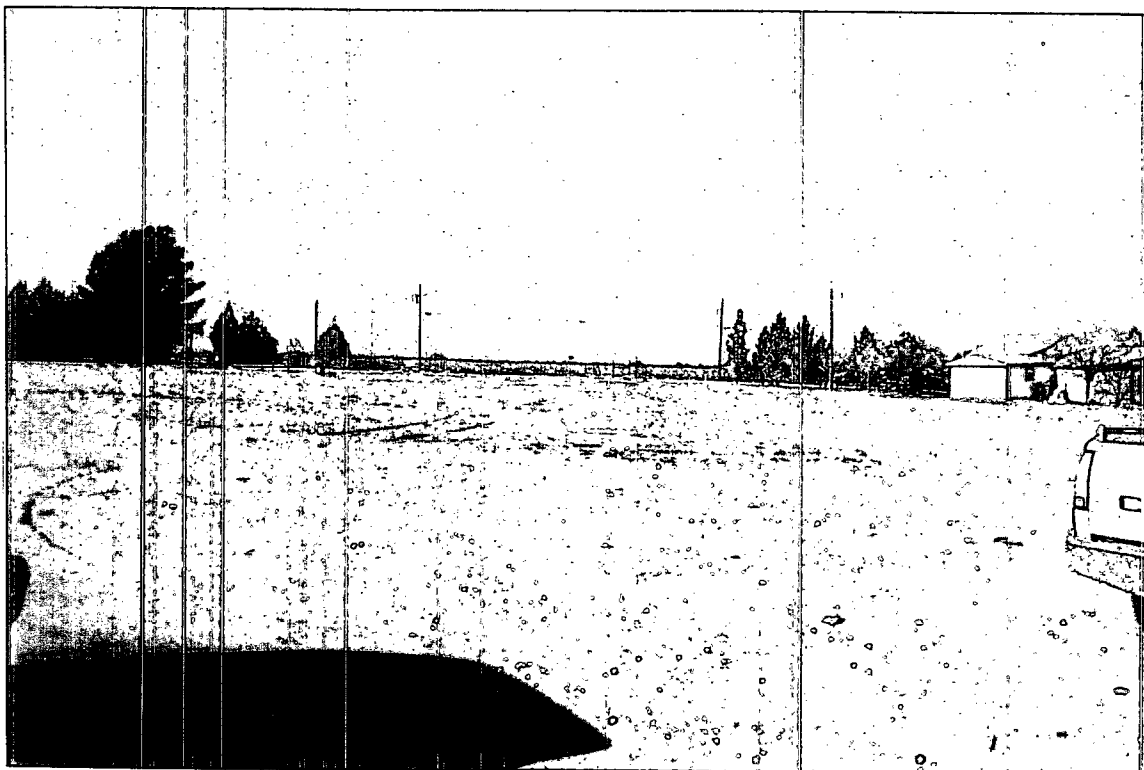
**5. Tank Battery Location – After Remediation (Looking West)**

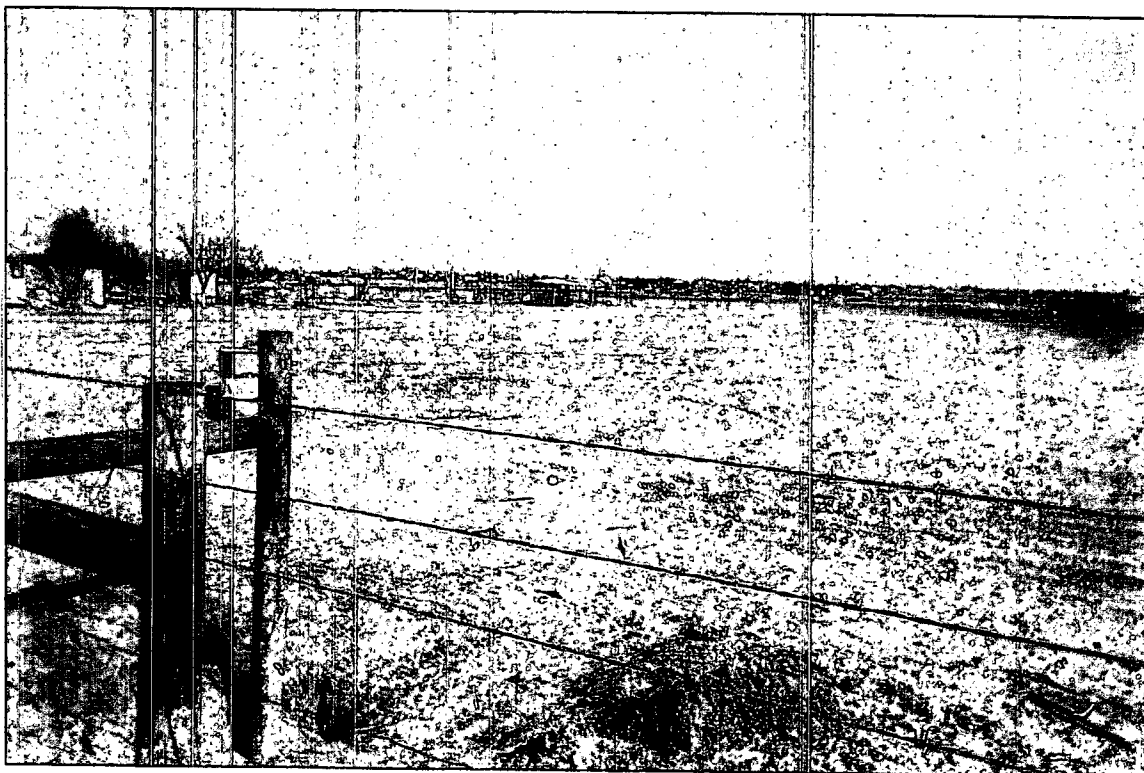
**6. Tank Battery Location – After Remediation (Looking Northeast)**

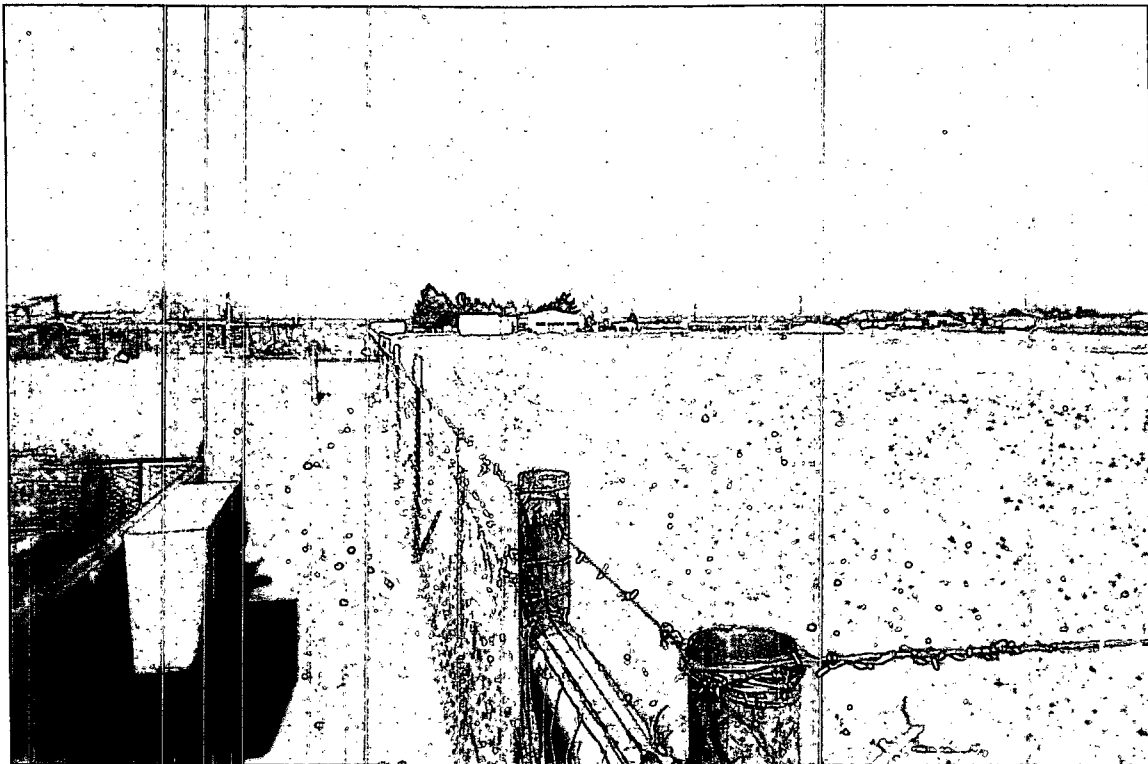
**7. Emergency Pit Location – After Remediation (Looking North)**

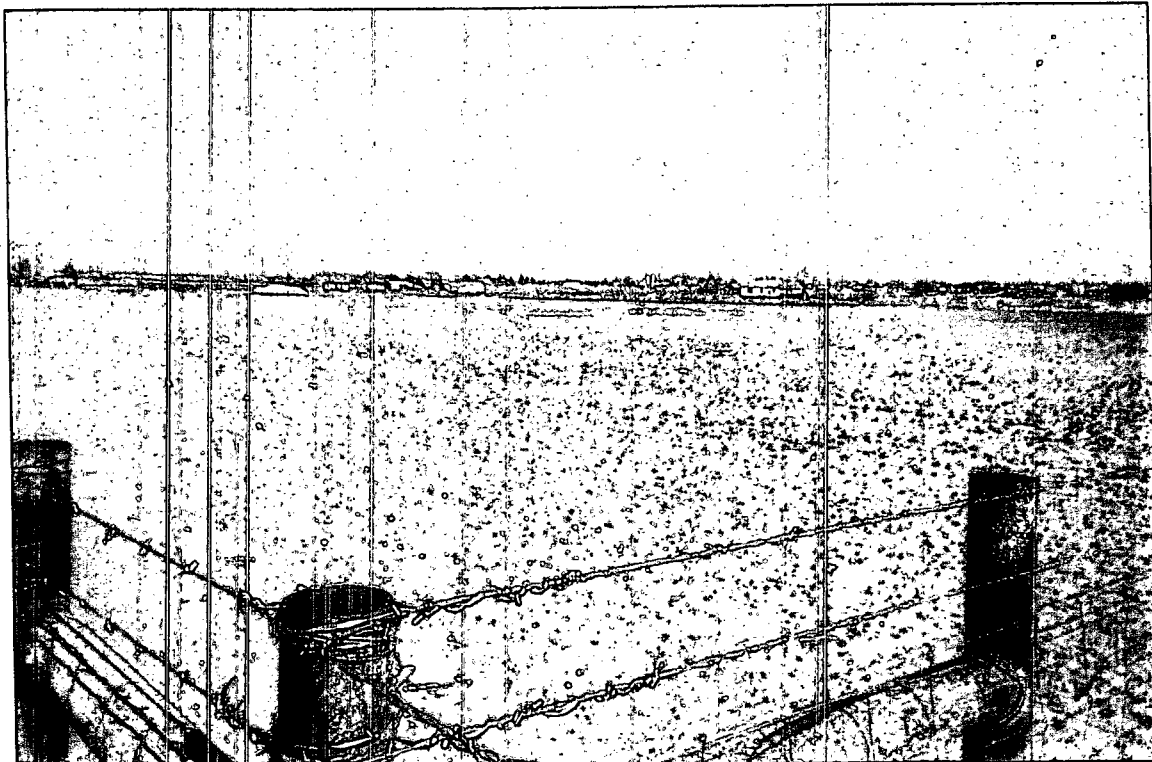
**8. Emergency Pit Location – After Remediation (Looking Northeast)**

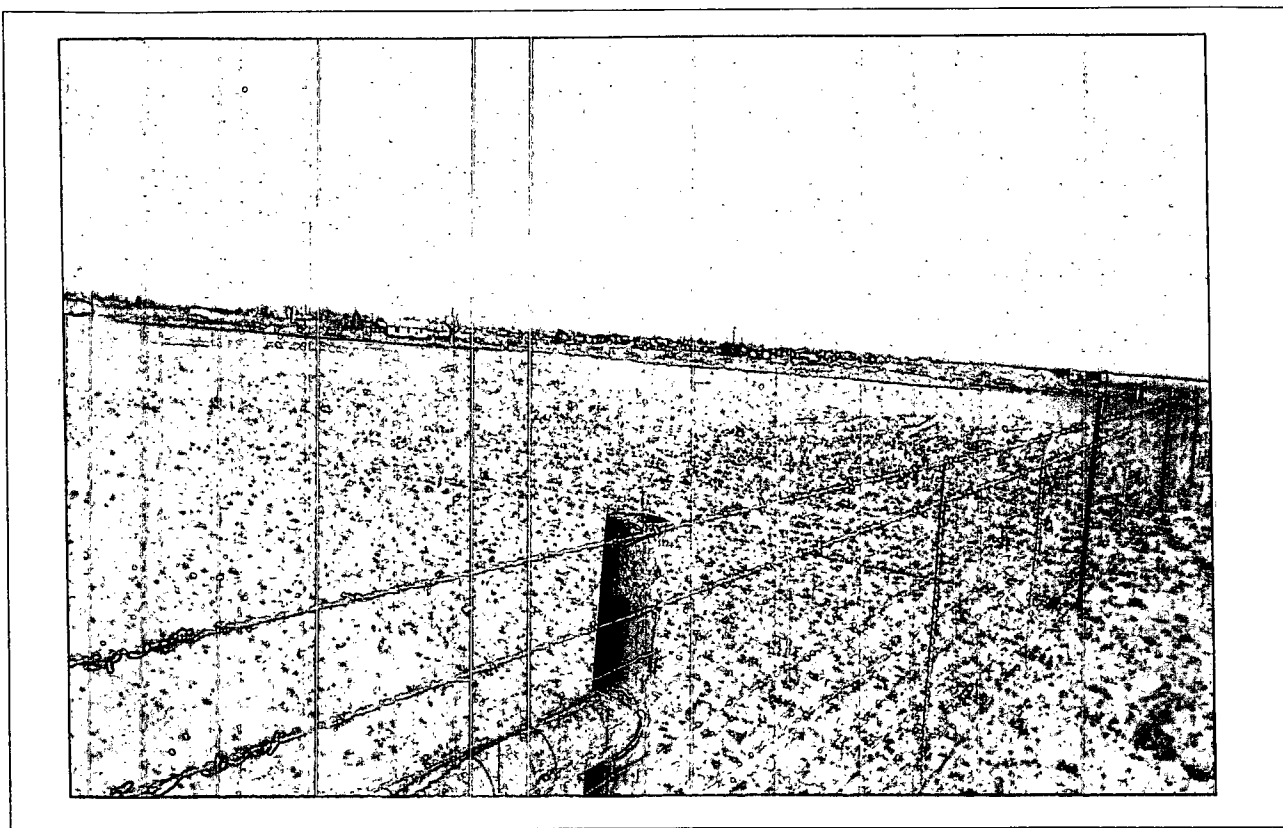
**9. Emergency Pit Location – After Remediation (Looking East)**
