# CONOCOPHILLIPS

## MCA Battery 1 Trunkline Leak (10-19-04)

### ENVIRONMENTAL SITE INVESTIGATION

**November 4, 2004**

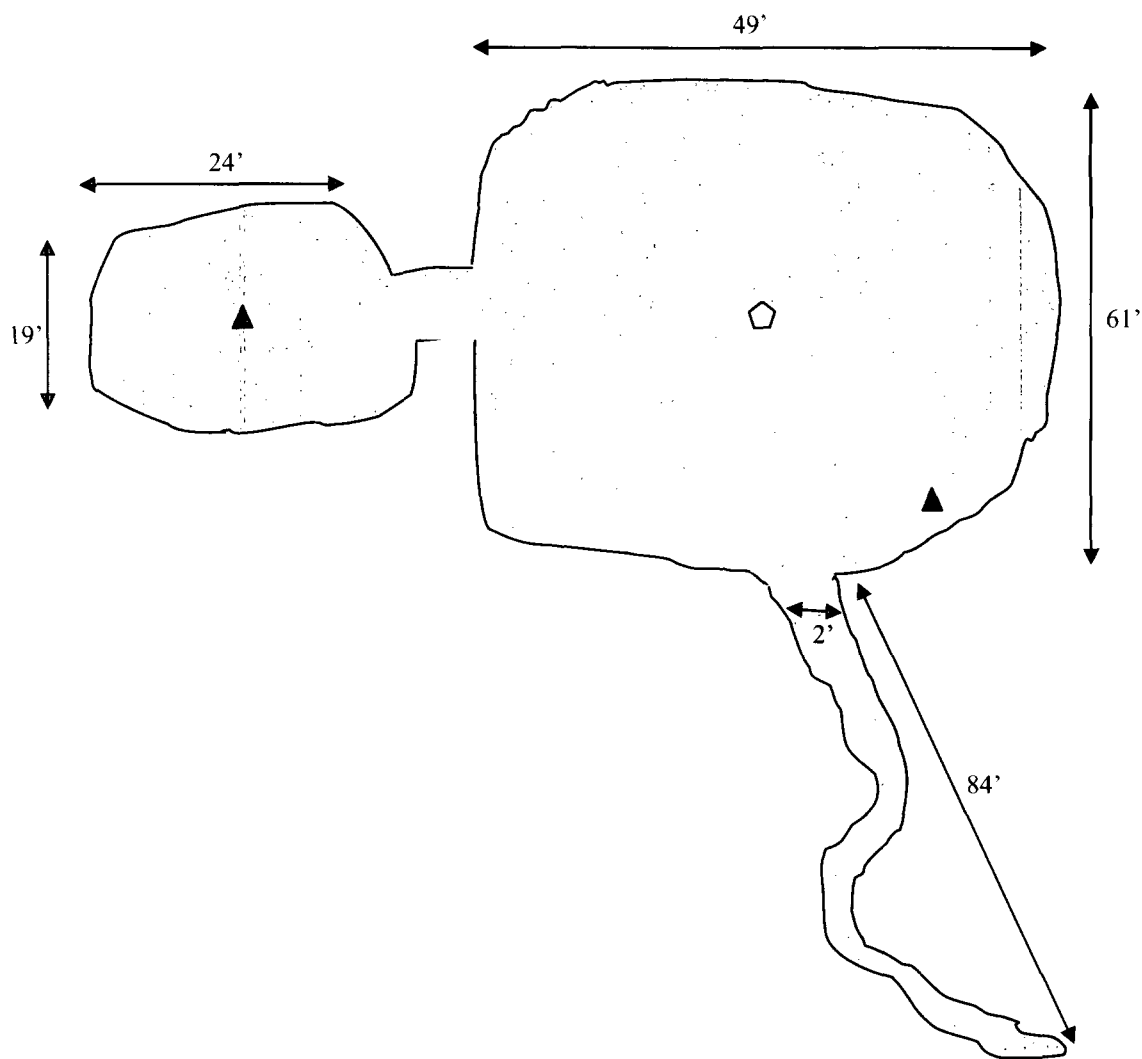
# CONOCOPHILLIPS EVGSAU WELL MCA BATTERY 1

The leak area measures approximately ~~61 feet by 49 feet~~ with a smaller area that measures approximately ~~19 feet by 24 feet.~~ A sketch of the leak area including the sample points can be reviewed in Appendix II of this report. The surface soil is red sand. There is no water source within 1,000 feet of the site. There is no surface water within 1,000 feet of the site. Based on data from the ground water monitoring well located at the Maljamar Plant, depth to ground water is approximately ~~90 feet.~~

Two near surface samples were taken; one from the north end of the leak area and one from the south end of the leak area. The samples were taken at a depth of one foot and were taken to Cardinal Laboratories for chloride analysis. Laboratory analysis for Sample Point 1-1' is 2799 ppm chloride. Laboratory analysis for Sample Point 2-1' is 3199 ppm chloride. Laboratory analytical results for this sampling event can be reviewed in Appendix I of this report. The location of the sample points can be viewed on the site diagram in Appendix II of this report.

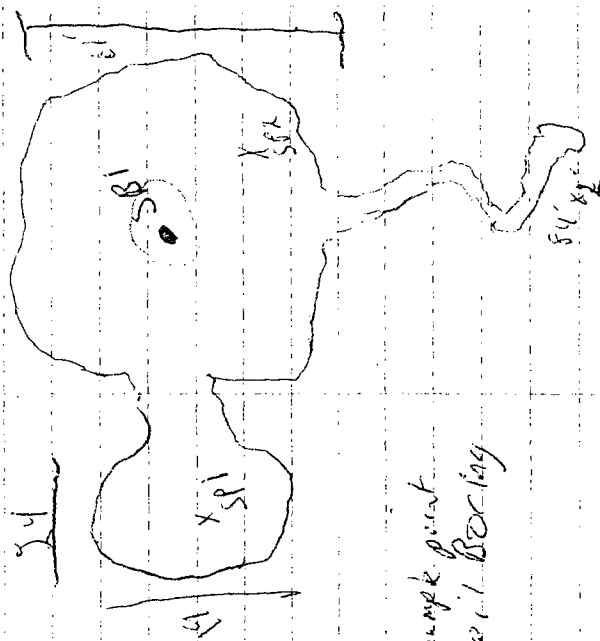
SB1-1' 10:27:24 10:00 7800  
 SB1-3' " 10:28 11,000  
 SB1-5' " 10:30 10,200  
 SB1-10' " 10:31 8600  
 SB1-15' " 11:30 5400  
 SB1-20' " 13:11 4800  
 SB1-25' " 14:34 3000

SB1 Basin; GPS N 31.81184°  
 W 103.79137°

Sample 1-1' 10:27:24 10:51 3400

Sample pr 2-1' 10:27:24 11:28 4120
