Release Notification and Corrective Action

PHASE II ENVIRONMENTAL SAMPLING ASSESSMENT

Chalupa #4 SWD Flow Line Leak

ENVIRONMENTAL REMEDIATION DIG & HAUL OPERATIONS

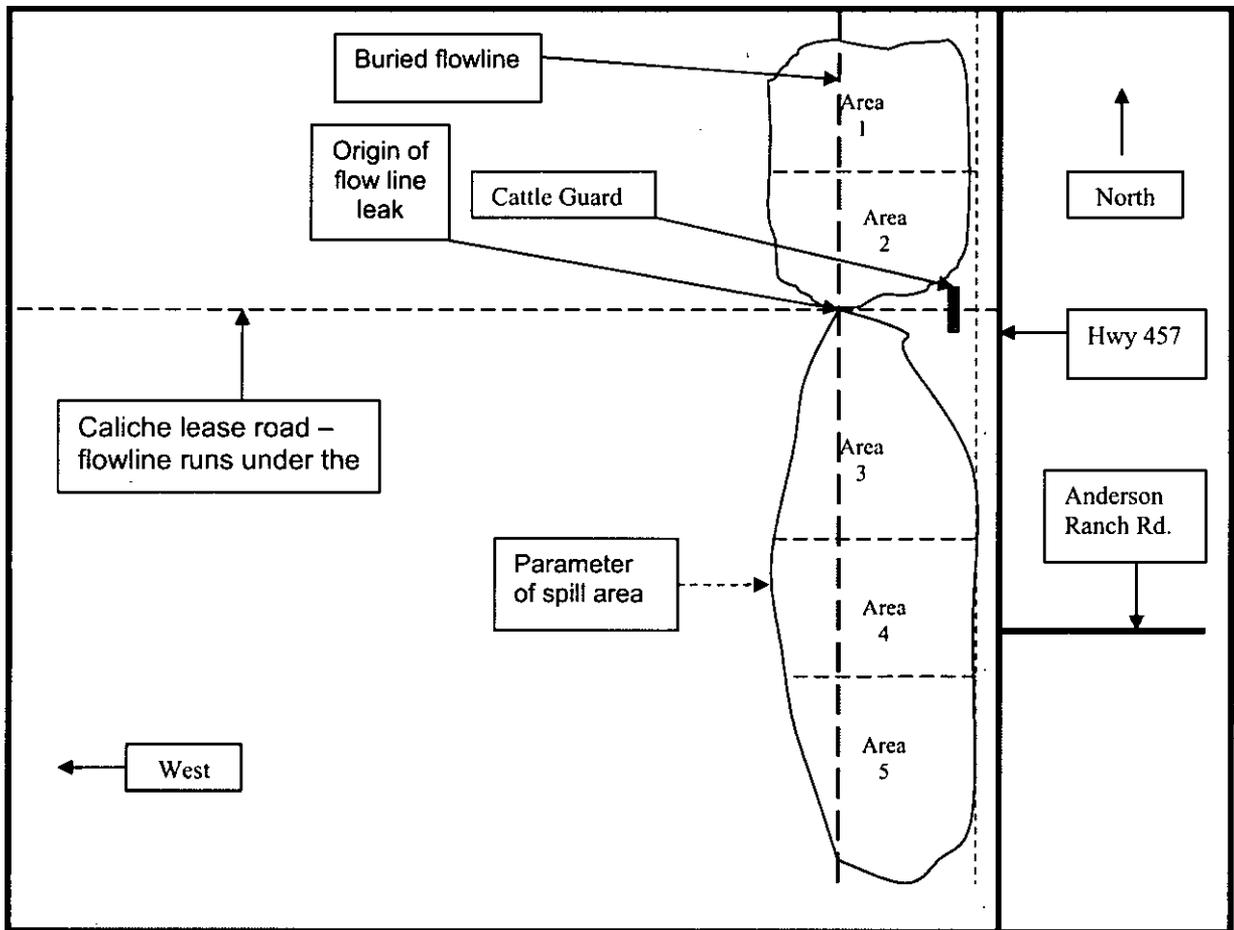
- Sampling Grid: Areas were identified as 1, 2, 3, 4, 5.
 - **Chlorides:** Highest chloride levels were **35400ppm** at surface level in grid area "1". Acceptable levels for chlorides are expected to be reached at 1' to 4' depths depending on each grid area.

- **TPH:** All levels of TPH were determined to be **less than 5000ppm** with the **highest level 3260ppm**.
- Lab Samples: Composite samples were taken from grid areas 1, 2, 3, 4, 5.

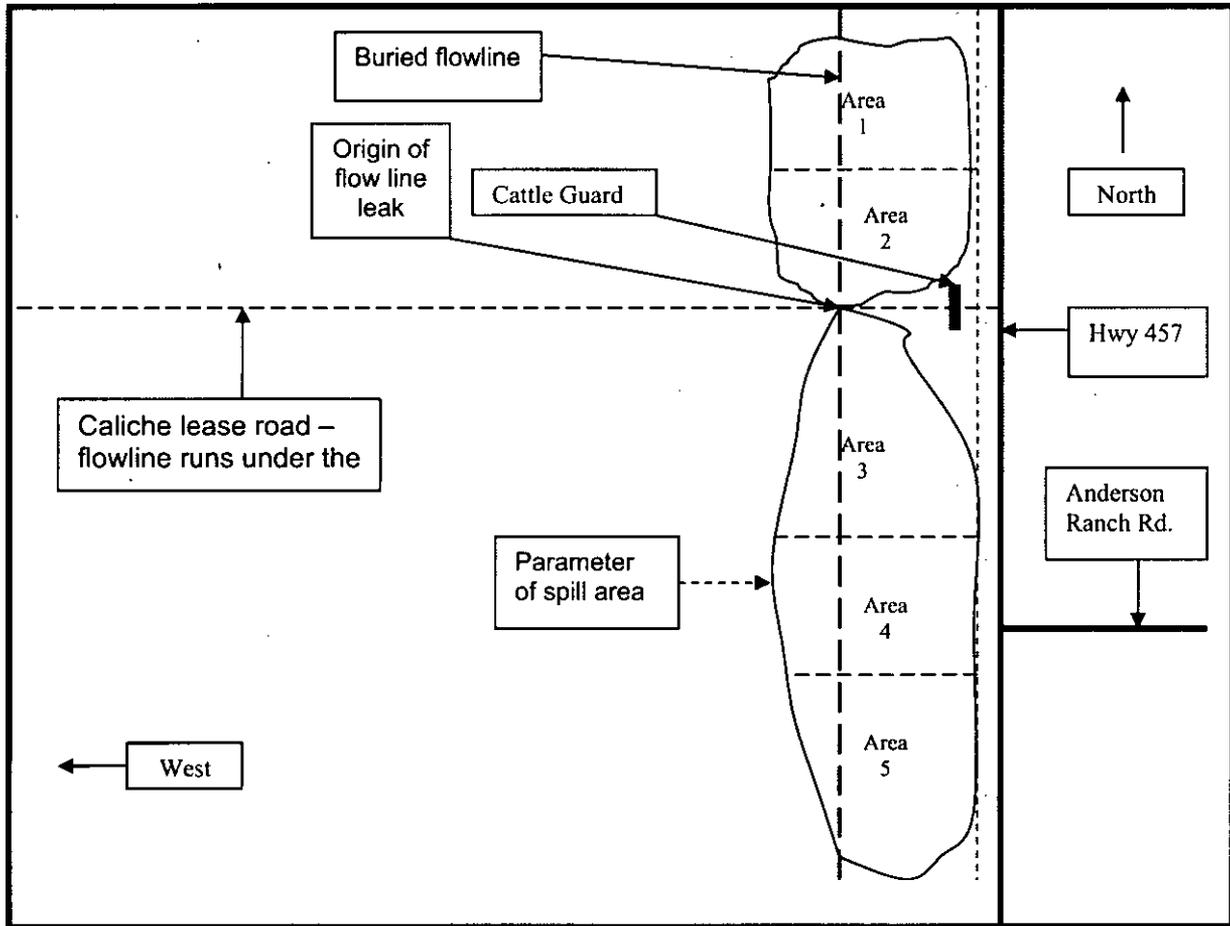
- Formal lab samples were taken at the total depth of the excavation and photos were taken as well to document the completed excavation. Please see enclosed photos. Over all excavation depths ranged from 1' to 3' depths. **Please see lab results chart listed at the end of this report with depths of excavation and levels for TPH and chlorides.**

Sample field code	Chloride PPM	Sample field code	TPH PPM
1 - 1' depth	<200	1 - 1' depth	<50.0
2 - 2' depth	<200	2 - 2' depth	<50.0
3 - 3' depth	<200	3 - 3' depth	<50.0
4 - 1' depth	<200	4 - 1' depth	<50.0
5 - 2' depth	<200	5 - 2' depth	<50.0
