Figure 2  
Site Map  
Southern Union Gas Services  
Trunk O Monument  
Lea County, NM

SOUTHERN UNION GAS SERVICES  
TRUNK "O" MADDOX ROAD RELEASE SITE  
LEA COUNTY, NEW MEXICO

**Client:** Southern Union Gas Services  
**Project Name:** Trunk "O" Maddox Road

**Prepared by:** NOVA  
**Location:** Lea County, New Mexico

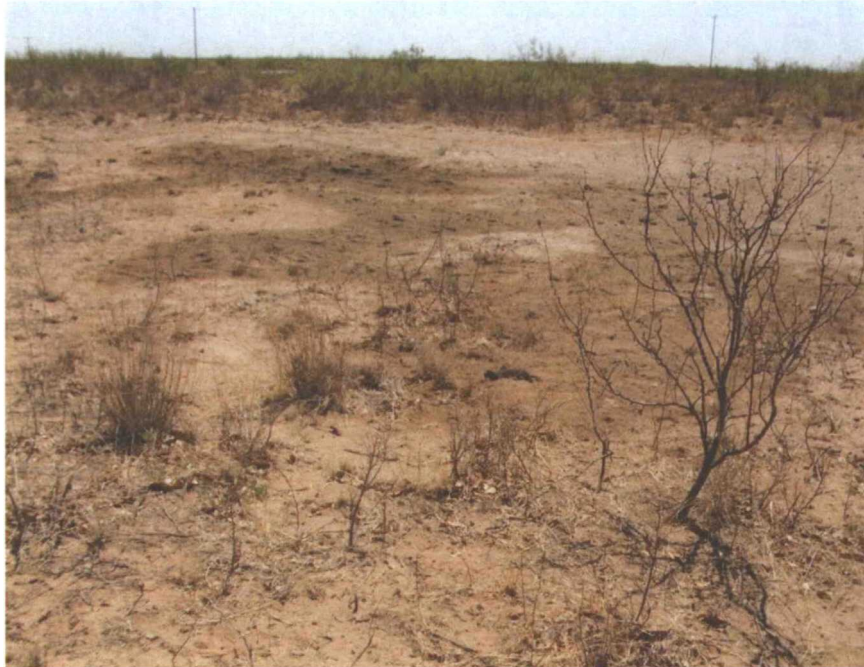
**Photograph No. 1**

**Description:**  
View of the initial  
release.

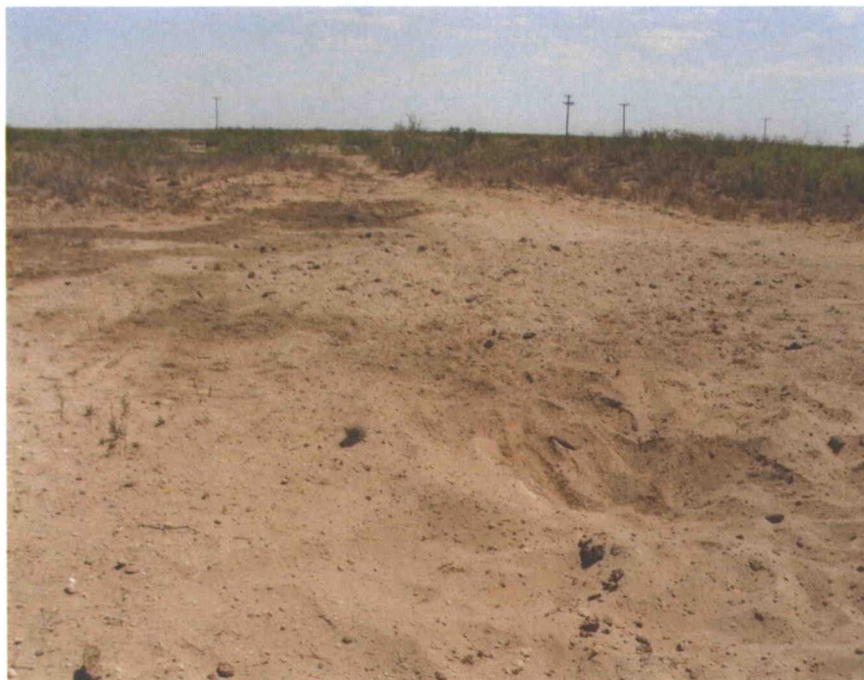
**Photograph No. 2**

**Description:**  
View of the initial  
release.

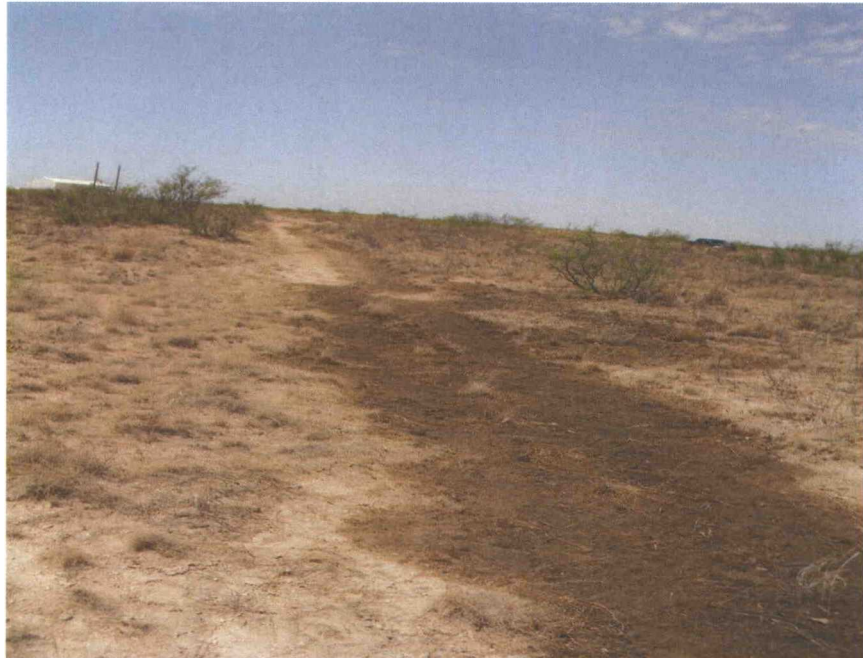
**Photograph No. 3**

**Description:**  
View of the initial  
release.
