Report Type: Work Plan

Site:	Pronghorn SWD Facility		
Company:	COG Operating LLC		
Section, Township and Range	Unit B	Sec 24	T19S R32E
Lease Number:	API 30-025-32735		
County:	Lea County		
GPS:	32.65218° N	103.71698° W	
Surface Owner:	Federal		
Mineral Owner:			
Directions:	From the intersection of 529 and CR-126, travel south on 126 for 9.9 miles, turn left and travel 4.5 miles, turn right (at tin horn) and travel 0.6 miles to location

Release Data:	Spill #1	Spill #2	Spill #3
Date Released:	10/15/2009	11/20/2009	7/20/2011
Type Release:	Produced Water	Produced Water	Produced Water
Source of Contamination:	Pressure Gauge	1x4 Swedge	Check Valve
Fluid Released:	60bbbls	1500bbbls	100bbbls
Fluids Recovered:	45bbbls	1300bbbls	95bbbls

**Re: Work Plan and Assessment Report for the COG Operating LLC,
Pronghorn SWD Facility Spills, Unit B, Section 24, Township 19 South,
Range 32 East, Lea County, New Mexico.**

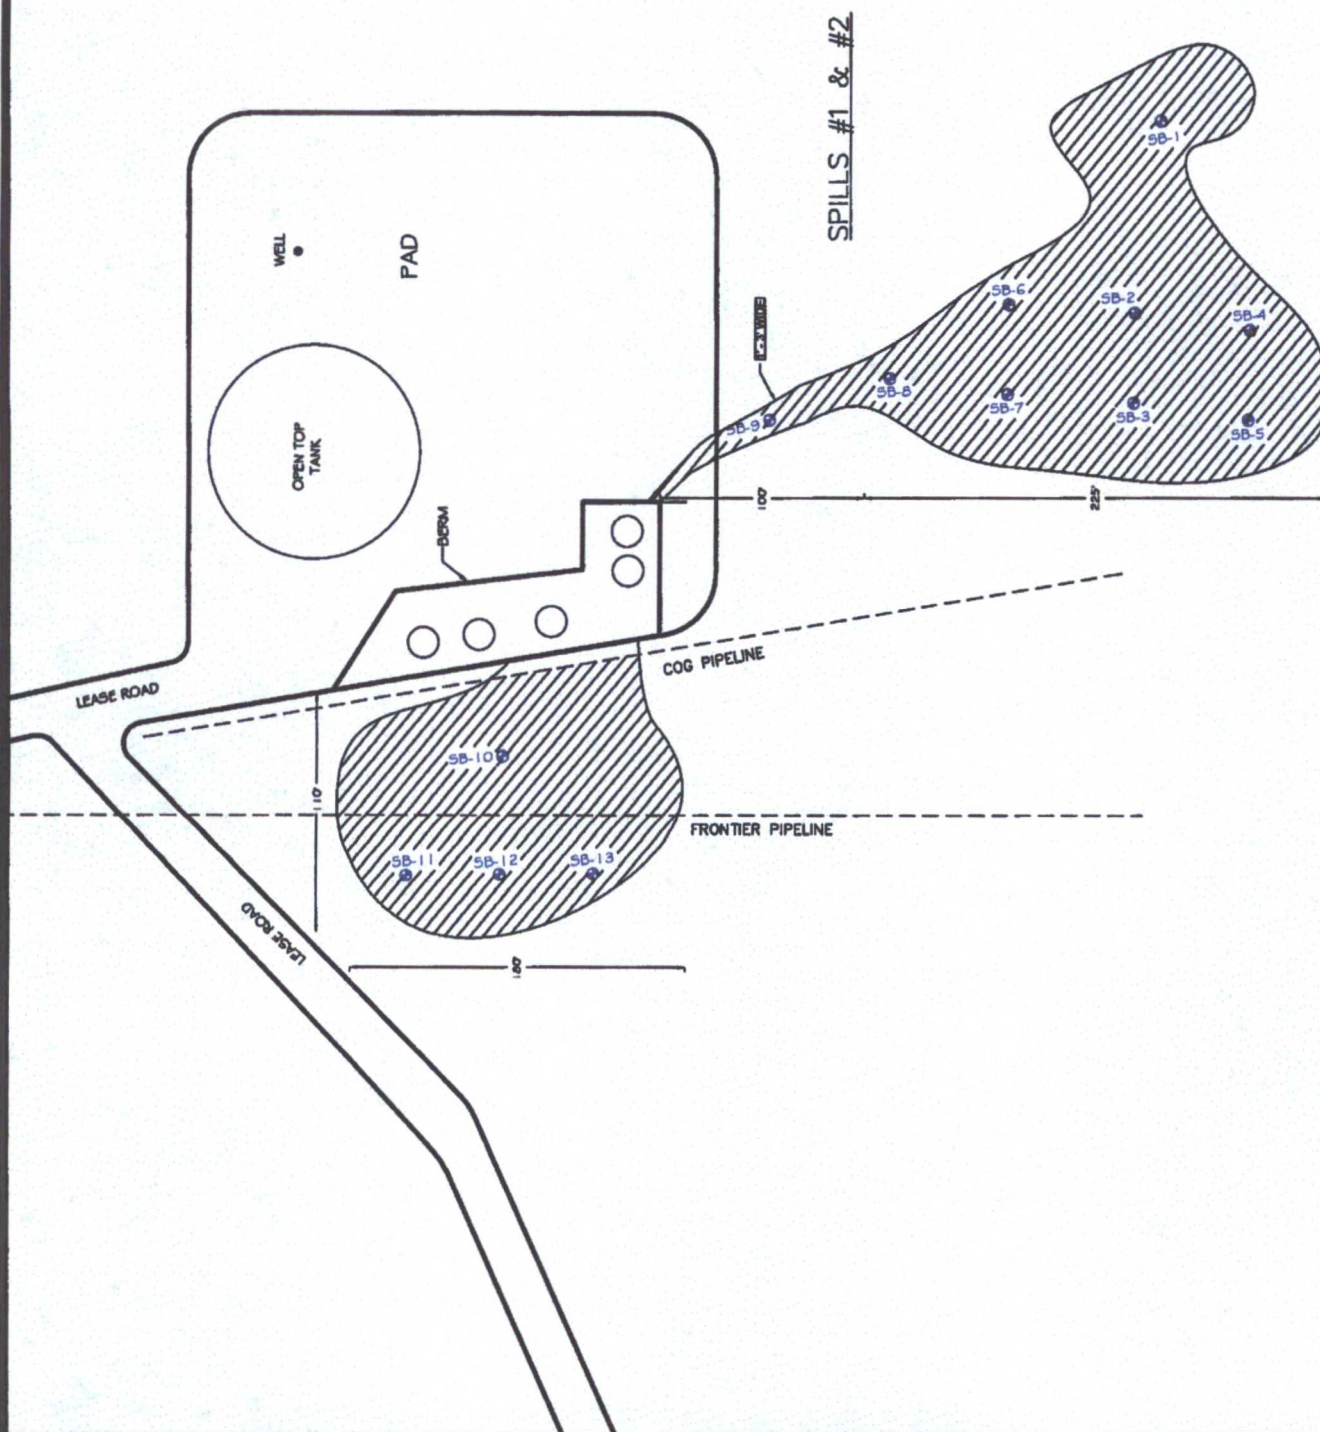
Figure 3a

Spill #1 & #2 Assessment Map w/ Aerial

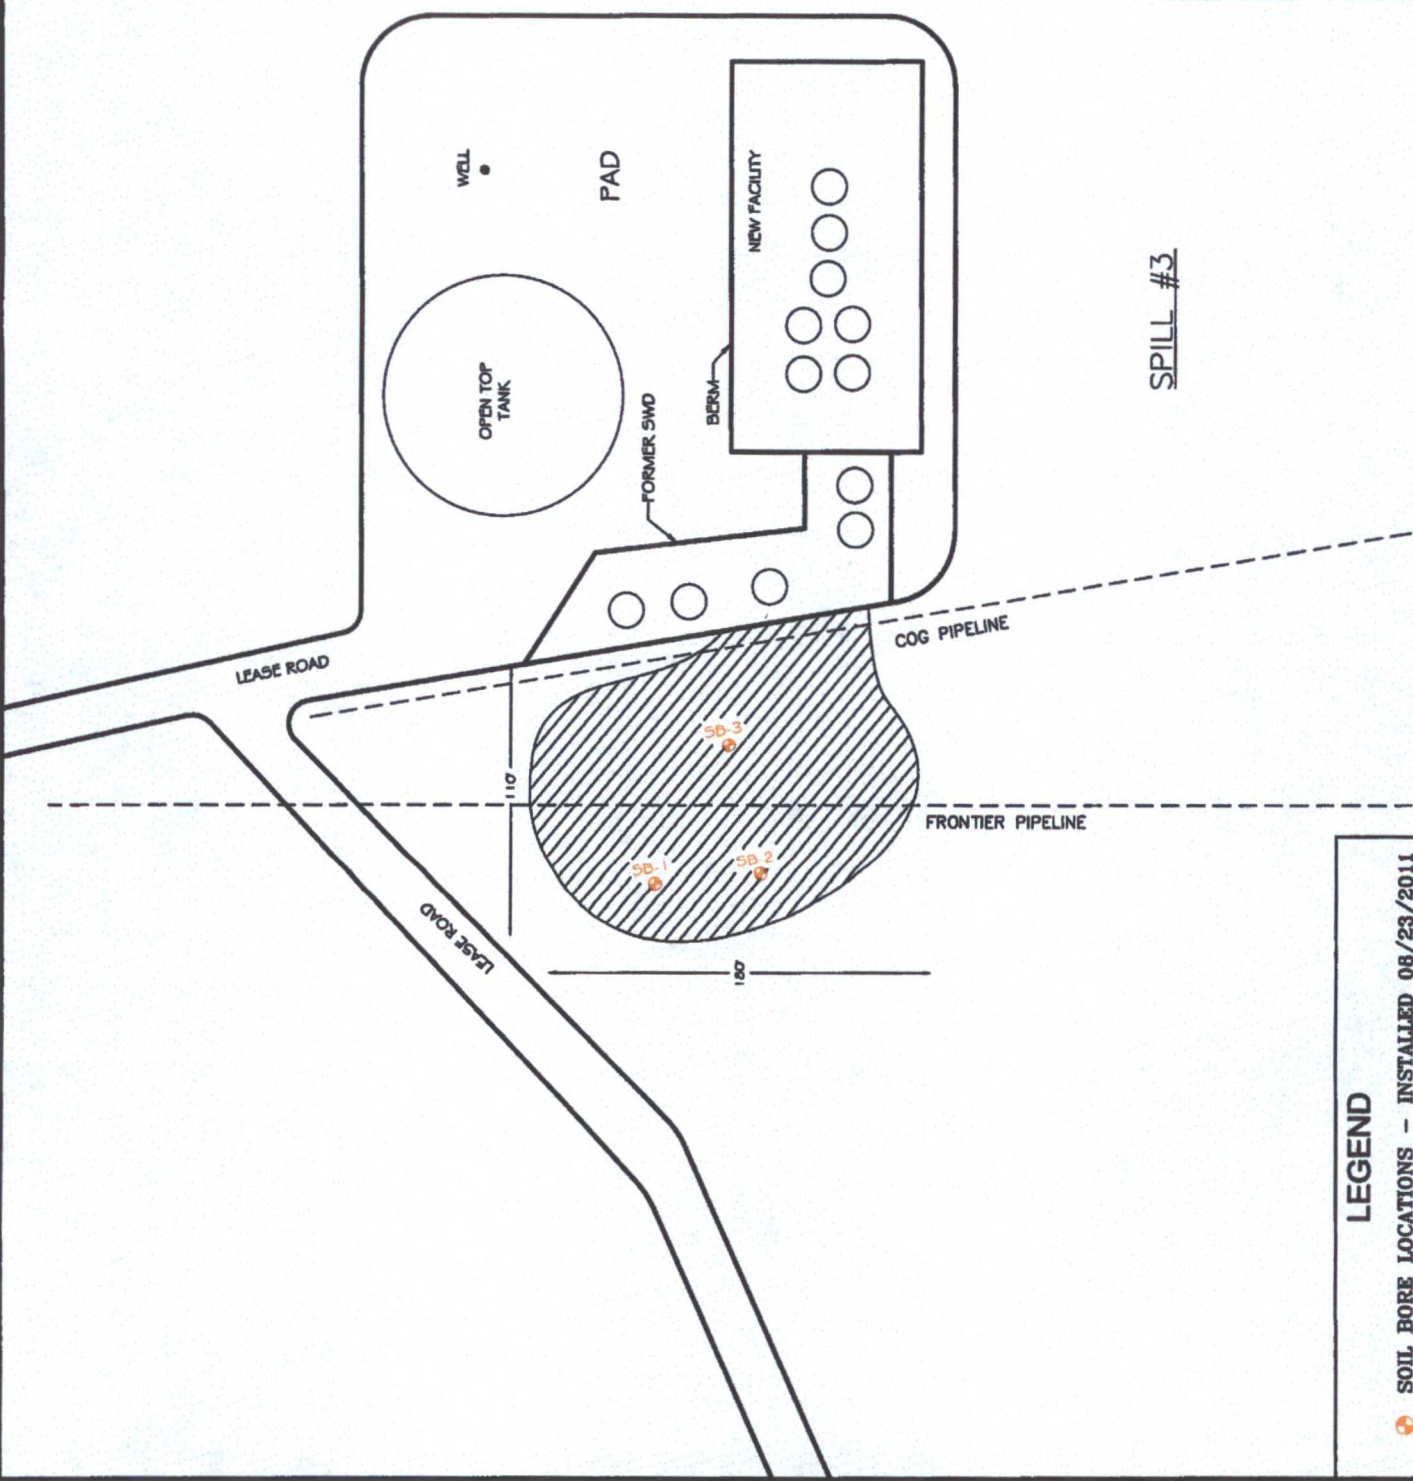
Figure 4a

Spill #3 Assessment Map w/ Aerial

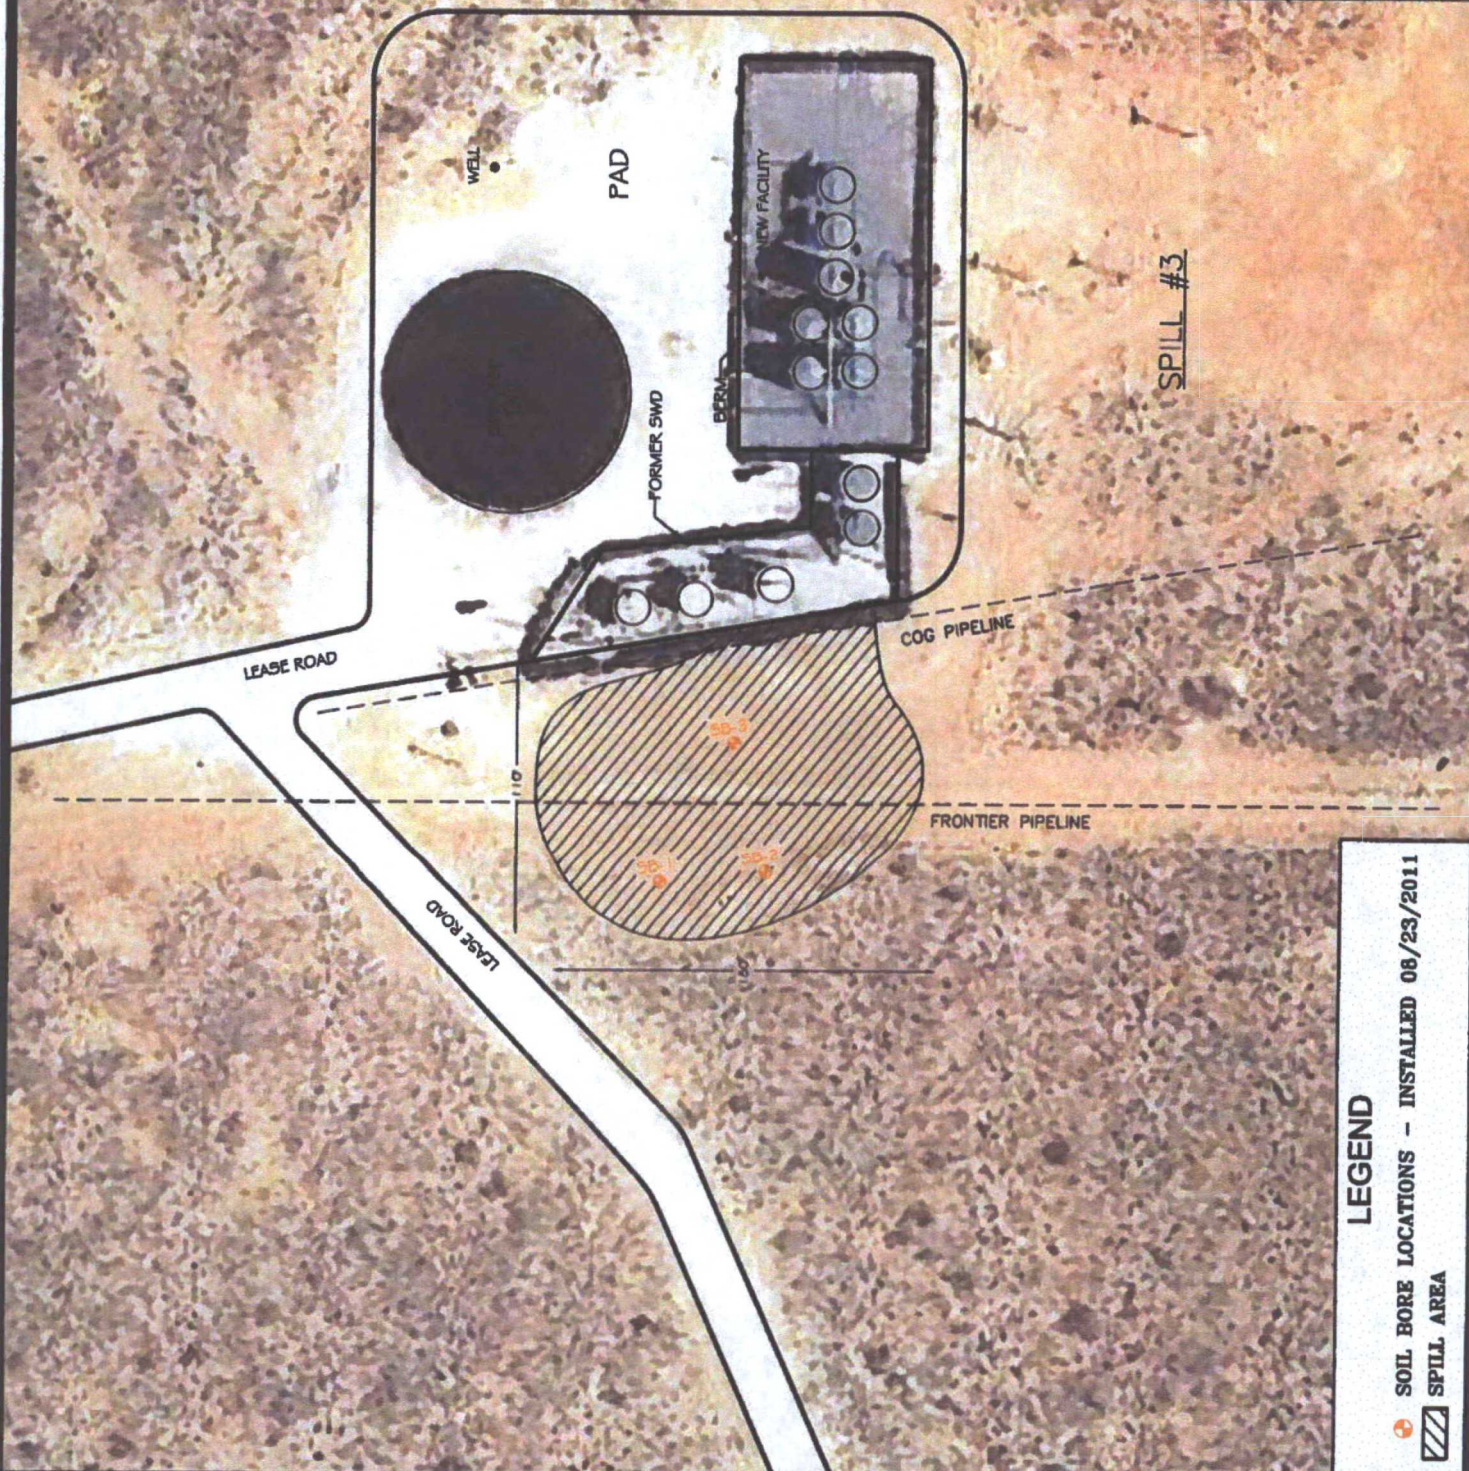
Figure 5

Spill #1, #2 & #3 Assessment Map

In order to remediate the site, COG proposes to excavate the impacted soils to re-establish surface growth and to reduce the environmental liabilities for the protection of the groundwater. The proposed excavation depths are highlighted in Table 1 and Table 2 and shown on Figure 5. Due to the size of the release, COG proposes excavating an additional 2.0' of soil for a total excavation depth of 4.0' below surface. Once excavated, to the appropriate depth, the excavation bottom will be capped with either clay material or 40 mil liner and backfilled to grade with clean soil. All of the excavated soil removed will be properly transported to proper disposal.

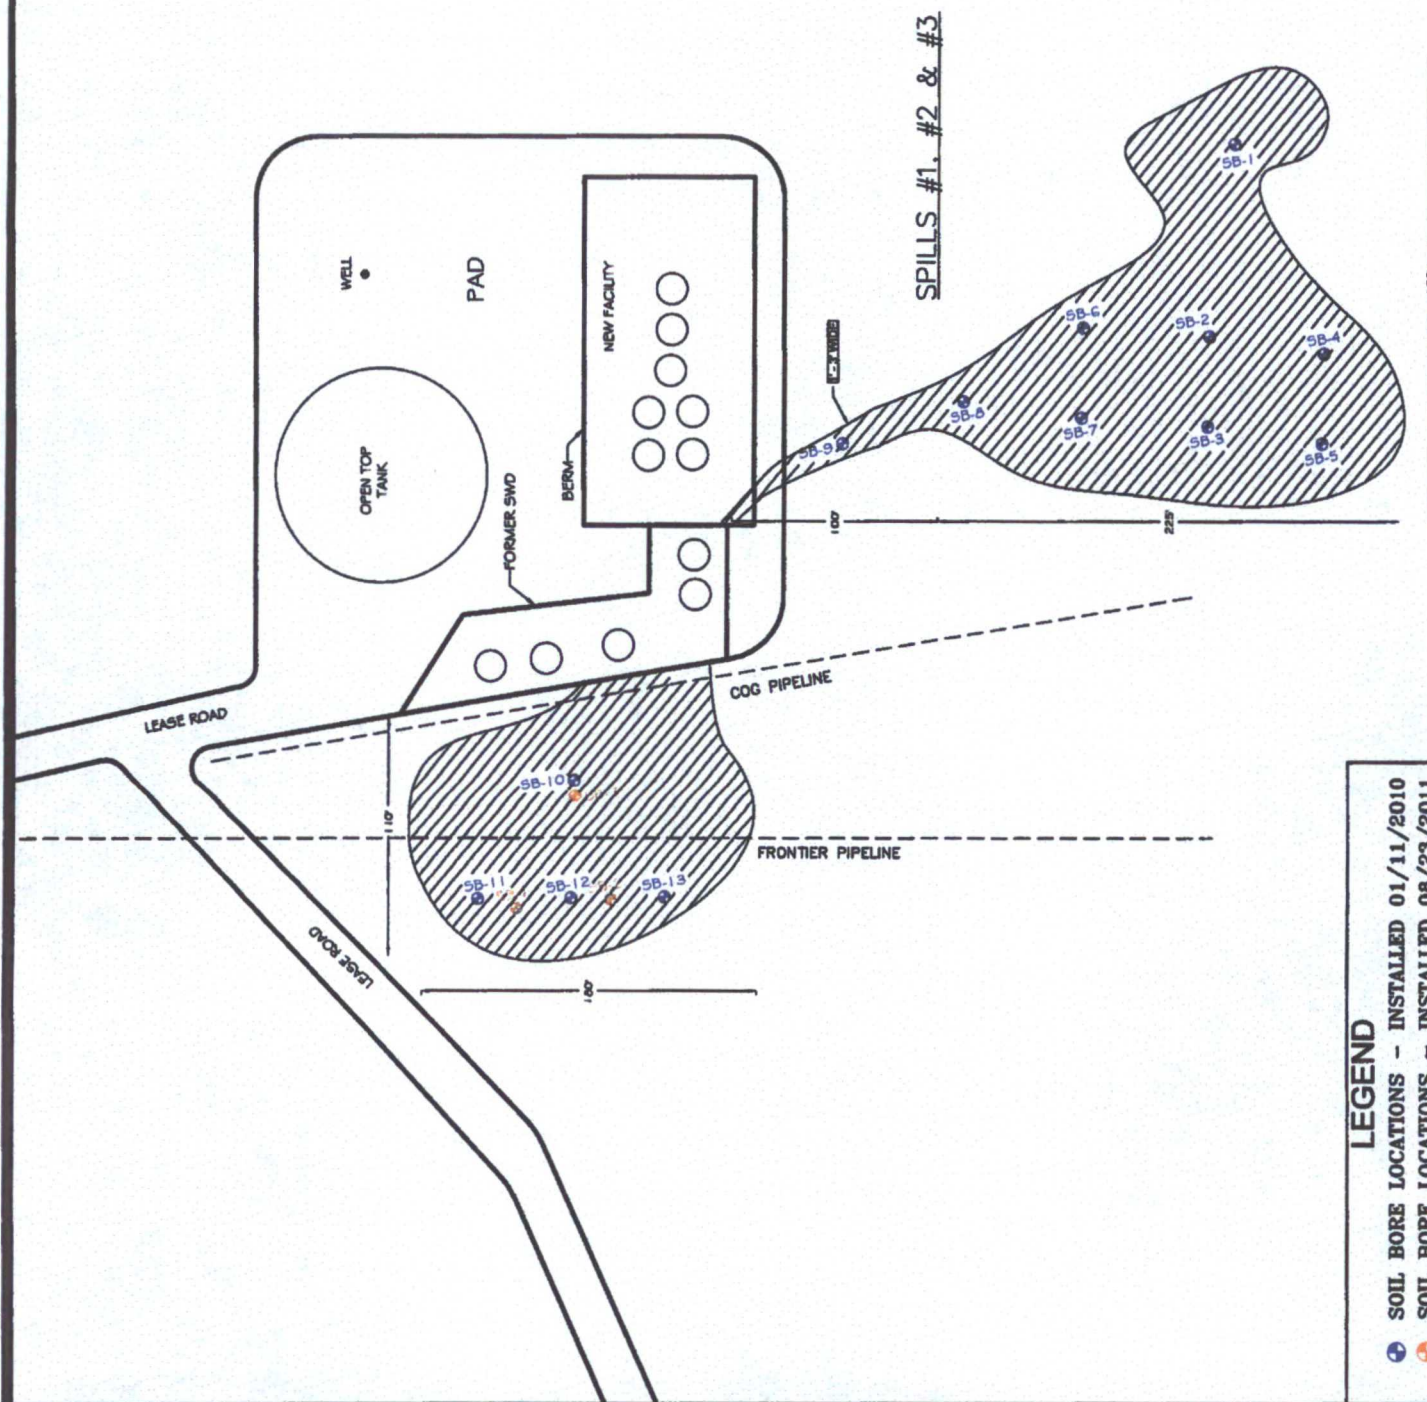
Figure 6

Proposed Excavation Areas & Depths Map

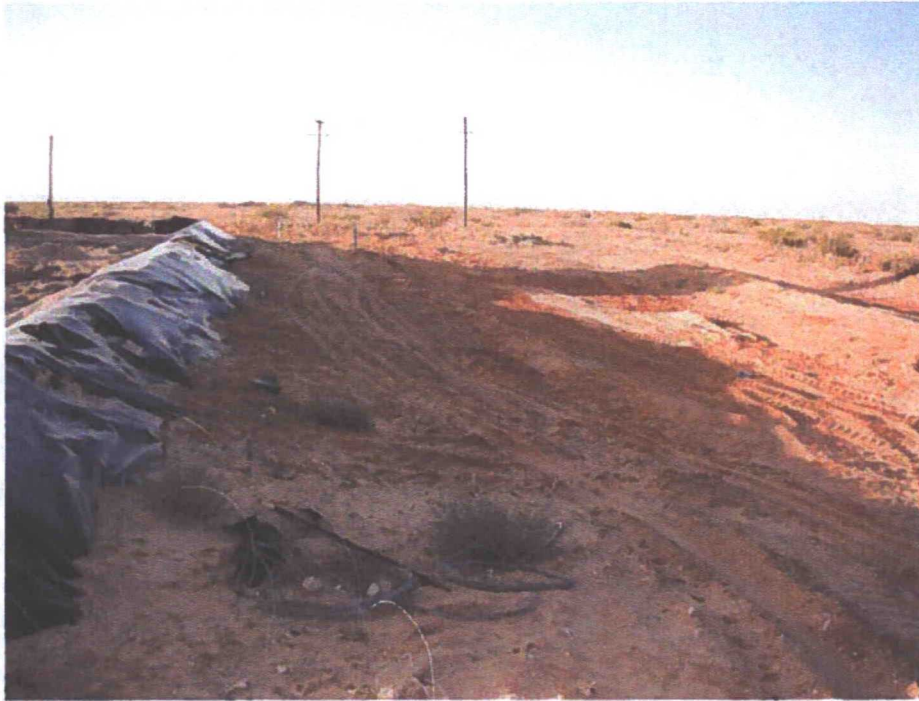
Excavated Area West of Facility

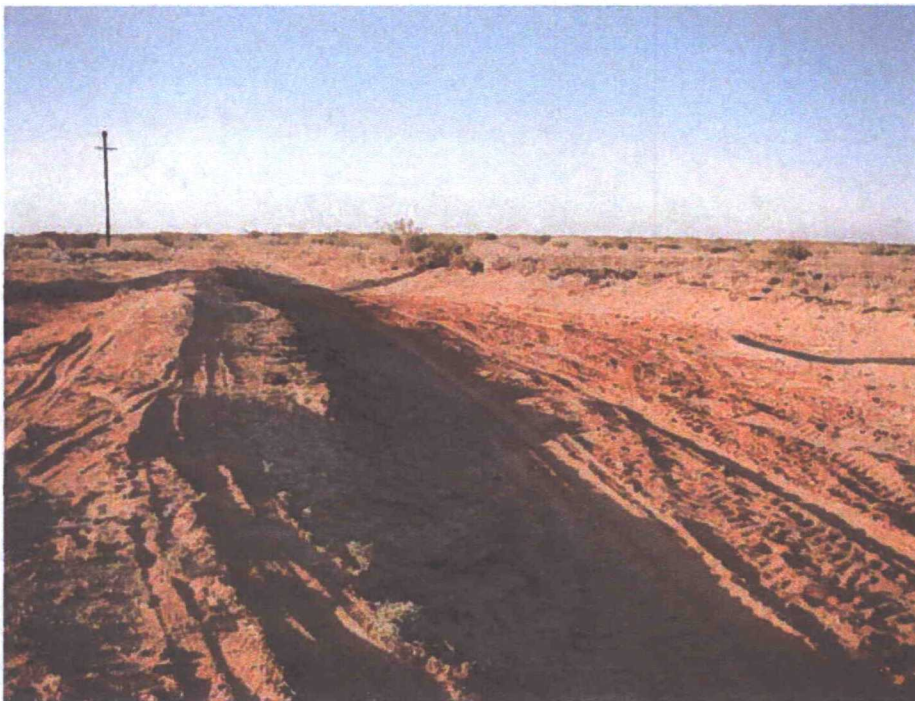
Excavated Area West of the Facility

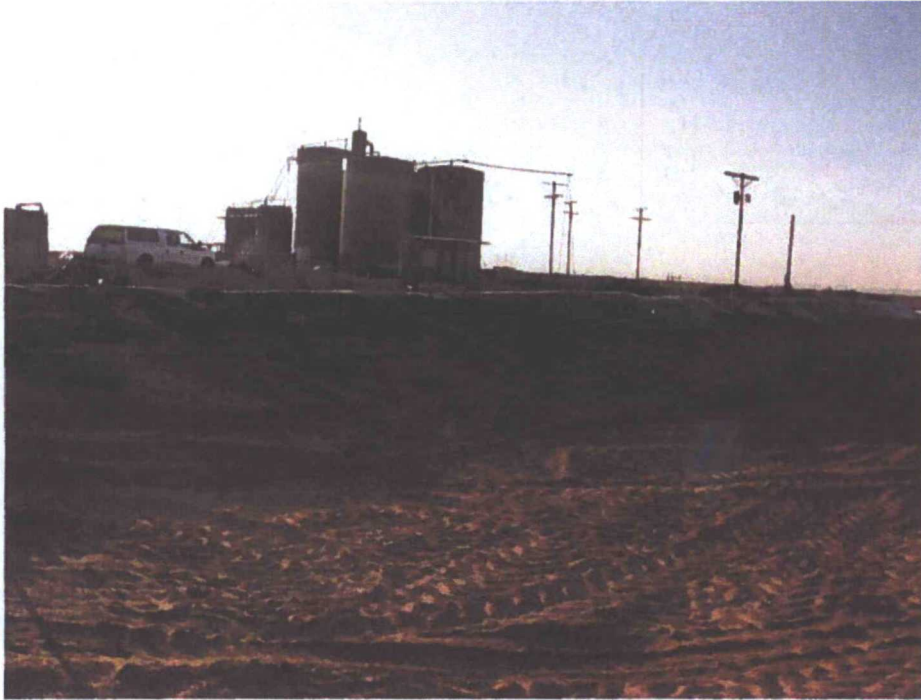
Excavated Area West of Facility

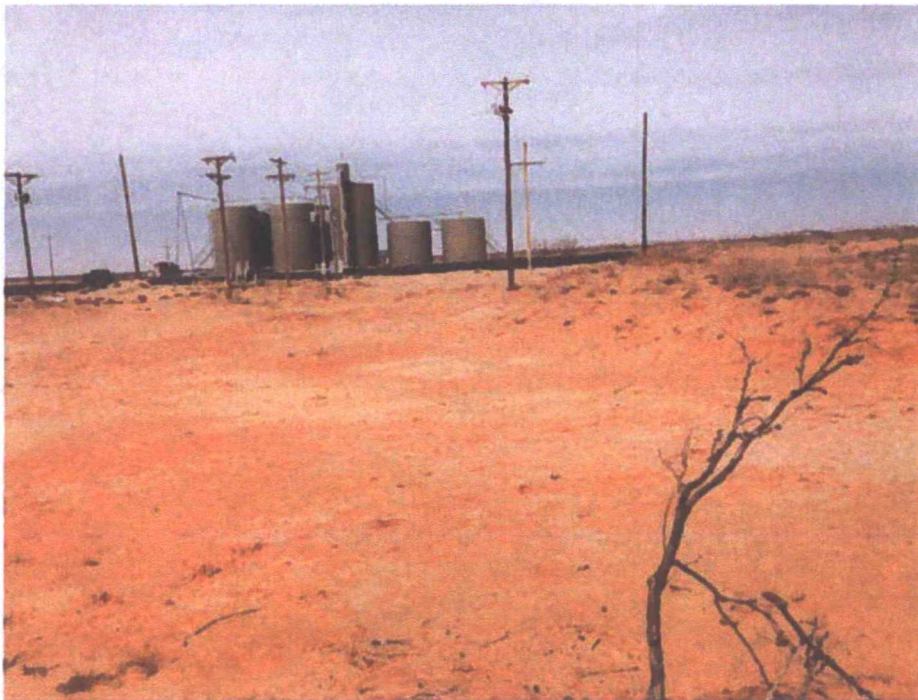
Excavated Area South of the Facility

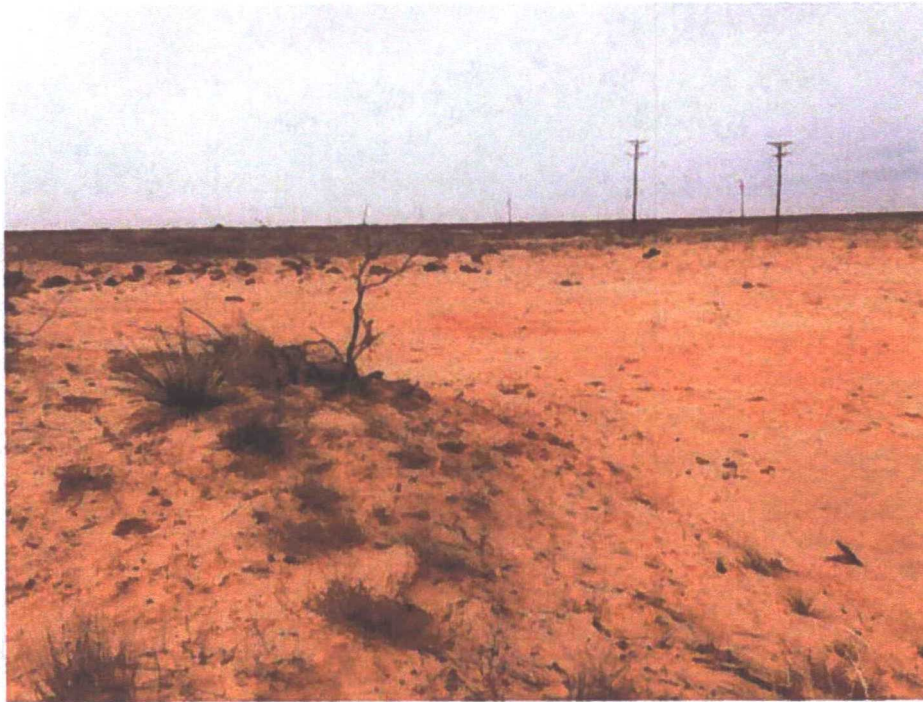
Excavated Area South of Facility

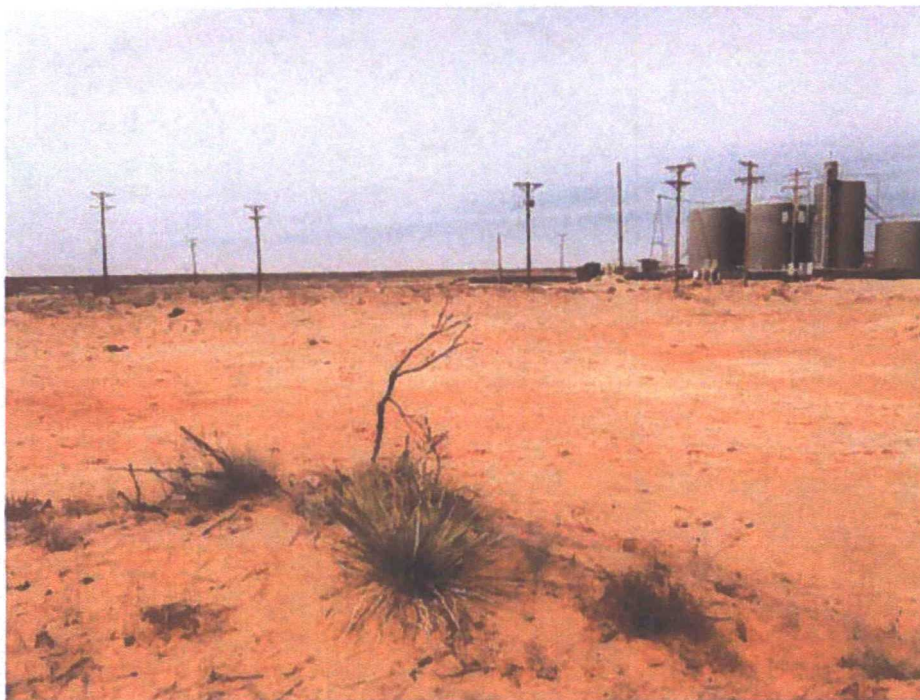
Excavated Area South of the Facility

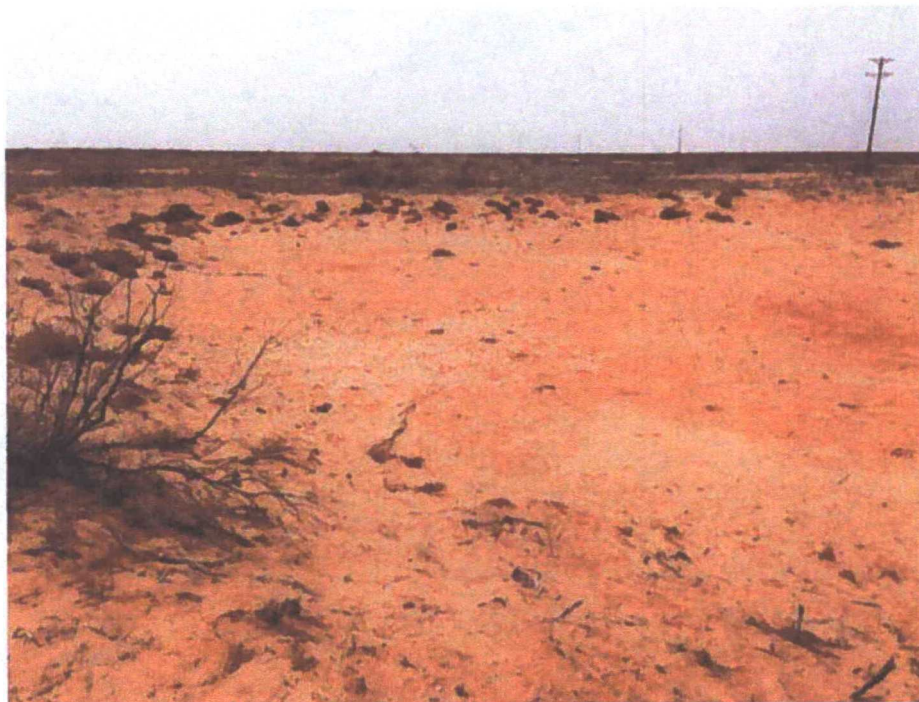
View West - Excavated Area South of Facility

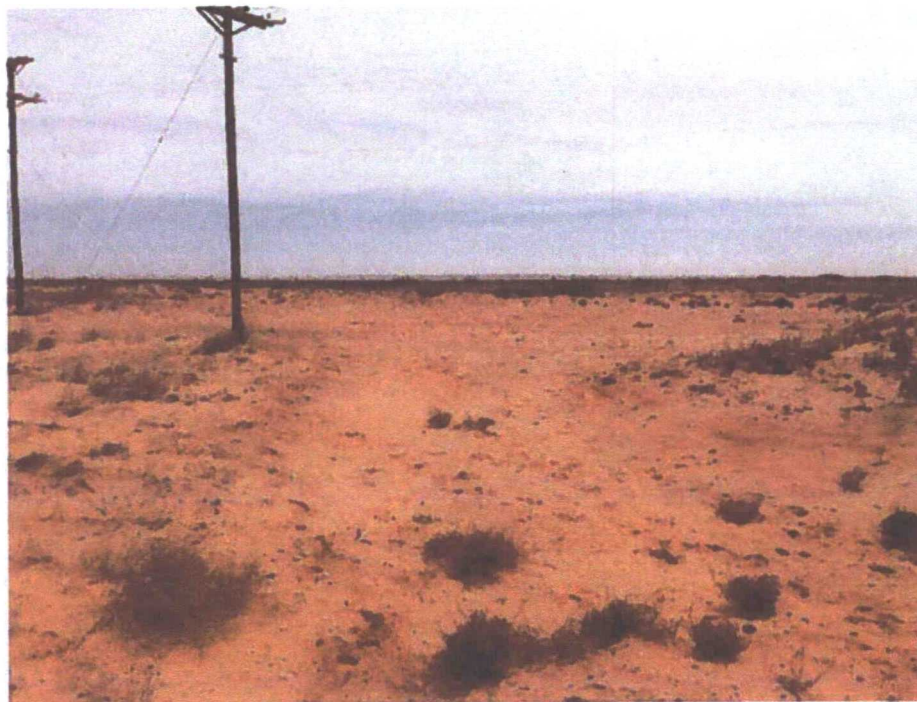
View South - Excavated Area South of the Facility
