**Release Notification and Corrective Action**

# **Closure Compliance Report**

**Russell Turner Water Station  
Section 20, T17S, R31E  
Eddy County, New Mexico**

**March 26, 2007**

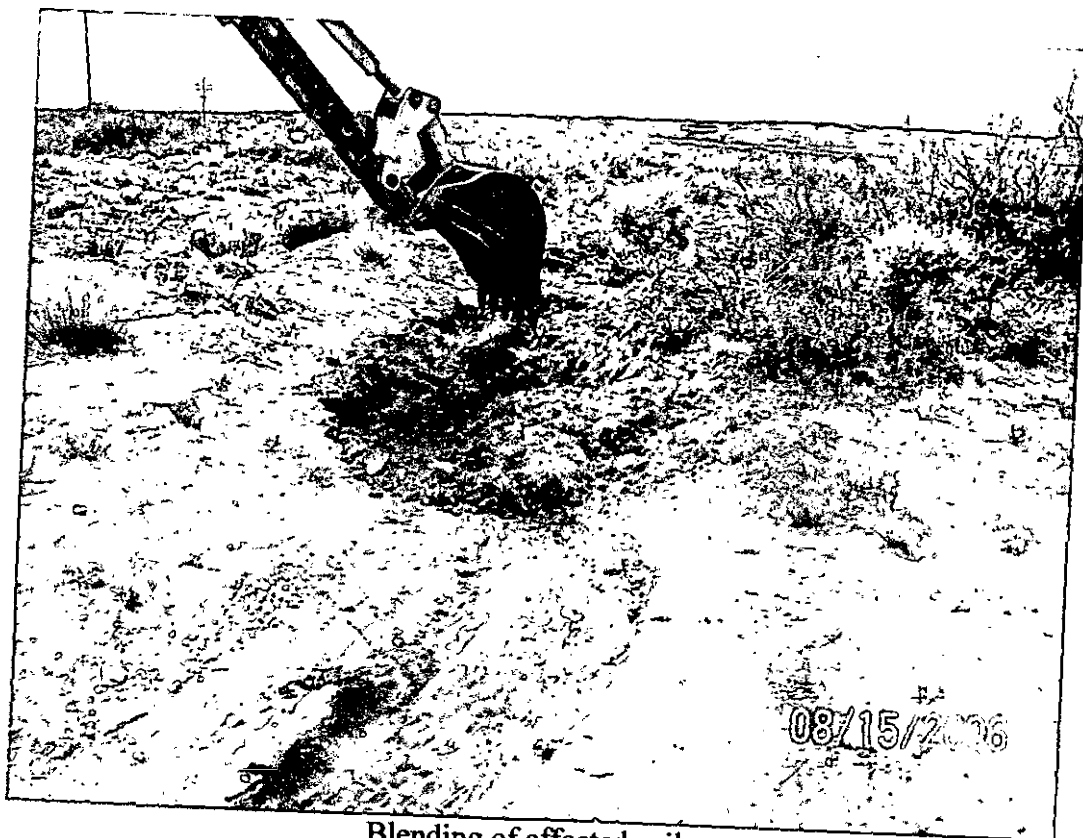
Blending of affected soils

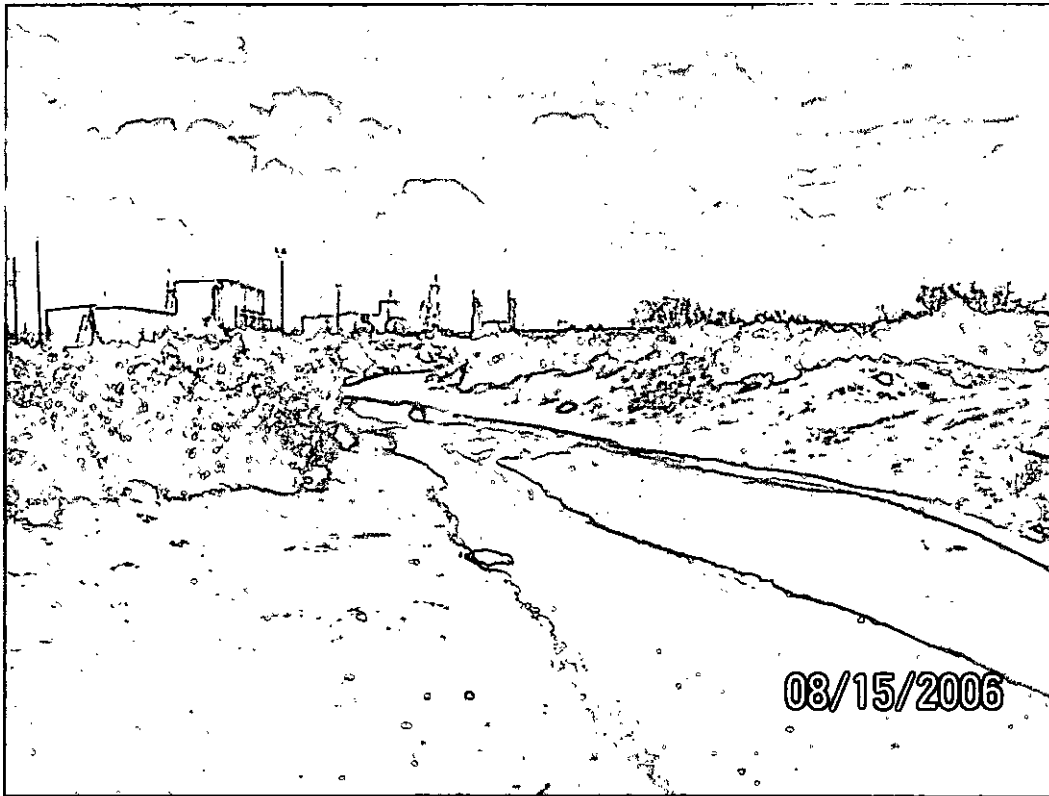
Typical view of the affected arroyo

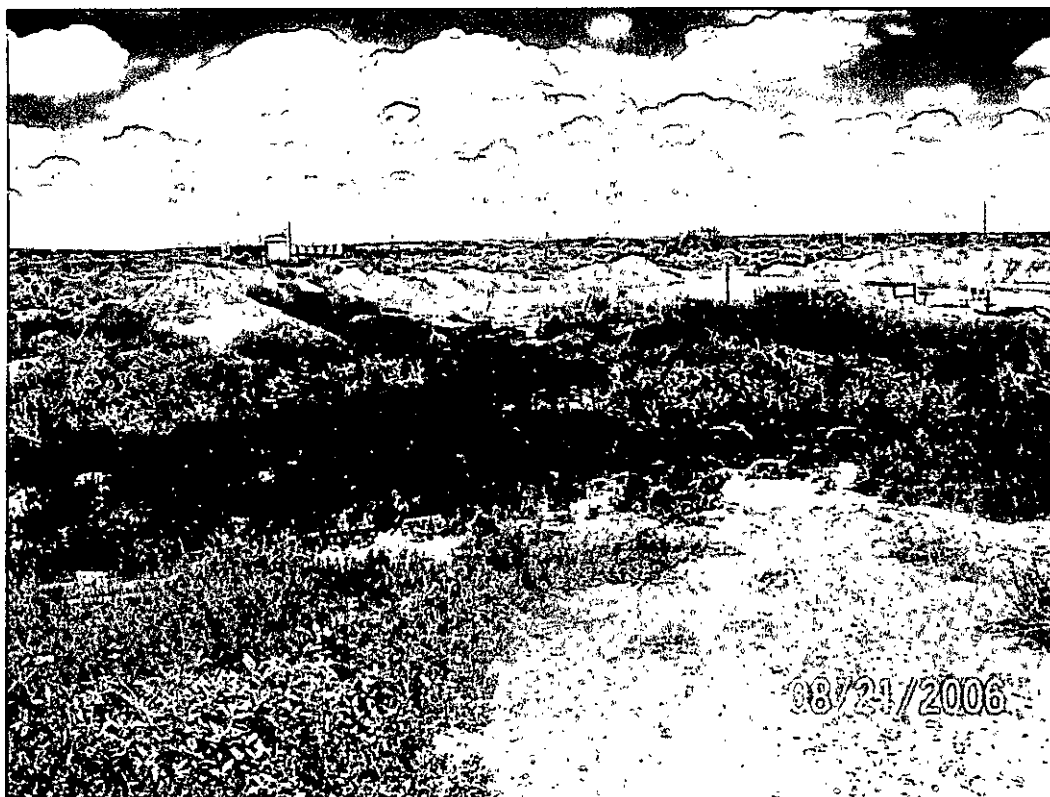
During the evening a second heavy rain event occurred. The second rain event flooded the arroyo, floating the remaining oil from the soils. The oil was floated approximately 1,800 feet further down to a flat area where it affected the bottom six inches of some of the surrounding tumbleweeds and broomweed. On August 24 and 25, 2006 all free oil was absorbed using Peat-Sorb and the remaining affected soils and vegetation were treated with Micro-bac M-1000, a blend of naturally occurring microbes, which assist in the degradation of hydrocarbons.

Affected vegetation after second rain event

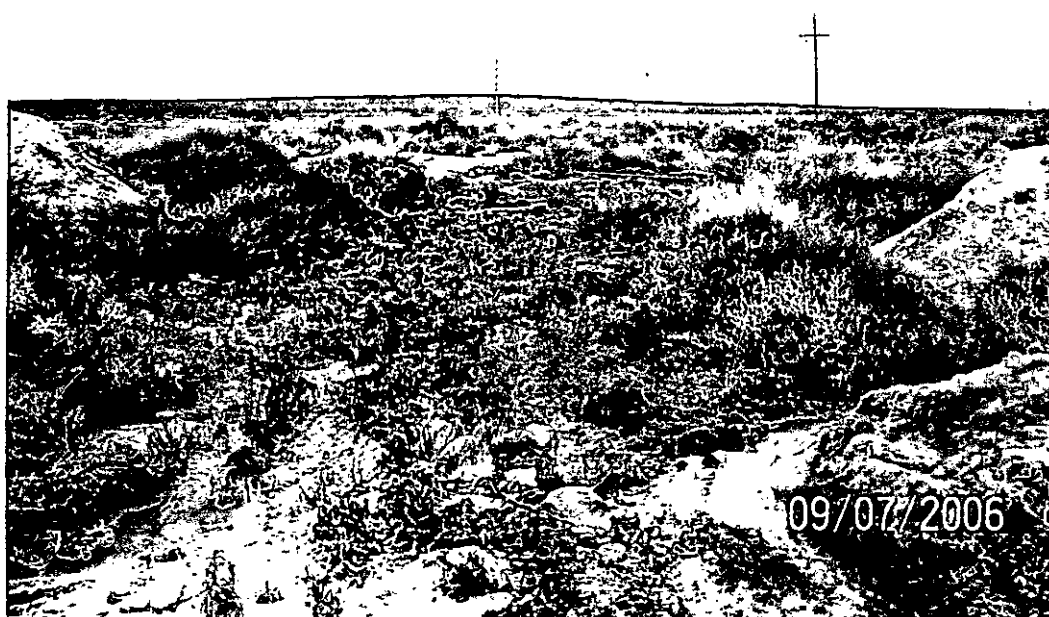
Affected vegetation after treatment

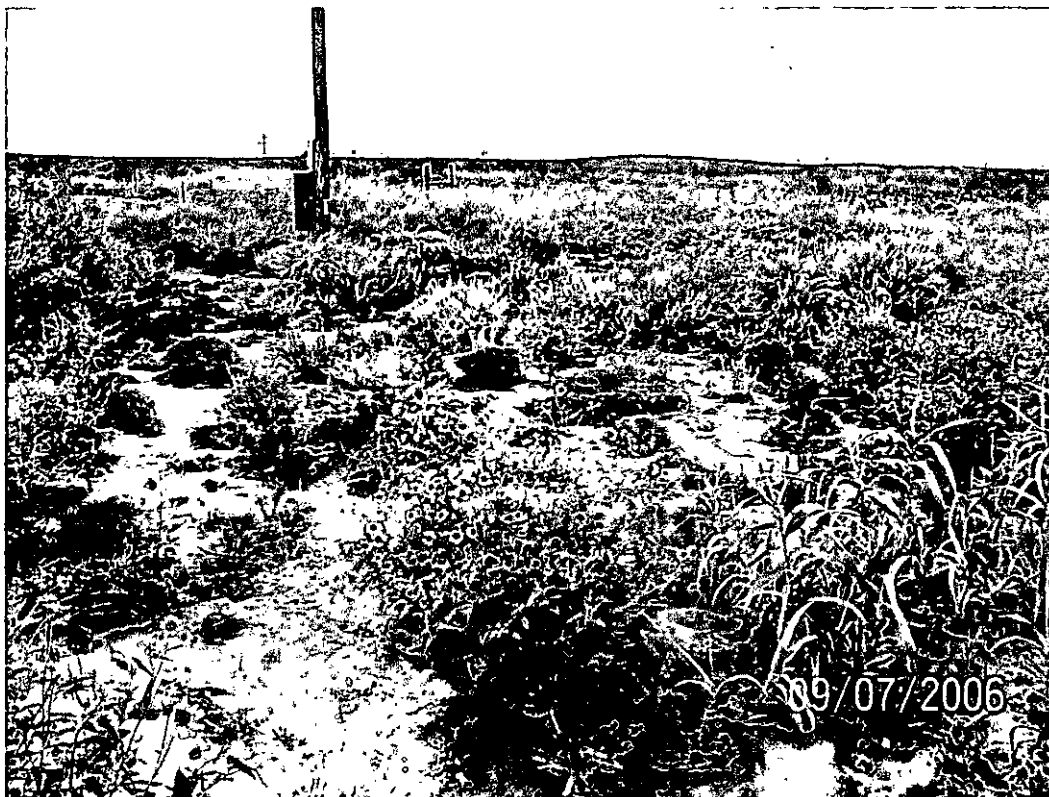
Affected vegetation after treatment
