**Cimarex Energy Company  
Cottonwood Draw 22 Federal Com #1  
Delineation Report**

**Eddy County, New Mexico**

**April 6, 2012**

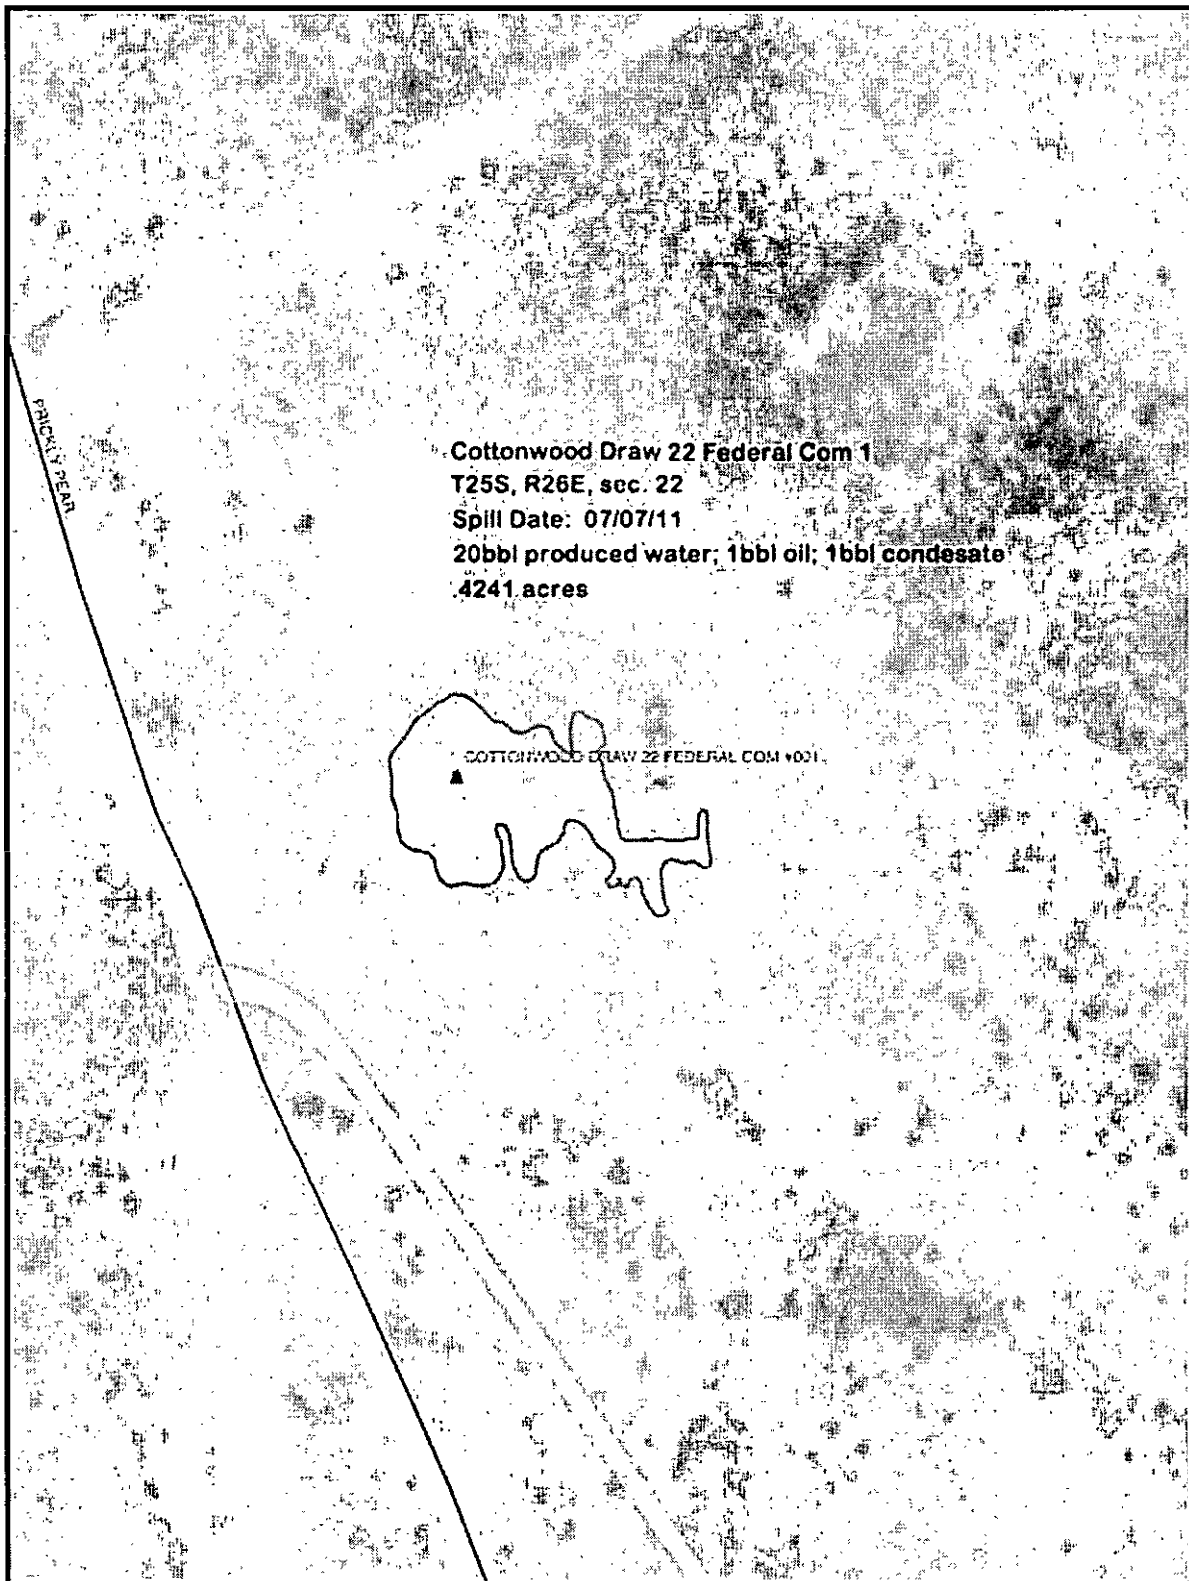
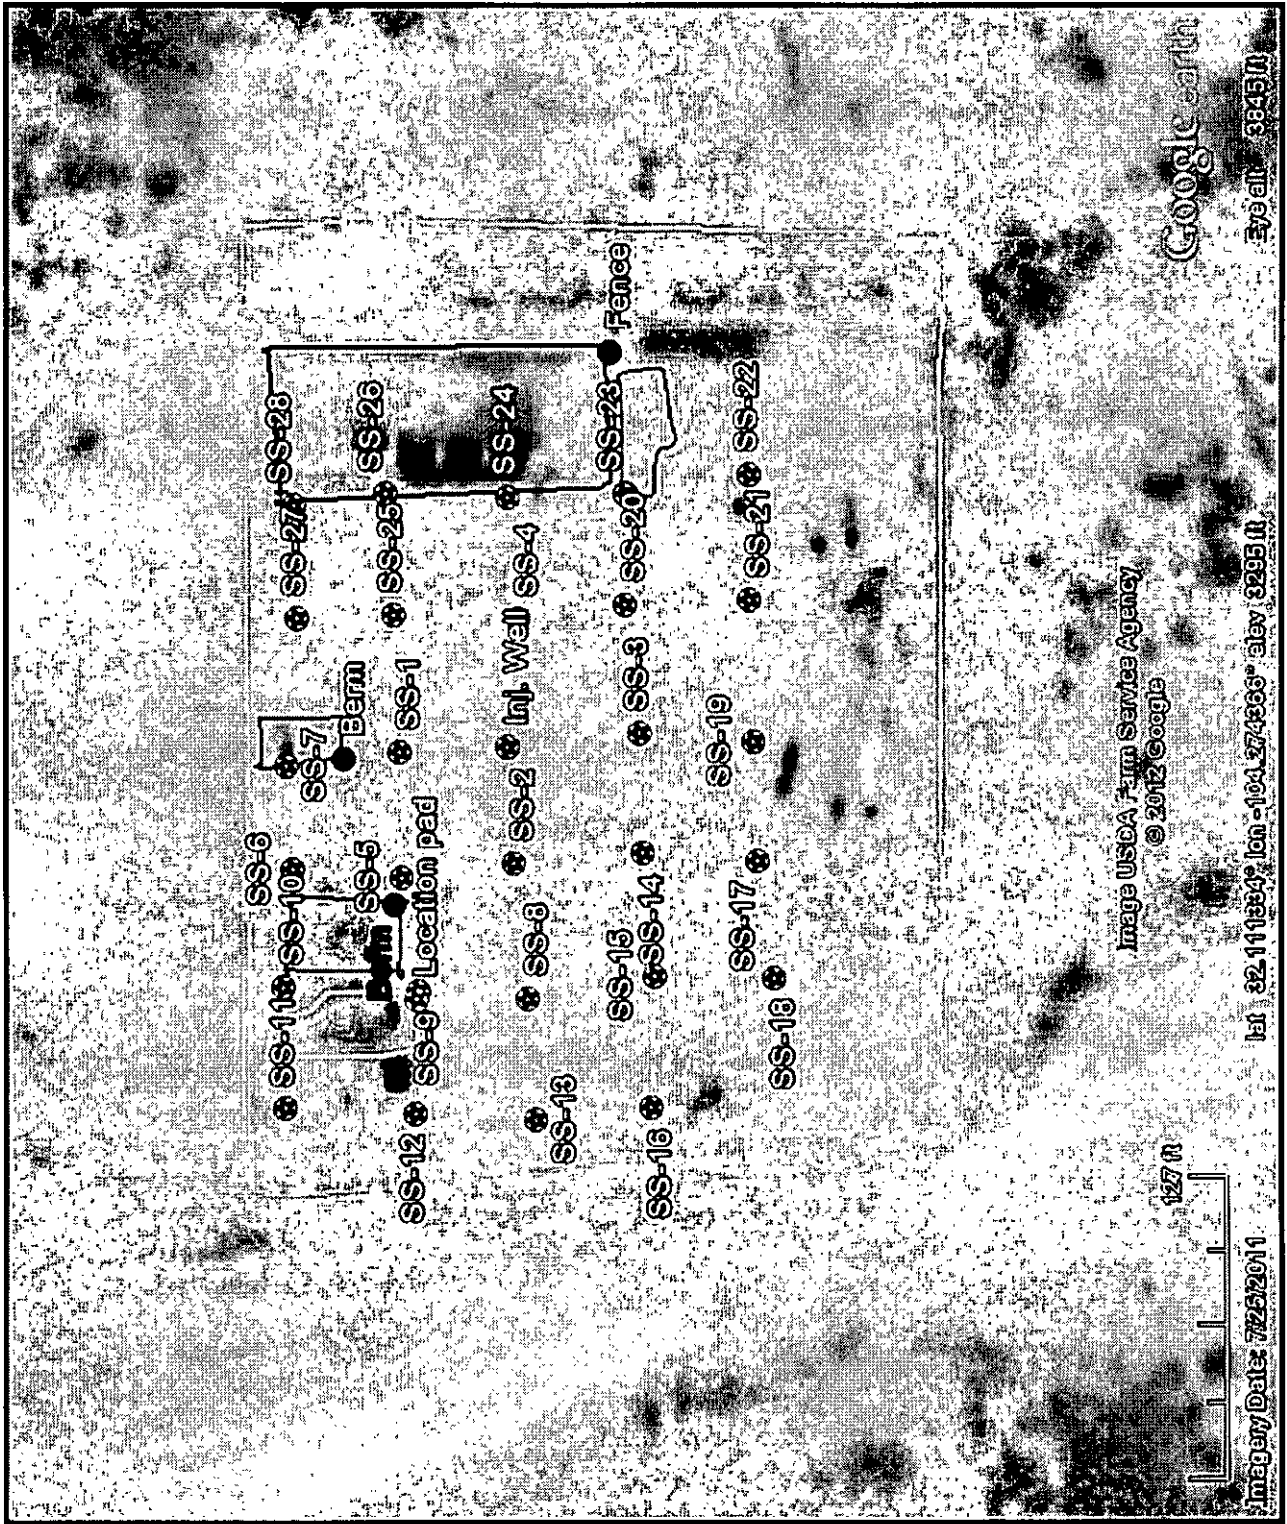
## **Figure 2 Site Plan**

A total of 28 surface samples were obtained from the location pad. As a result of the field chloride testing Surface Sample # 12 was the only sample less than 250 ppm and was properly preserved and transported to Cardinal Labs for confirmation as presented in the table below.

The results of the sampling reported above indicate almost the entire location pad currently exhibits elevated levels of chlorides. Due to the large area of contamination on the pad, Cimarex Energy Co. feels that to excavate the contaminated pad material would result in creating preferential pathways that may allow any future releases to penetrate deeper and thus creating a greater threat to the groundwater in the area. In lieu of excavation, Cimarex proposes that the pad be further delineated for vertical extent of contamination using boreholes instead of test trenches. The vertical extent of contamination will be documented and the contamination will be addressed upon the abandonment of the location.

In the interim, Cimarex proposes a lined shallow stormwater pond be constructed at the southeast corner of the pad to capture rainfall runoff from the pad. It should be engineered to contain the maximum amount of runoff from a single severe rainfall event as predicted by the weather service. Following the event, it should be emptied and the water disposed of at an approved facility. In addition to the pond, the berm surrounding the area should be inspected and repaired as necessary to prevent rainfall not captured by the pond from exiting the pad. Any standing water following a rainfall event should also be removed.

At closure Cimarex will address the most highly contaminated material by scraping and removal. In the case that the delineation reveals chloride contamination that is presenting a threat to the groundwater in the area, action would be taken to prevent further migration of the contamination in those areas.

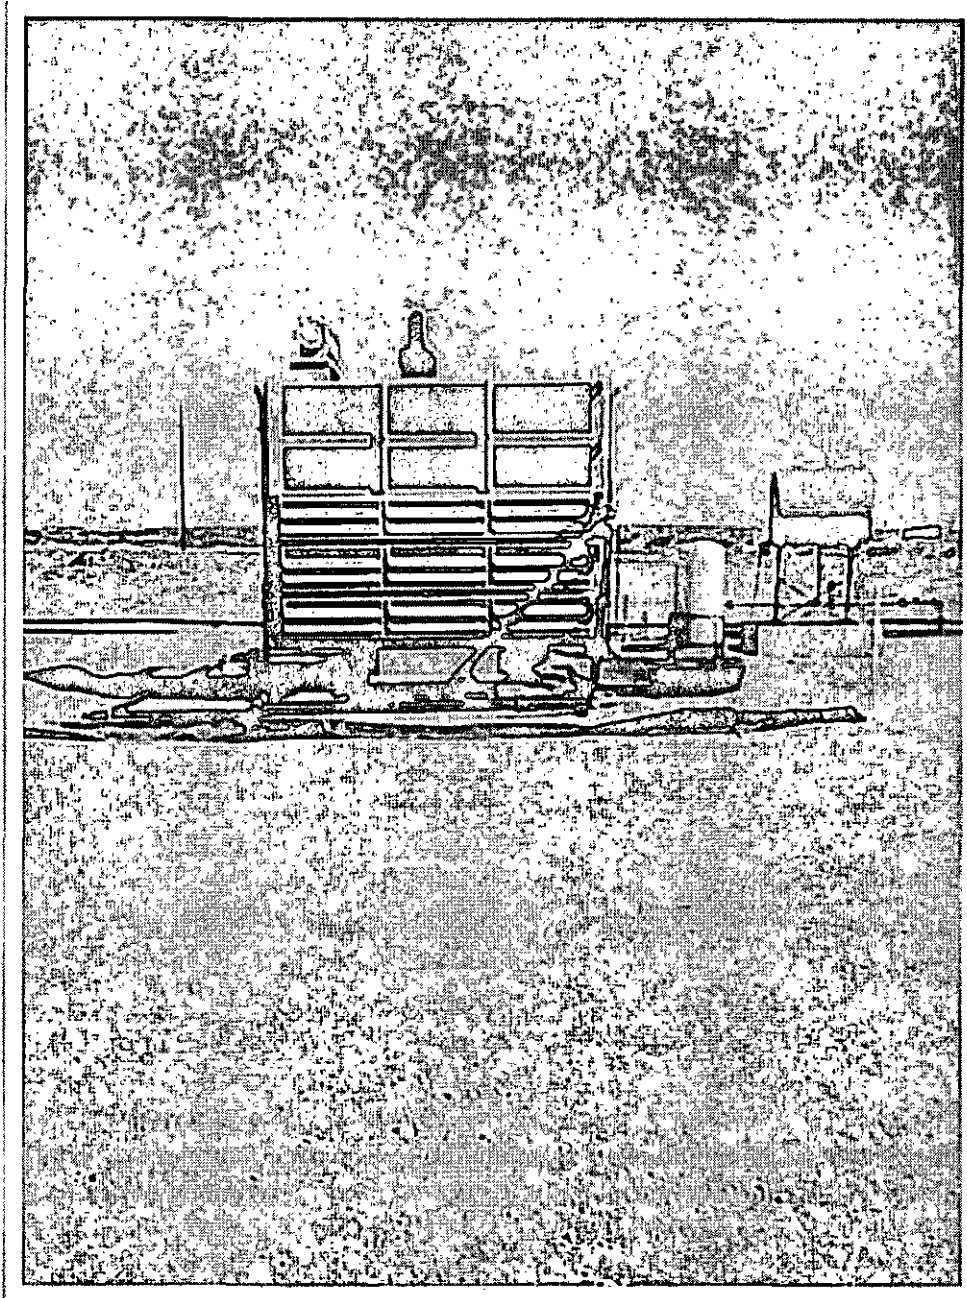
Compressor north area of location facing north

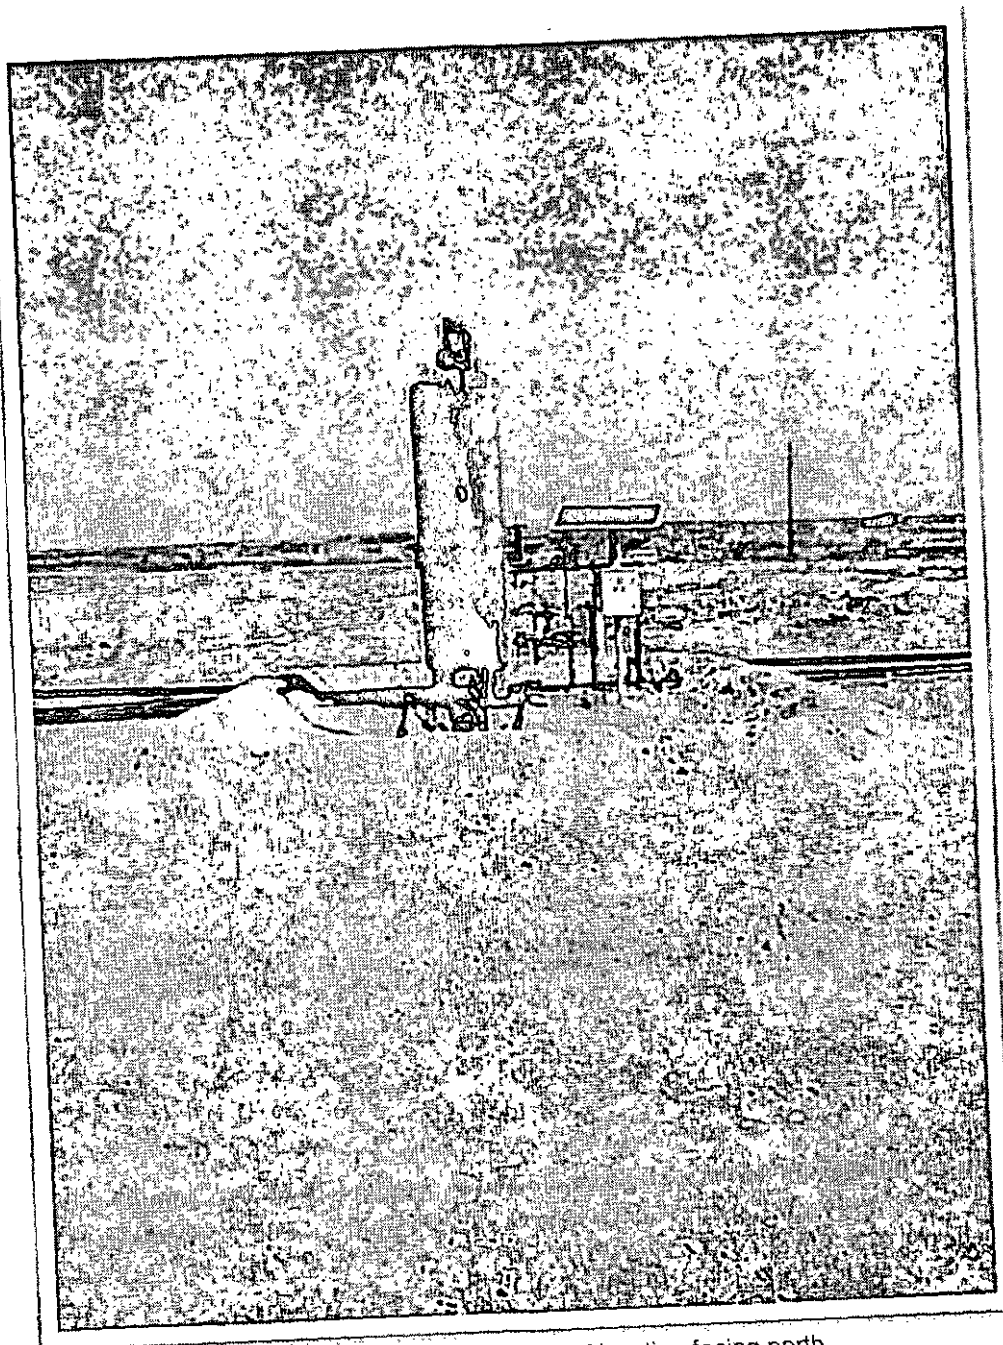
East of compressor north are of location facing north

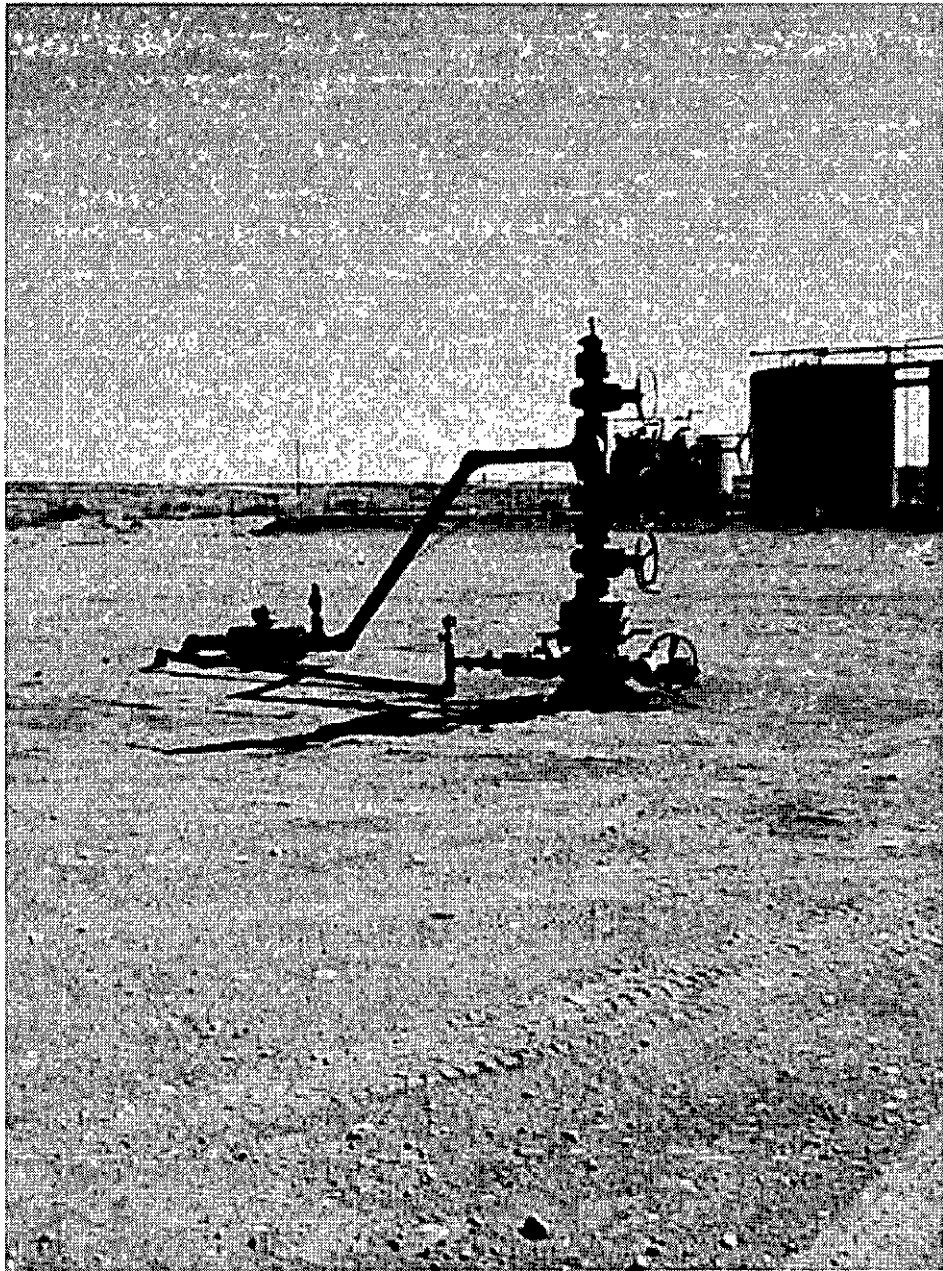
Injection well facing northeast

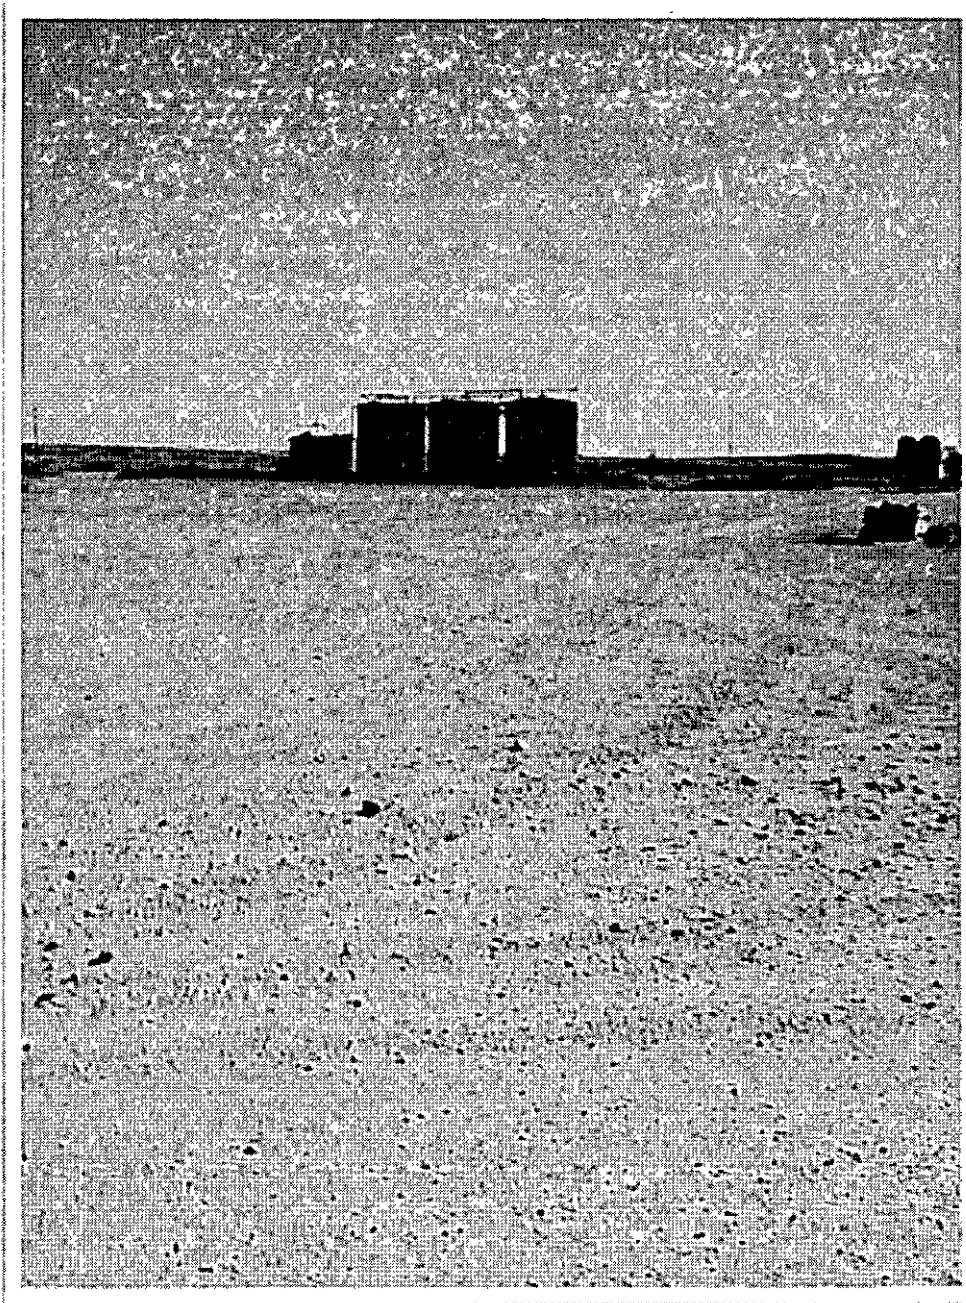
Location facing east

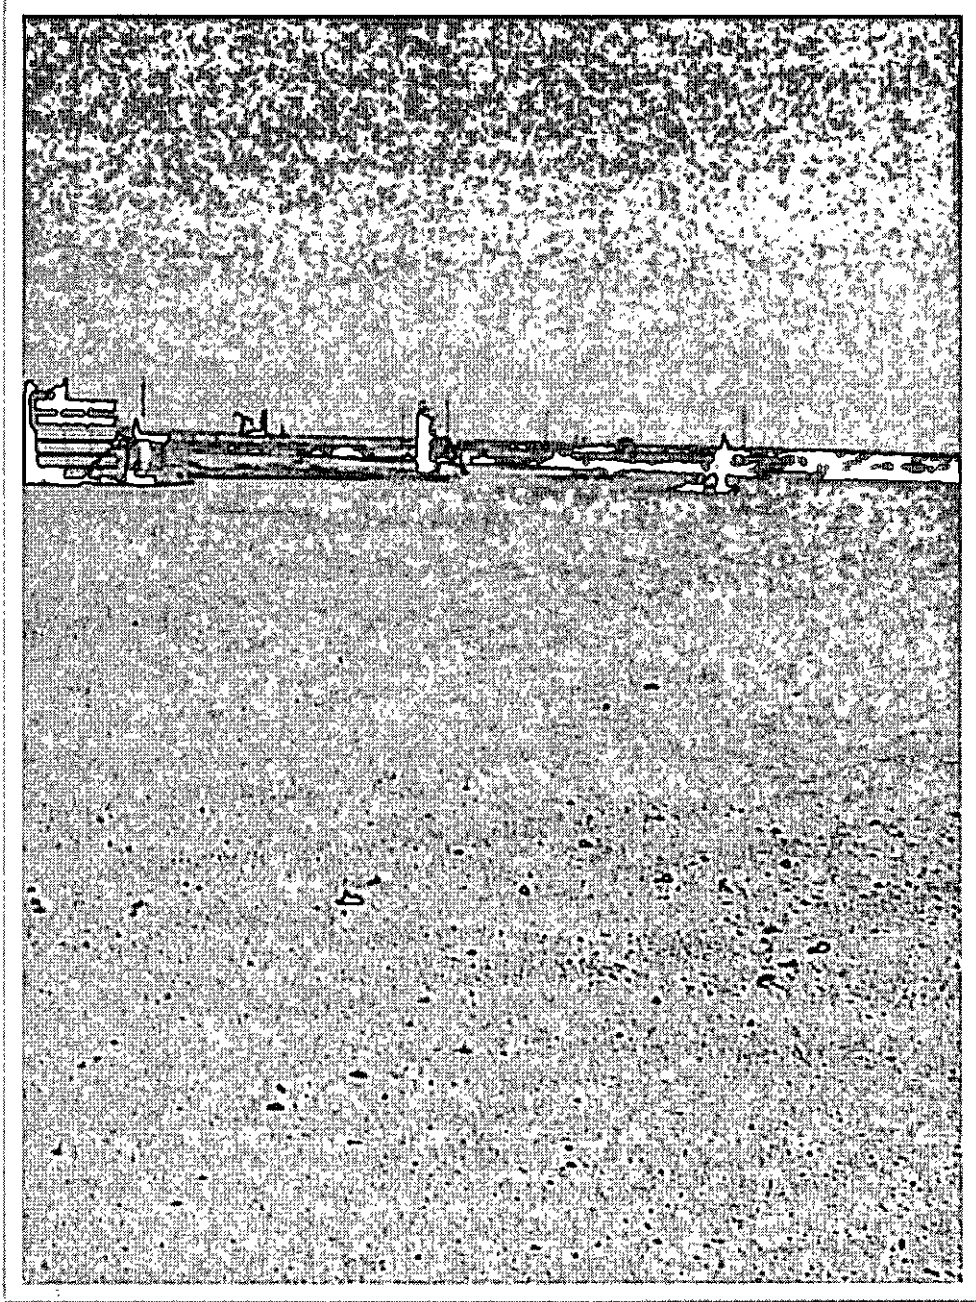
Location facing northeast

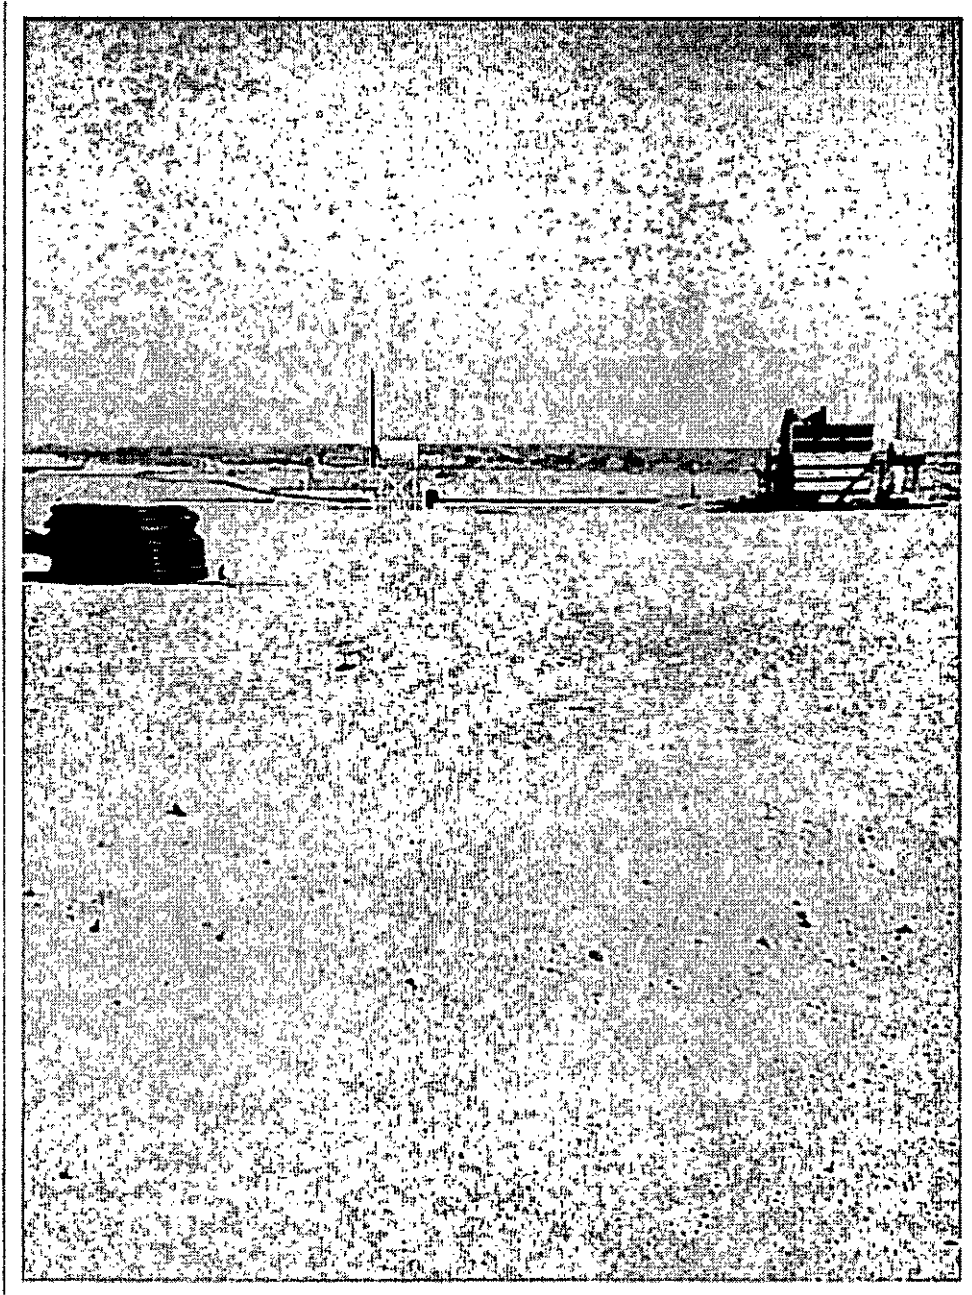
Northwest corner of location facing north

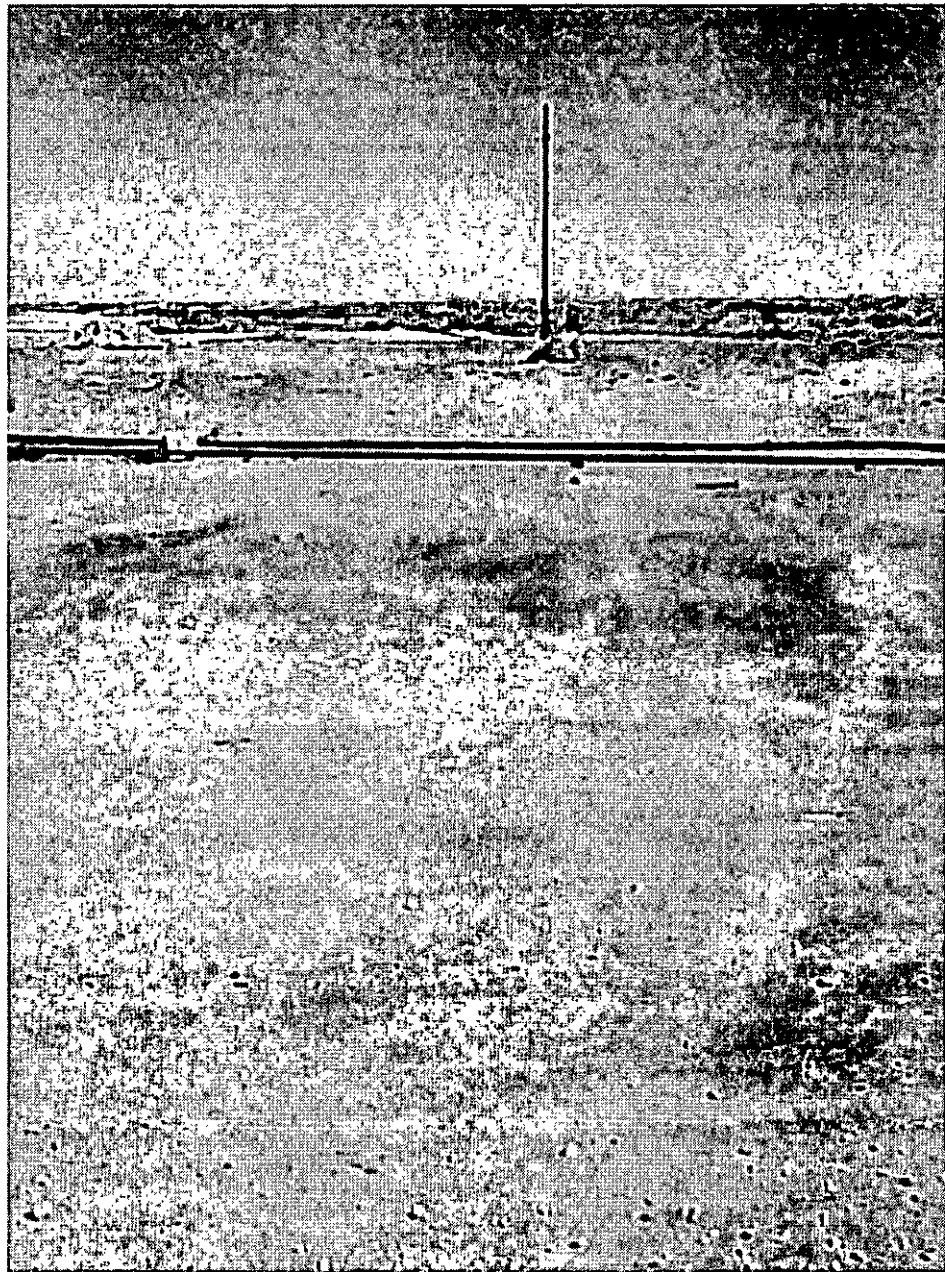
Pad west of compressor facing north

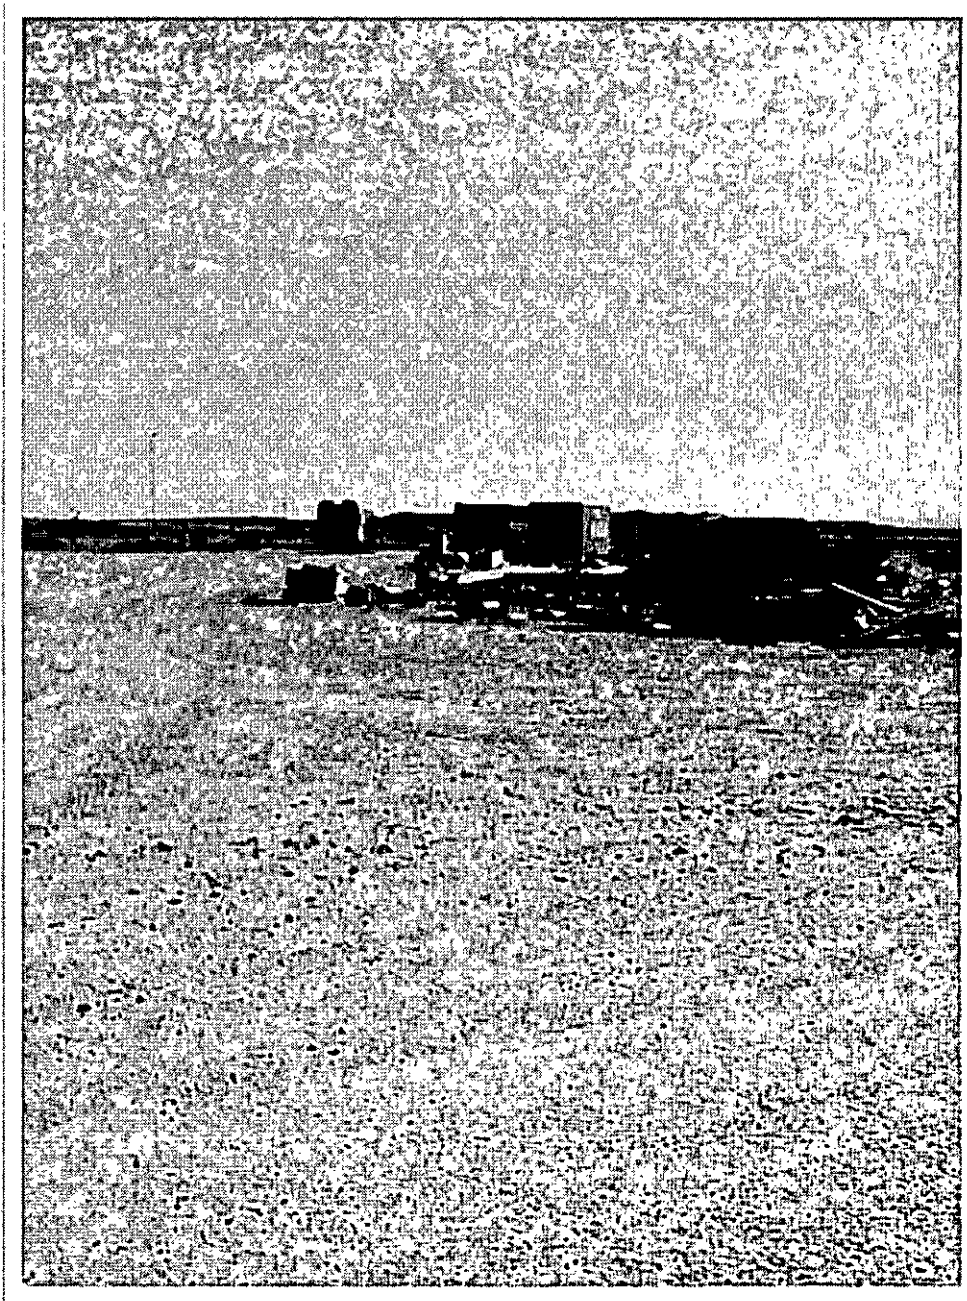
South area of location facing east

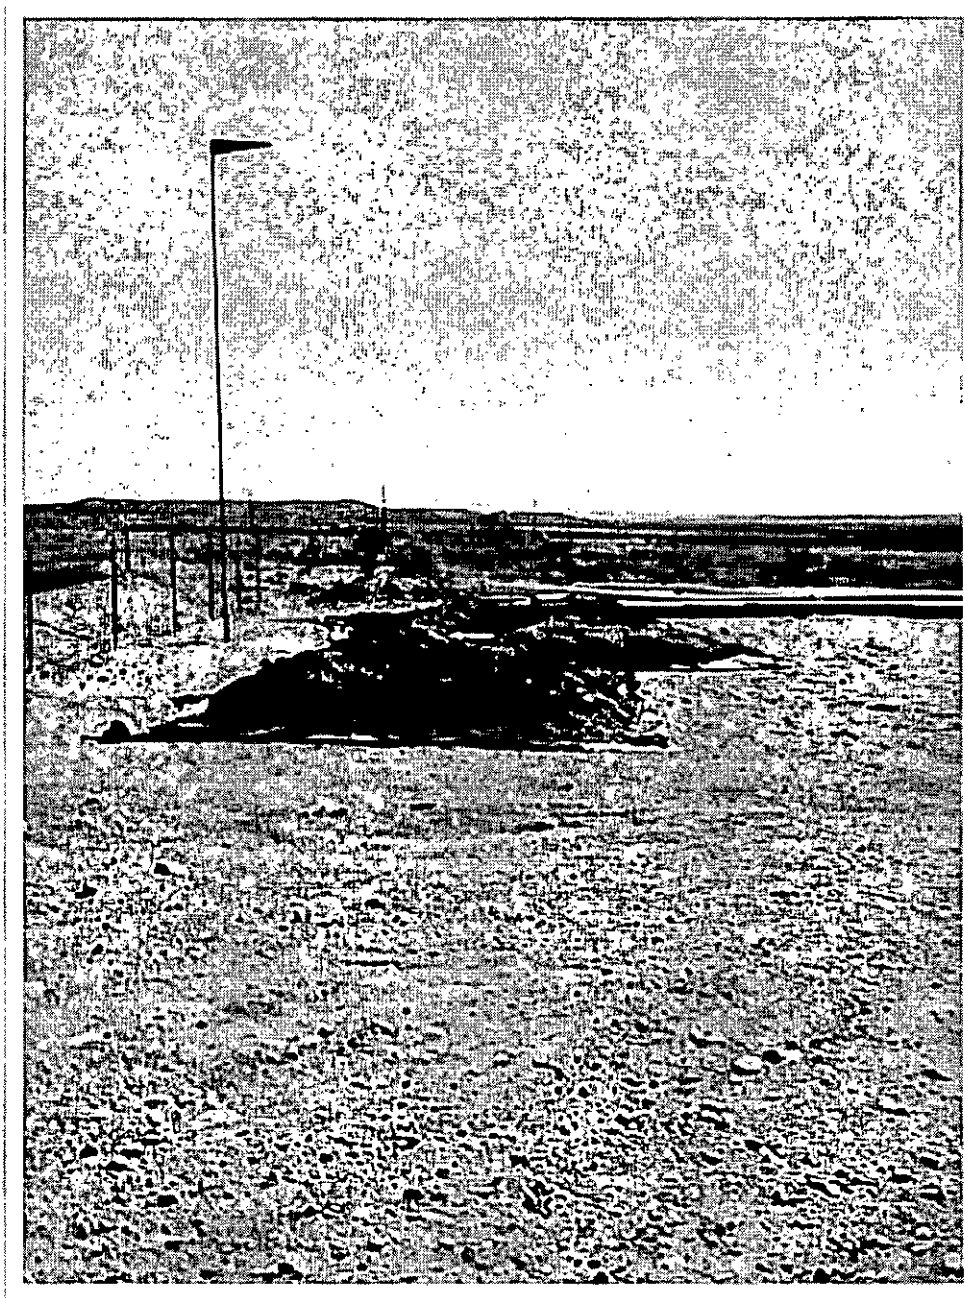
Spoils pile on liner south of tanks facing east

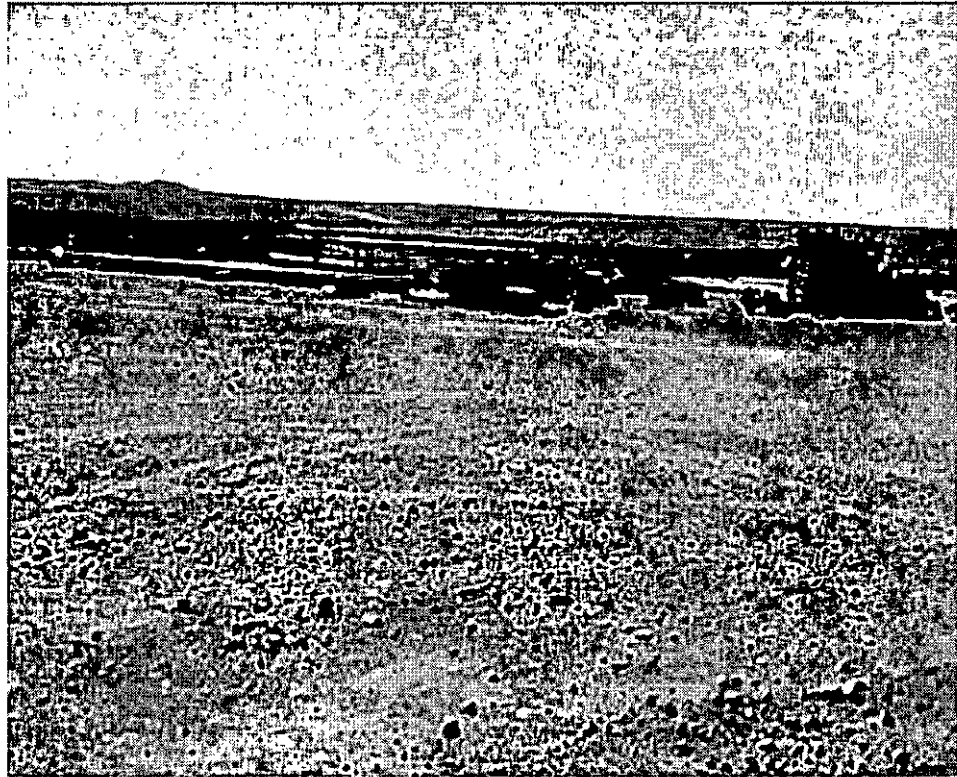
Staged supplies south of location facing south

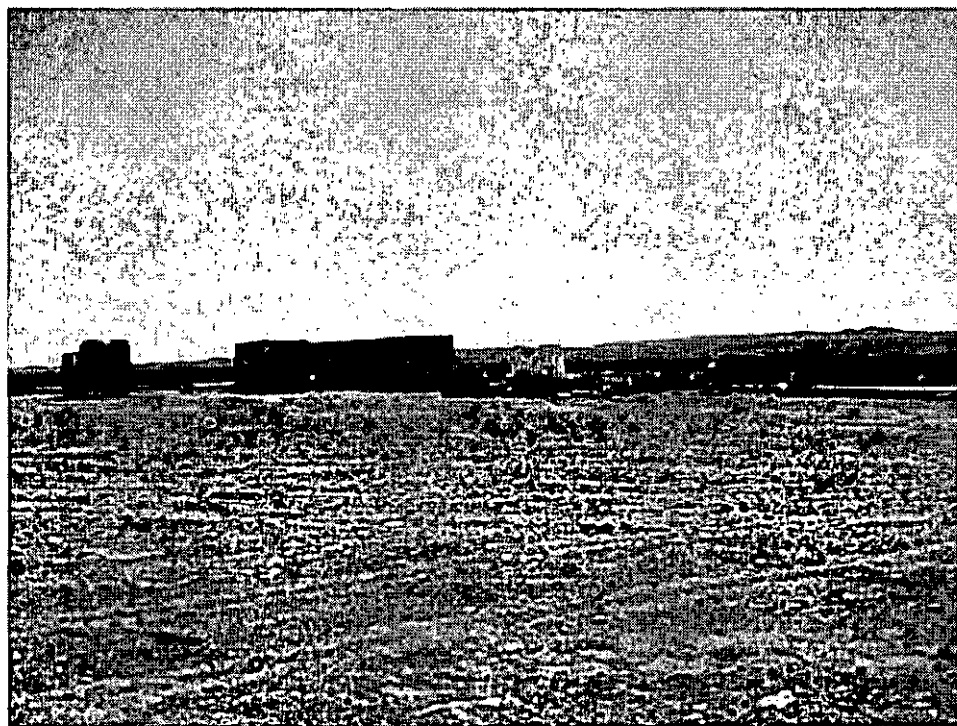
Staged supplies south of location facing south

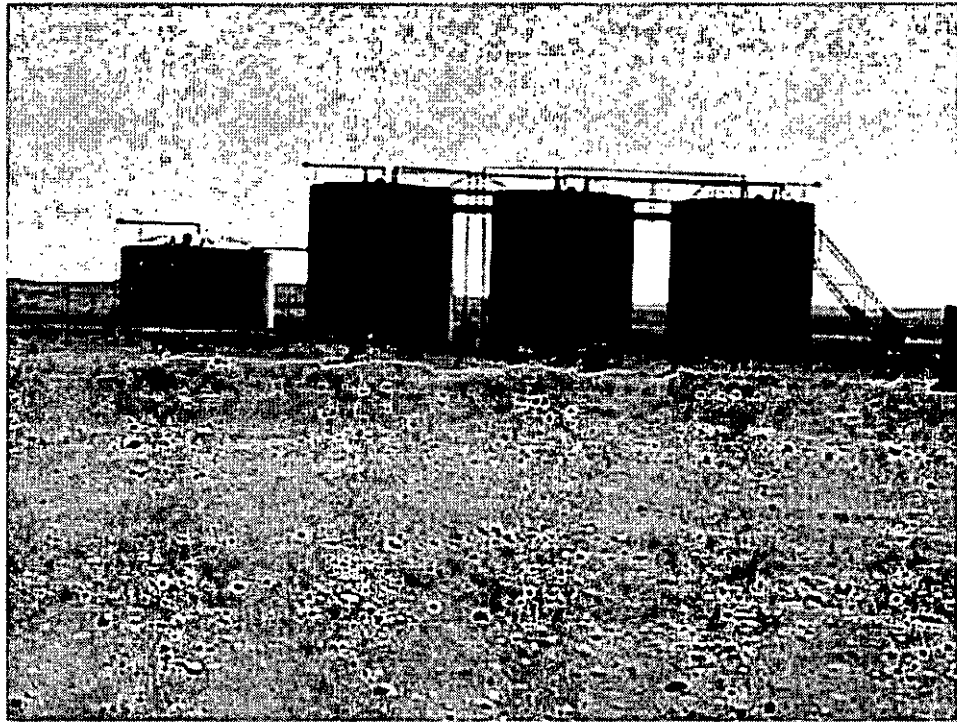
Tanks east of location facing east
