Release Notification and Corrective Action

Name of Company: BOPCO, L.P. **2100737** Contact: Amy Ruth
Address: 522 W. Mermod, Suite 704 Carlsbad, N.M. 88220 Telephone No. 575-887-7329
Facility Name: James Ranch Unit 29 SWD Facility Type: Exploration and Production

Surface Owner: State Mineral Owner: State API No. 30-015-27735

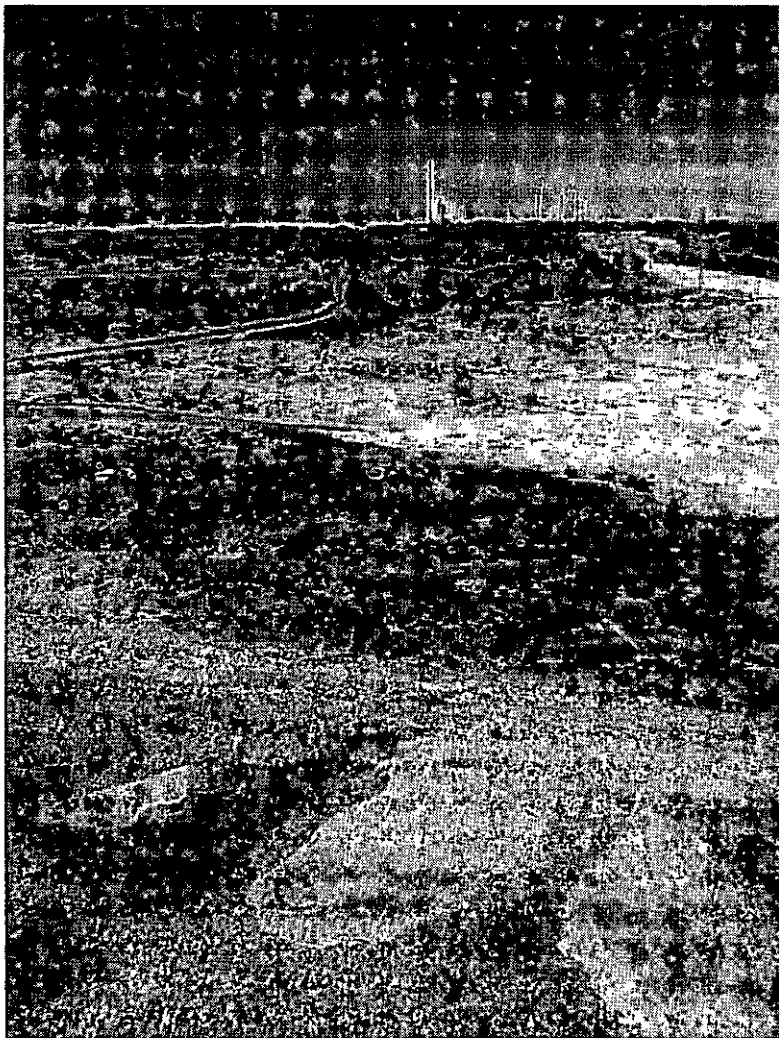
Bopco personnel were contacted by contractor concerning swd tanks overflowing at JRU 29 SWD Btry. The majority of release was contained to impervious containment but fluid did escape on location due to over fill of containment. We were unable to recover any fluid that impacted the ground.

The release was due to scada equipment issues and live stock damaging communication satellite.
