Release Notification and Corrective Action

Name of Company: New Mexico Saltwater Disposal Co.	Contact: Will Palmer	
Address: P.O. Box 1719 Lovington, NM 88260	Telephone No.: 575-396-5391	
Facility Name: Jenkins Sta. 13 transfer line	Facility Type: oilfield water disposal system	
Surface Owner: Shannon Kizer	Mineral Owner	Lease No.: SW0083

**Remediation and Site Restoration Protocol  
New Mexico Salt Water Disposal Jenkins Sta. 13 S. Leak  
1RP- 2611**

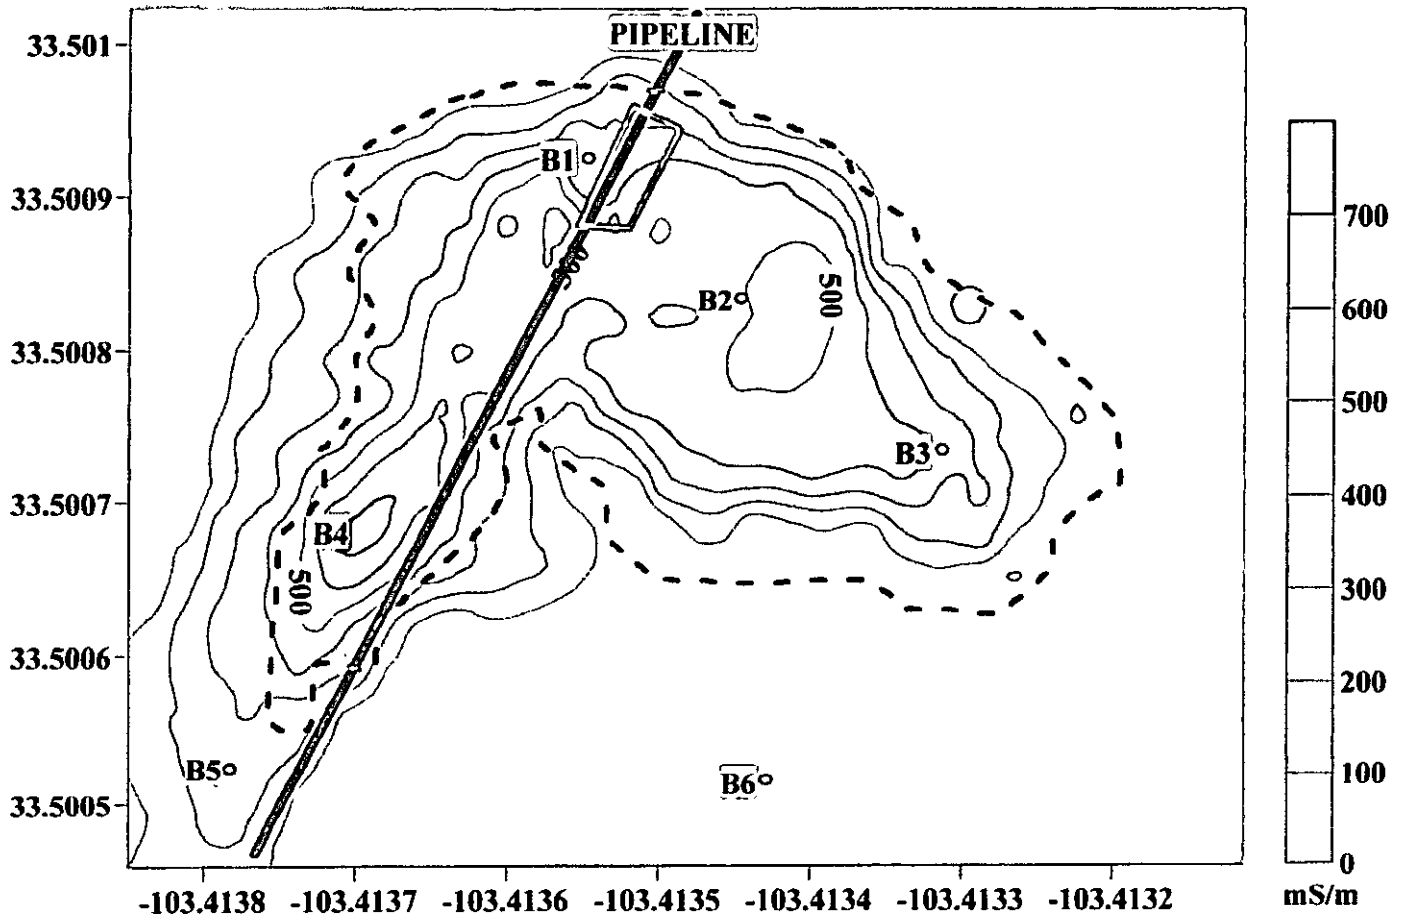
NMSWD JENKINS STA. #13 S. LEAK  
SW/SE 1/4 UL/O SEC 25 - T9S - R34E  
1451' FEL & 1067' FSL  
EM38 SURVEY AREA 218' E&W X 200' N&S= 1.0 ACRE  
GPS: WGS84 (DECIMAL)  
N33.500906950 / W103.413513200
