Administrative/Environmental Order

CELERO ENERGY II, LP

Re: Closure Report for the Celero Energy II LP, Priest #1 Tank Battery, Unit D, Section 1, Township 15 South, Range 37 East, Lea County, New Mexico.

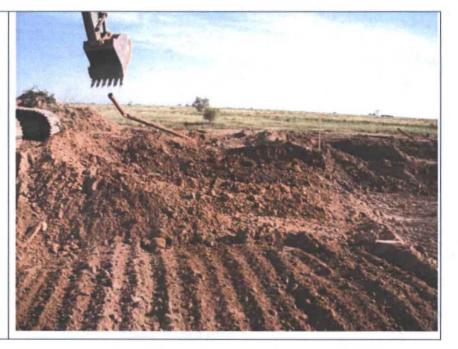
Photo: 1

View of excavation of site.

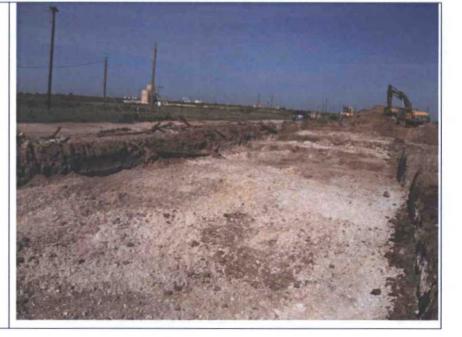
Photo: 2

Excavation of site.

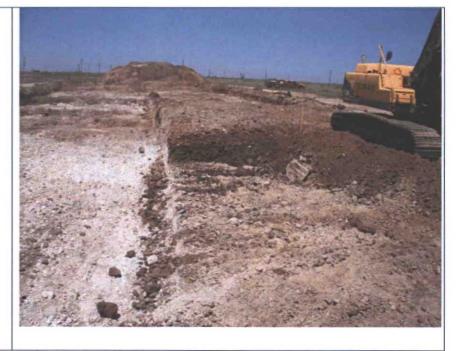
Photo: 3

Excavation of the site.

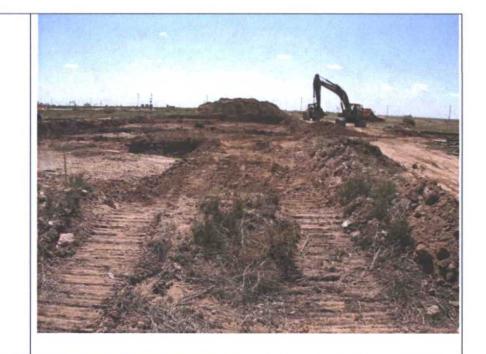
Photo: 5

View of excavation.

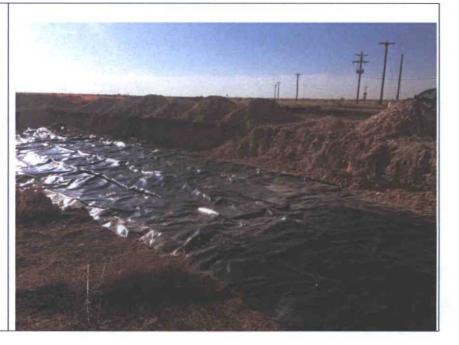
Photo: 6

Installation of liner.

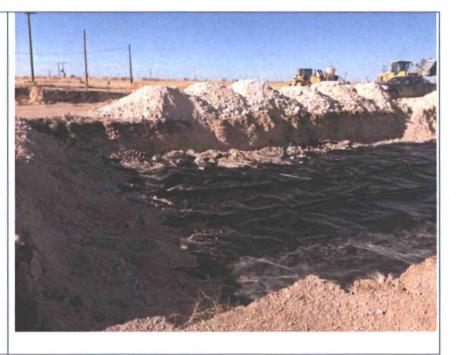
Photo: 7

Installation of liner.

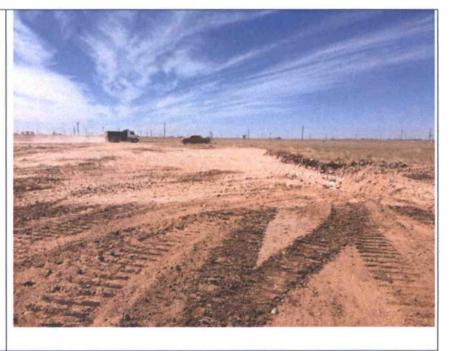
Photo: 8

Backfilling of site.
