Release Notification and Corrective Action

Name of Company: Targa Midstream Services, L.P.	Contact: Don Embrey
Address: 6 Desta Drive, Suite 3300, Midland, TX 79705	Telephone No.: (432) 688-0555
Facility Name: Kennann 6" (Site #12)	Facility Type: Natural Gas Pipeline
Surface Owner: Winnie Kennann	Mineral Owner
Lease No.

Re: Spill Notification and Remediation Plan, Site #12, Targa Midstream Services, L.P., Unit Letter P (SE/4, SE/4), Section 30, Township 22 South, Range 38 East, Lea County, New Mexico

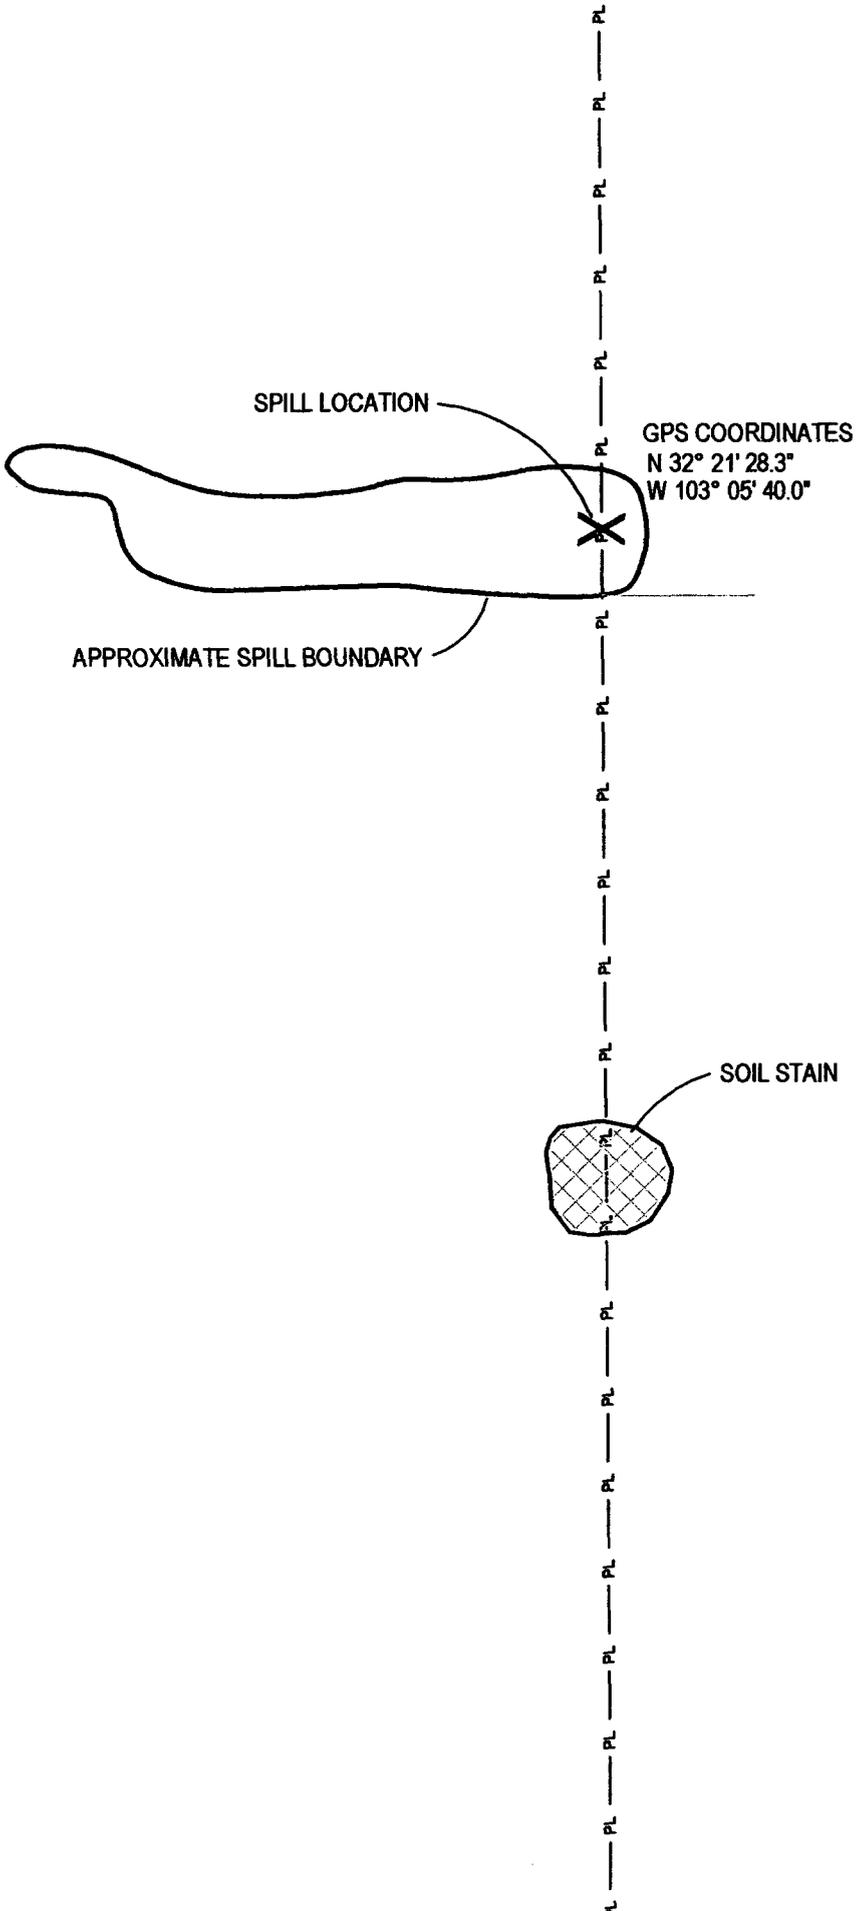
FIGURE # 2
LEA COUNTY, NEW MEXICO

Describe Cause of Problem and Remedial Action Taken.* Release was due to corrosion of steel pipeline. The pipeline was exposed and corroded line segment was replaced with poly pipe. Soil will be remediated to OCD guidelines.

Describe Area Affected and Cleanup Action Taken.*: Release flowed on the surface about 75 feet west of release and affected area about 10 feet wide. Soil will be excavated and hauled to an OCD approved surface waste management facility. Area will be filled with clean soil and seeded.

TMS will excavate soil from Site #12 until benzene, BTEX, TPH and chloride are reduced below the RRAL. Soil will also be excavated from the area of surface staining located about 90 feet south of Site #12. The soil will be hauled to an OCD permitted commercial landfarm. Soil samples will be collected from the sides and bottom of the excavation, submitted under proper preservation and chain-of-custody control to an environmental laboratory and analyzed for the above-referenced constituents. Benzene and BTEX will not be analyzed if headspace samples exhibit readings below 100 parts per million ("ppm"). The laboratory analyses will be submitted to the OCD within 45 days following receipt of the report from the laboratory and the excavations will be filled with clean soil following OCD approval. You may call Mr. Don Embrey with TMS at (432) 688-0555 or email dembrey@targaresources.com. I may be reached with questions at (432) 687-0901 or email mark@laenvironmental.com.
