Release Notification and Corrective Action

Facility Name Ore Ida 14 Federal 10 **Facility Type** SWD

Ore Ida 14 Federal 10 SWD

285BBLS PW_Fire_5.22.2018

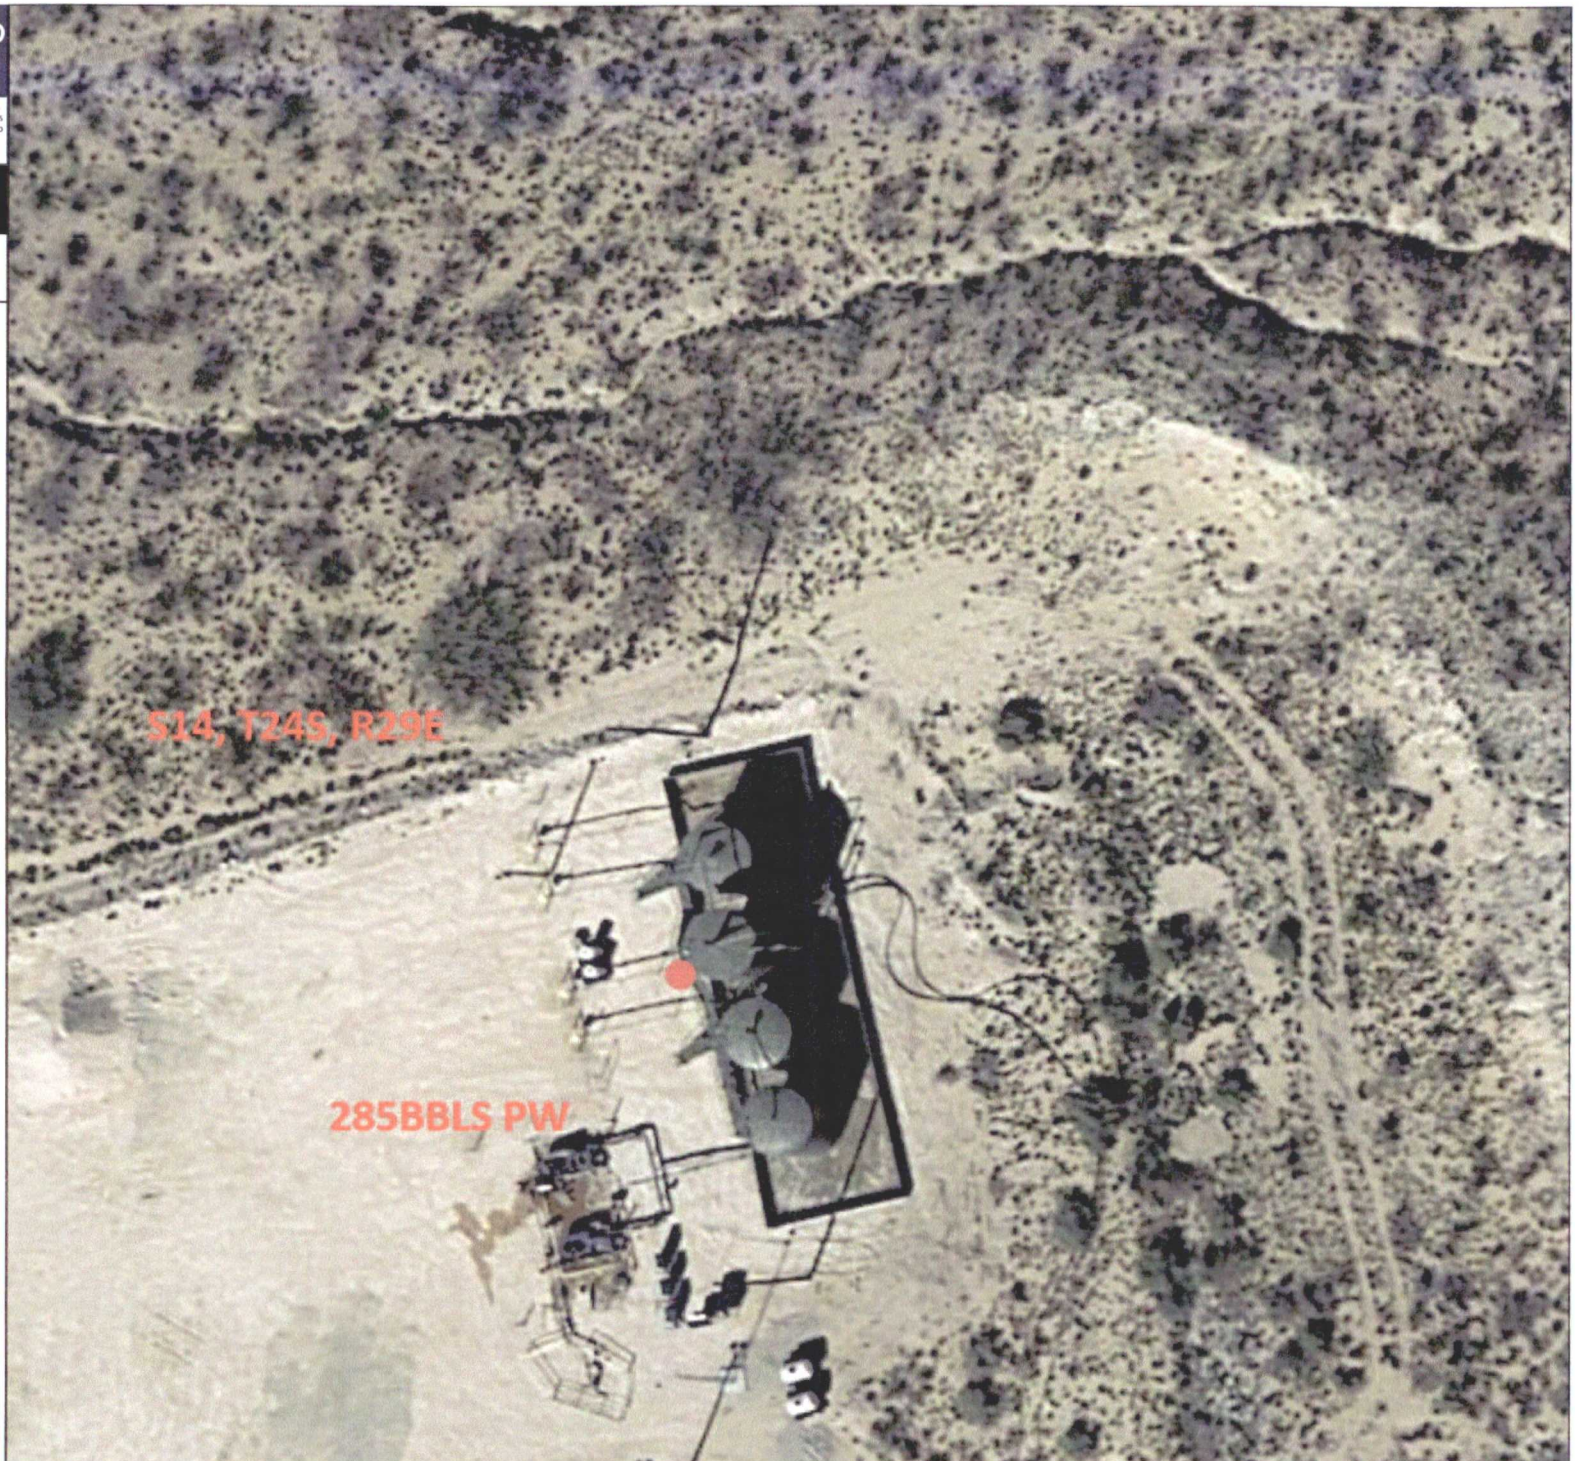
The Ore Ida 14 Fed 10 SWD Facility was struck by lightning which resulted in a fire. The fire department was called and extinguished the fire. All fluid remained on location.

Approximately 285 bbls of produced water was released. Approximately 272 bbls was recovered (265 bbls from the lined containment and 7 bbls from the pad surface). An Environmental contractor will be contacted to assist with delineation and remediation efforts.

Attached you will find a C141 and GIS image for the 285BBL release that occurred at the Ore Ida 14 Federal 10 SWD on 5.22.2018. The red dot on the GIS Image represents the approximate origin of release.
