Re: Summary
MRU 35 # 1 site
UL – I, Section 35, T19S, R34E, 1980 FSL, 560 FEL
Lea County, New Mexico
1.5 miles southwest of Hwy 62 & Cr 27-A

This summary includes the project information summary and preliminary site investigation.

A. PROJECT INFORMATION SUMMARY

B. PRELIMINARY SITE INVESTIGATION

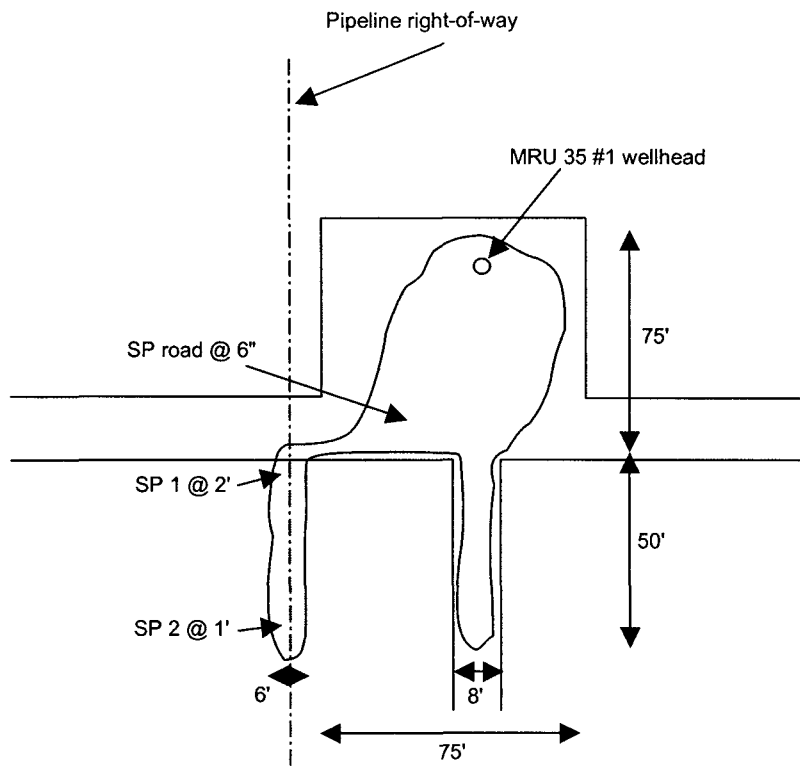
* = Sample points		Merit Energy Company	Figure 1 Site Map
Not to Scale		Mescalero Ride Unit 35#1	Prepared By: Jim Hollon Consulting
↑ N		1.5 miles southwest of Hwy 62 & Cr 27-A Lea County, New Mexico

The release occurred on August 5, 2006 from a connection at the wellhead. The integrity failure released approximately 24 barrels of produced water to the surface affecting primarily the well location and road with a narrow strip, approximately six feet by fifty feet, running down a pipeline right-of-way. The release covered a total area of approximately 775 square yards. There were no standing fluids to recover. The caliche location and road was dragged with a backhoe to blend the hydrocarbon carryover and facilitate in drying.

A soil auger was utilized to collect soil samples which were analyzed to evaluate the extent of chloride impact in the soil. One sample was collected from the road at a depth of six inches bgs which had a chloride concentration of 1,350 mg/kg. Two samples were collected from the pipeline right-of-way. Sample number one was near the road and collected from two feet bgs and sample number two was from near the end of the flow path from one foot bgs. The chloride concentration of the soil sample number one at two feet bgs was 2,630 mg/kg and the sample number two at one foot bgs was 601 mg/kg.

Shaded area represents affected area
