Release Notification and Corrective Action

Name of Company: Occidental Permian Limited Partnership	Contact: Tony Summers
Address: 1017 West Stanolind Road, Hobbs, N.M. 88240	Telephone No: 505.397.8236 or 505.390.9228
Facility Name Myers Langlie Mattix Unit South Injection line	Facility Type Production - Injection line #245

MLMU Injection
Leak South 8-24-07
Produced w/ r leak

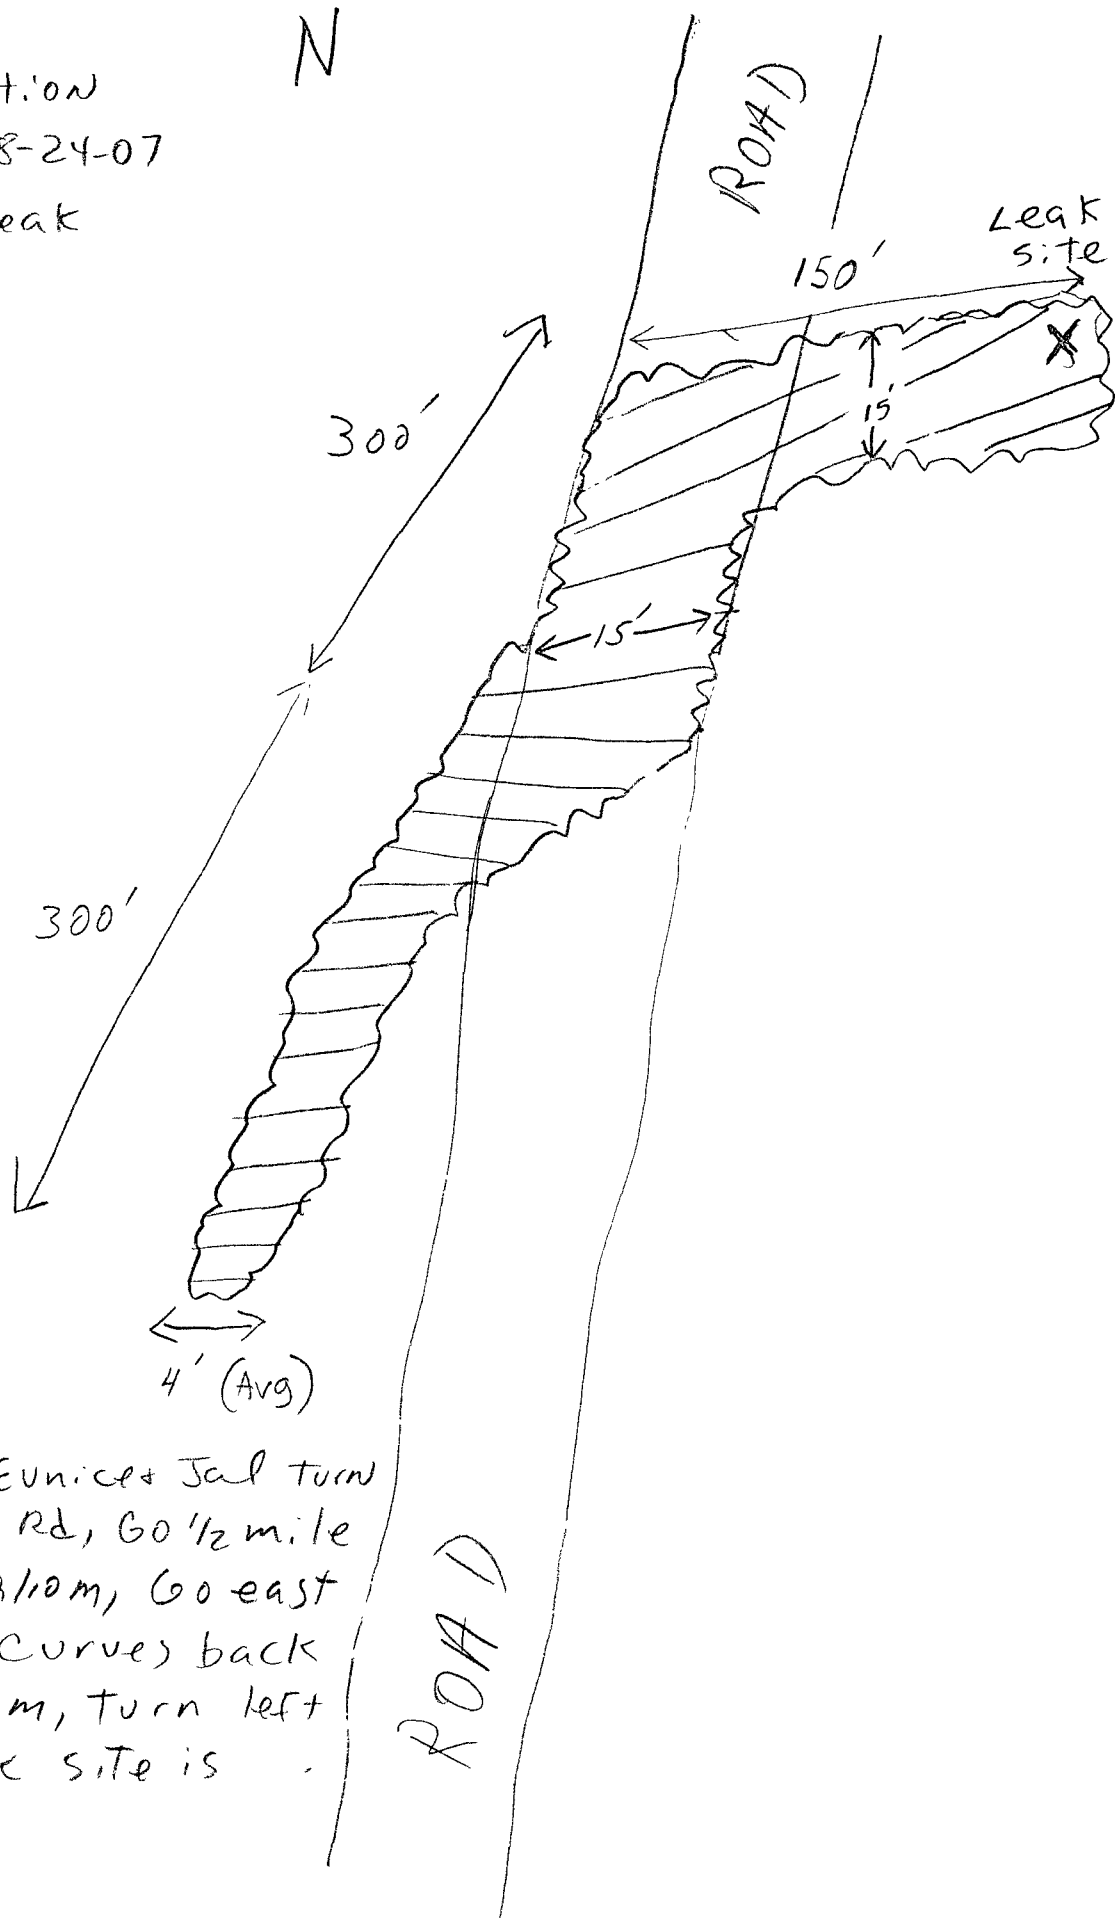
Describe Cause of Problem and Remedial Action Taken.* Leak was discovered by lease operator 89:00am Line was immediately shut in. Leak occurred in on a steel connection in a buried fiberglass line, corrosion. Vacuum truck was called and picked up 50 bbls of free standing produced water. Approximately 150 barrels of produced water were spilled Average chlorides for this water is 13000 ppm.

Describe Area Affected and Cleanup Action Taken.* Spill was in sandy area with limited vegetation. Contaminated soil will be removed down to NMOCD standards and replaced with clean soil. See attached map of spill site. According to NMOSE website, nearest depth to ground water found (sec 5) is 106' giving a ranking of 10
