NM1 - 3

# MONITORING REPORTS

1988 - 1989

LEA COUNTY, NEW MEXICO  
PARABO, INC.

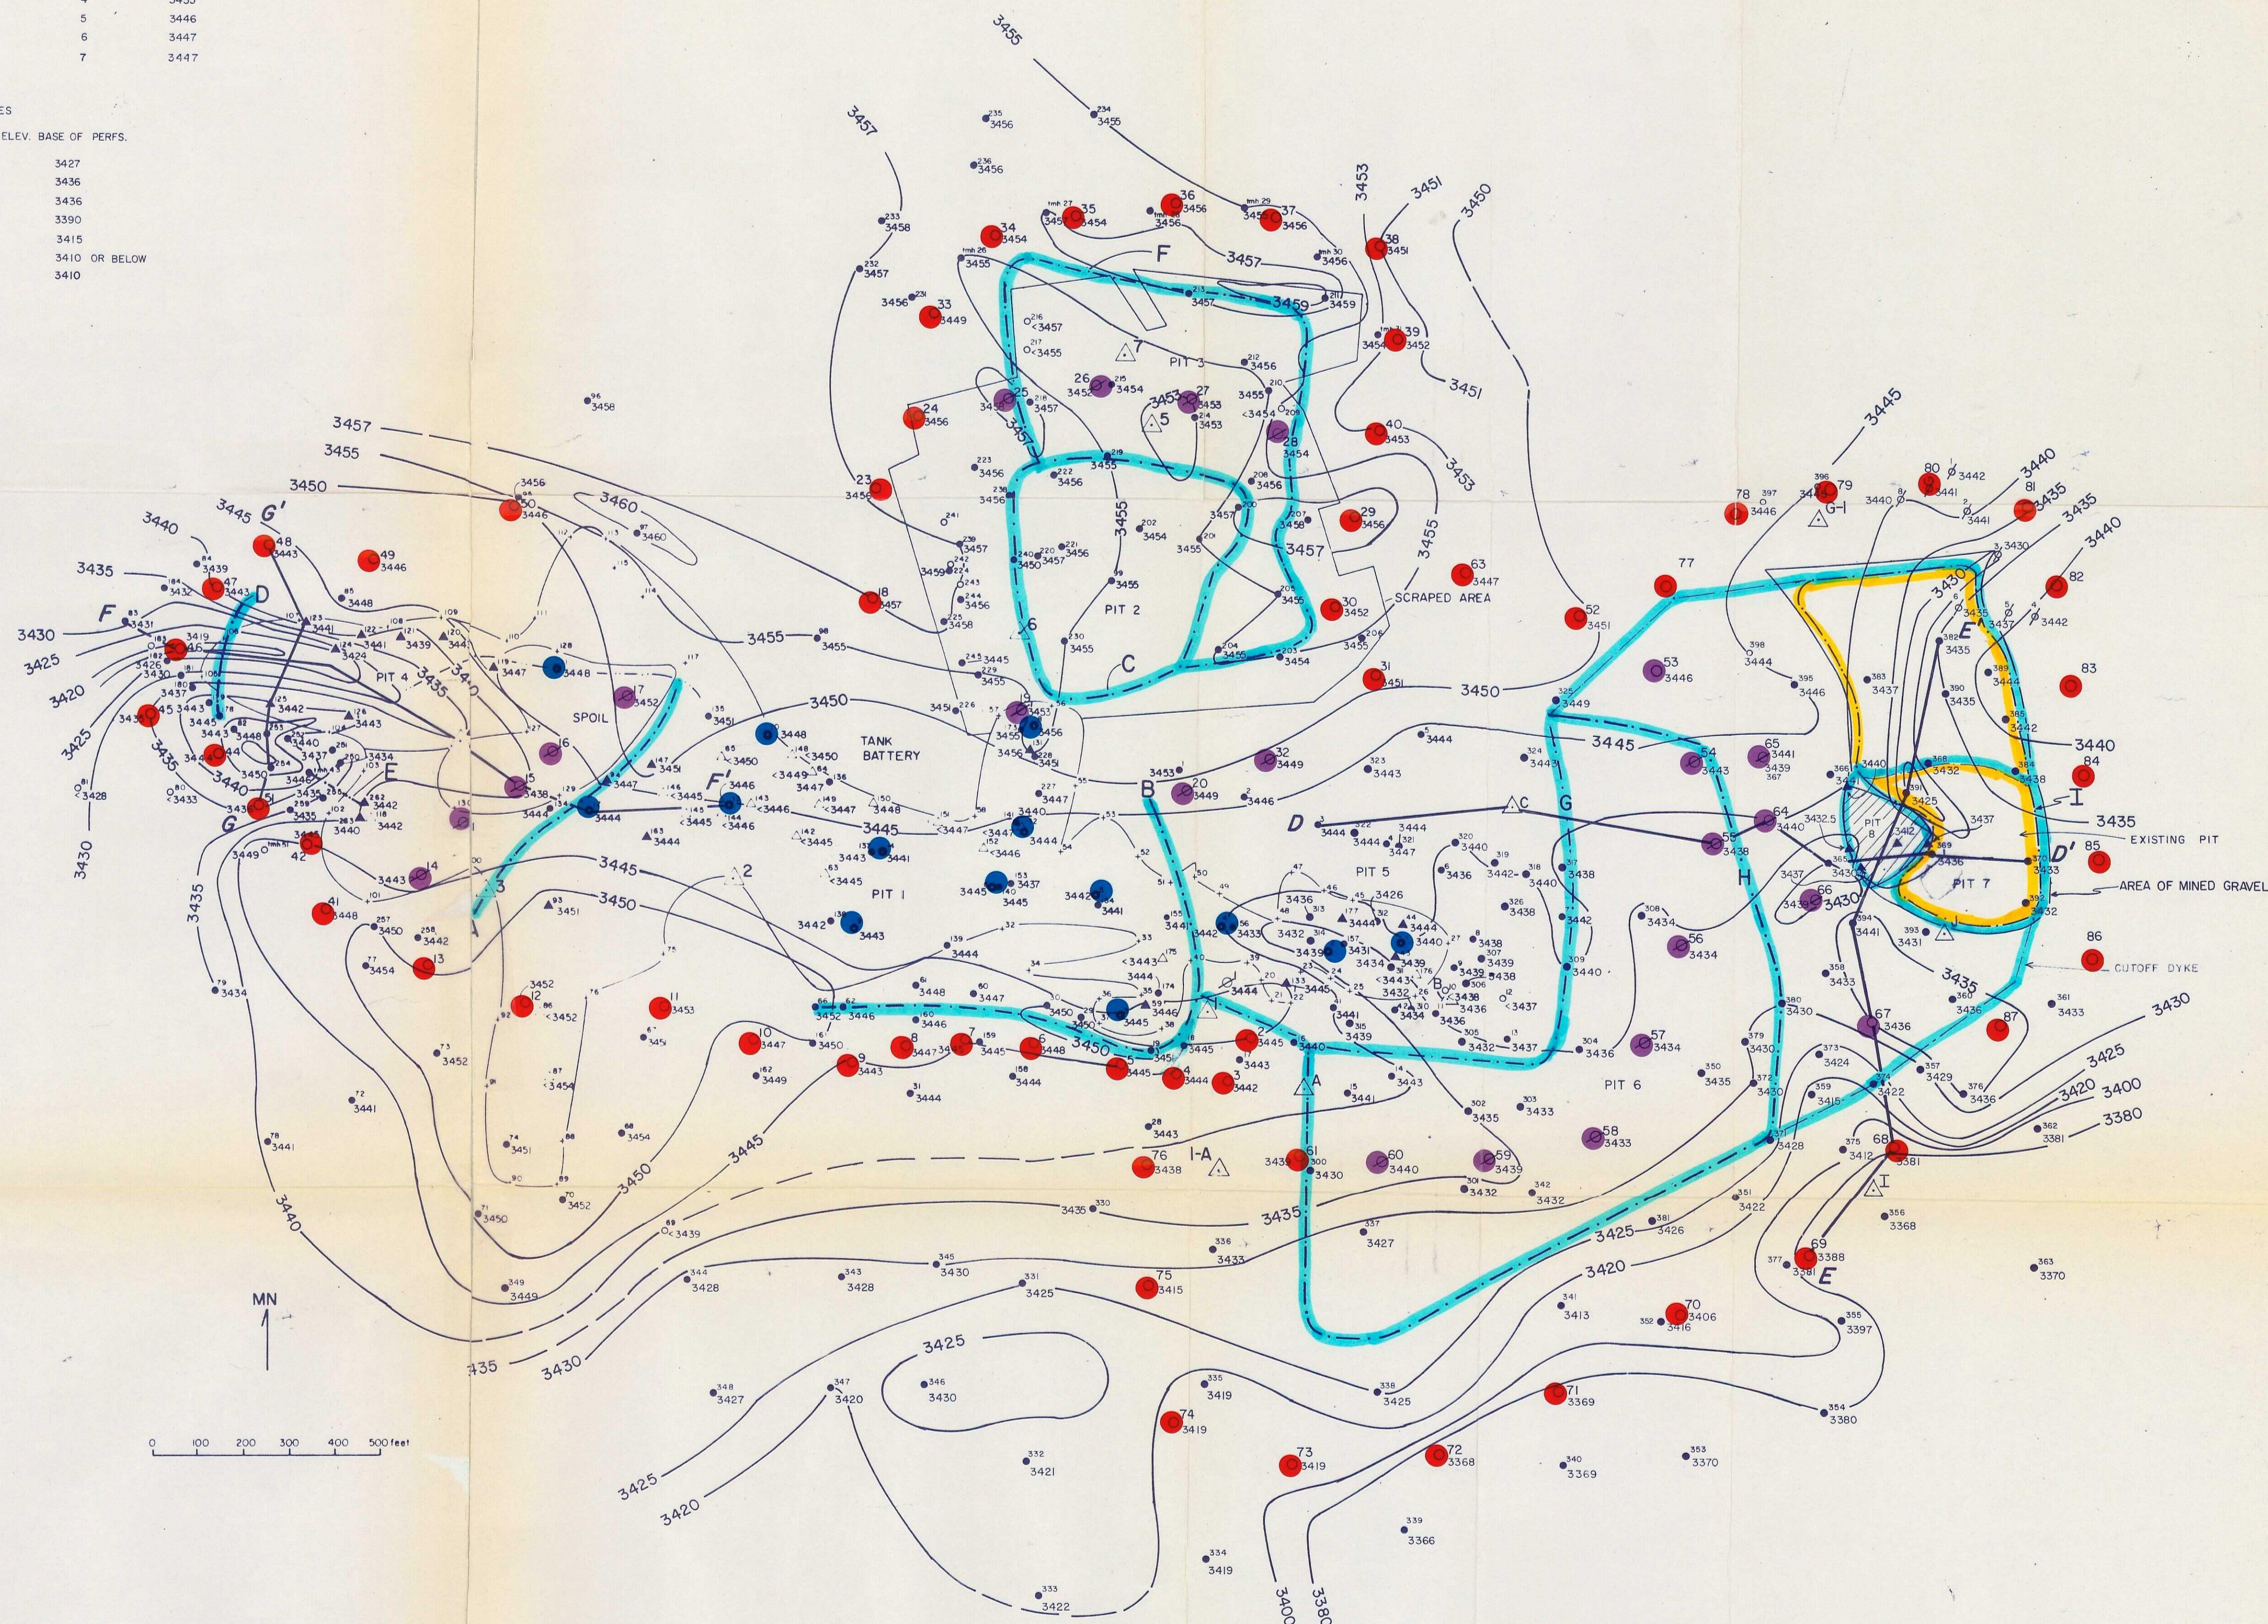
FIGURE-1

TOP OF TRIASSIC
