# Annual GW Mon. REPORTS

**March 7th, 2008**

**RE: Annual Report: OCD Case Number: 1R427-87  
Rice Operating Company – EME SWD System  
H-20 SWD Facilities (UL H Sec 20 T 20S R 37E)  
OCD Case Number: 1R427-87**

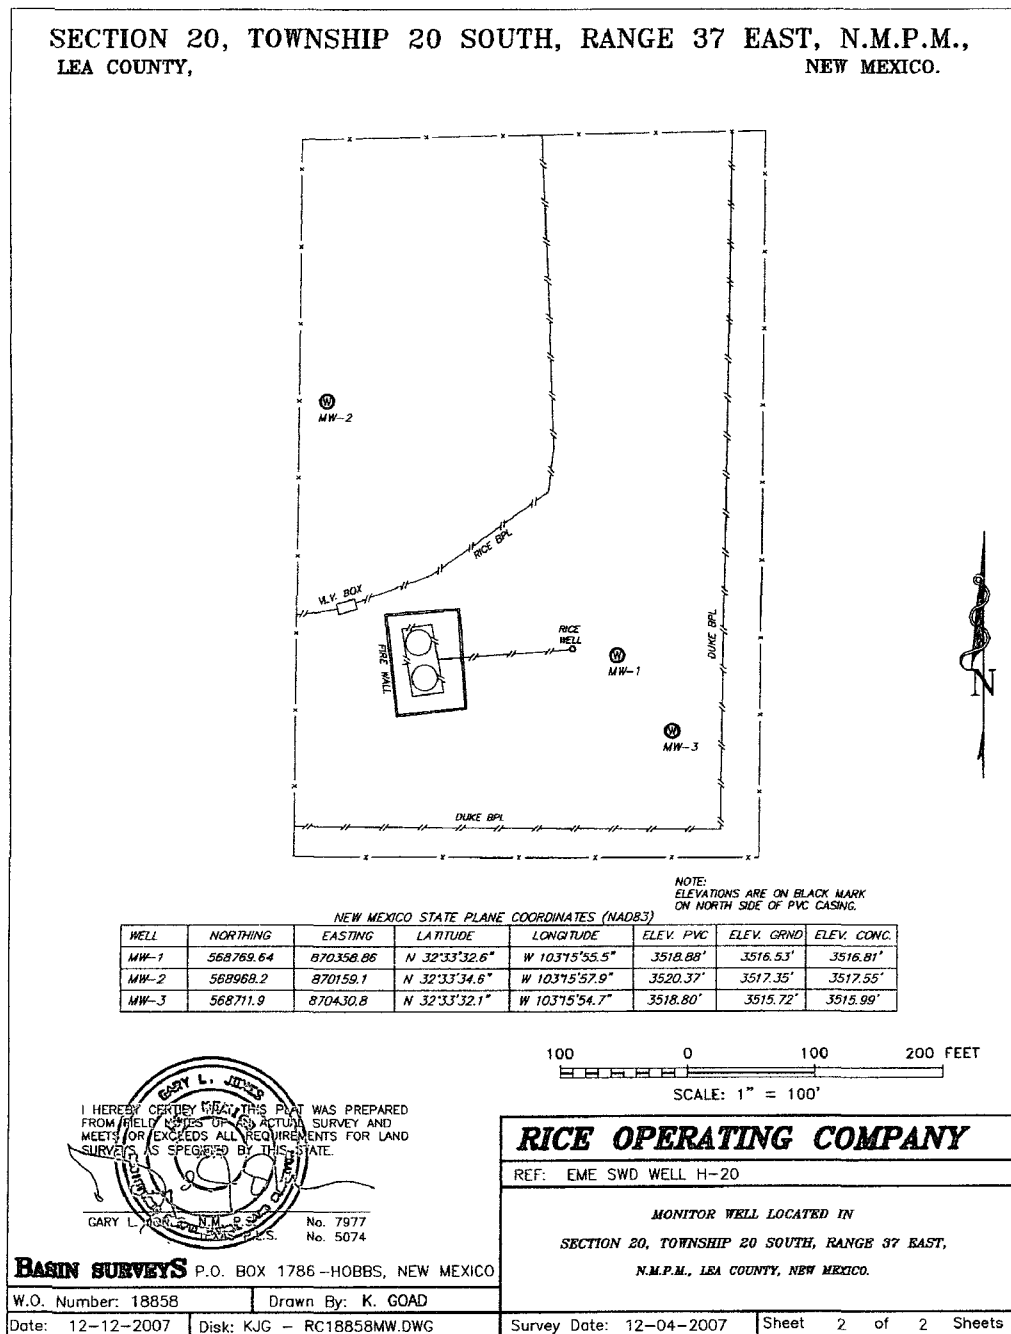
Elevated chloride levels (1,420 ppm) were found in a monitor well (MW-1) approximately 25 ft down-gradient from the former excavation. Groundwater chloride concentrations were similarly elevated (also 1,420 ppm) in a down-gradient well (MW-3) and 980 ppm in an up-gradient well (MW-2). Low levels of BTEX (0.052 ppm) were found in the near-source well, and near-trace concentrations (0.002 ppm) were found in the down-gradient well; (see Figure 3 and Table 1). A hydrocarbon sheen has also been noted in the near-source well. These results indicate that groundwater is not pristine as it flows onto the subject site, but suggests some impact from the former facilities.

**Figure 3 – Site survey map showing approximate locations of facilities and monitor wells.**

The results summarized here will be presented in more detail in a proposed "Corrective Action Plan" for this site. This Plan will propose further and more detailed, groundwater monitoring, as well as a remedy to attenuate dissolved phase hydrocarbons.
