RICE OPERATING COMPANY JUNCTION BOX FINAL REPORT

BD N-31 vent

Unit N, Section 31, T21S, R37E

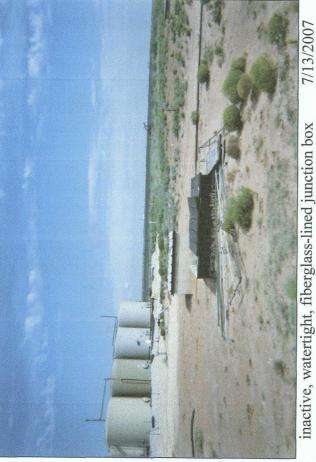
inactive, watertight, fiberglass-lined junction box
