**GW - 199**

**INSPECTIONS**

RE: Notice of Violation  
Inspection Report, GW-199  
Champion Technologies, Hobbs Yard  
Lea County, New Mexico

OCD Inspection: Champion Technologies GW - 199

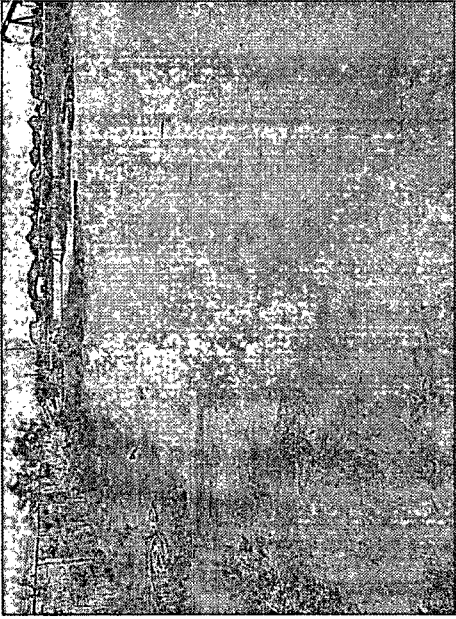
<p>Photo 1: West side of facility, west of bulk storage area; former location of soil on impermeable liner and empty AST.</p>	<p>Photo 2: West side of facility, west of bulk storage area; former location of soil on impermeable liner and empty AST.</p>

All loose soil stored in containers or on impermeable liner was placed in roll-off bins and sent to Lea County Class I Landfill for disposal. Prior to disposal, soil was analyzed for total petroleum hydrocarbons (TPH), reactivity, corrosivity, and ignitability (RCI) to verify soil was non-hazardous. *See photos: 1 and 2.*

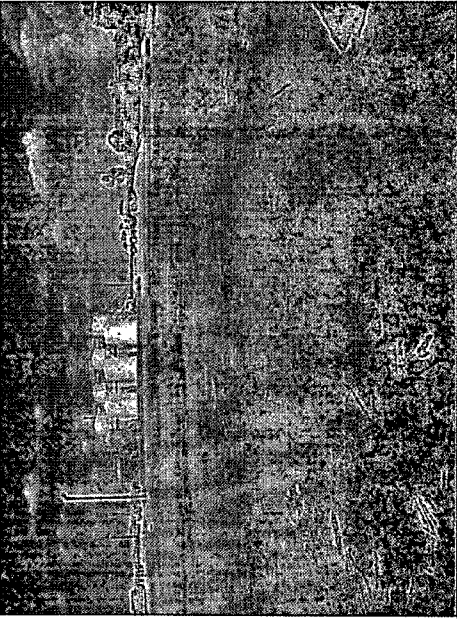
<p>Photo 3: Former drum storage area where residual products were stored; west of bulk storage tanks. View: facing east</p>	<p>Photo 4: Labeled drum View: facing west</p>

All containers onsite are labeled as to their contents in accordance with hazard communication requirements including, where applicable, National Fire Protection Rating (NFPA) labels. Unlabeled drums with residual products identified during the site visit were characterized by waste broker, Safety-Kleen as either hazardous or non-hazardous and transported to a permitted Transfer, Storage, and Disposal Facility (TSDF) for disposal. *See photos: 3 and 4.*

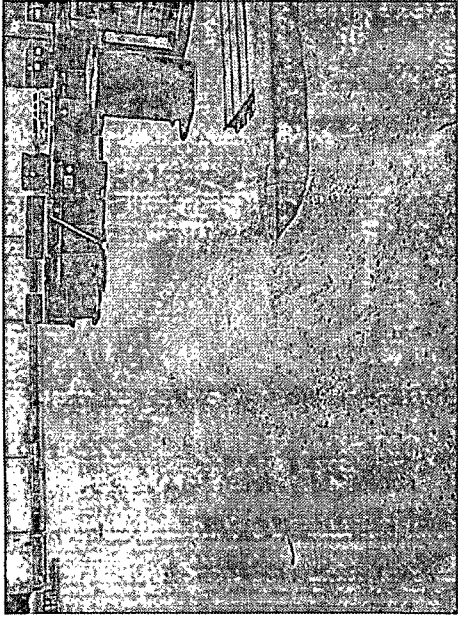
<p>Photo 5: Compacted soil (temporary measure) used for north side dike wall. View: facing west</p>	<p>Photo 6: Drums storage areas and yard; all containers containing product and/or empty with residual product stored within concrete secondary containment. View: facing northwest</p>

All containers containing chemical are now stored within secondary containment. Soil has been piled and compacted on the north side of the Drum Storage Area as a temporary measure. Champion Technologies is in the process of obtaining a contractor to pour a six inch curb with concrete ramps on both sides to allow for forklift access. The concrete curbing will be installed no later than September 20, 2008. The reason for the delay in completing the concrete work is due to the challenge of securing a concrete contractor for a small job in the area. *See photos: 5, 6 and 7.*

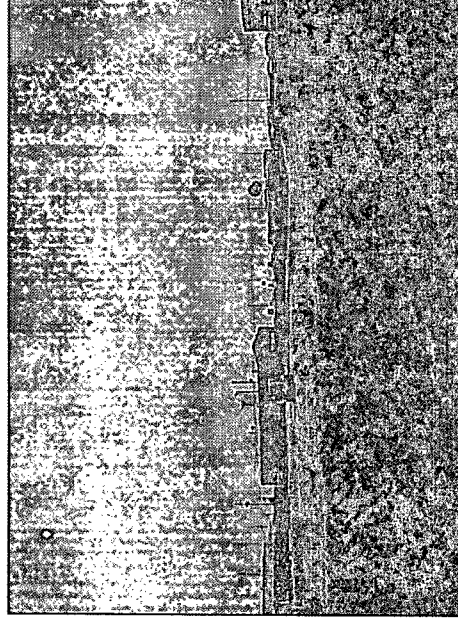
<p>Photo 7: Drums storage areas and yard; all containers containing product and/or empty with residual product stored within concrete secondary containment. View: facing southeast</p>	<p>Photo 8: Saddle tank moved several feet back in containment. Valve is located within secondary containment structure. View: facing south.</p>

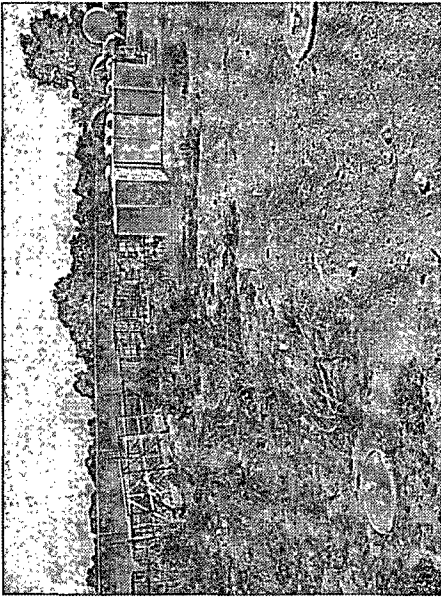
<p>Photo 9: Container stands and empty containers that are clean / out of service (do not contain Champion Product currently but will be used in future jobs). View: facing north-northwest</p>	<p>Photo 10: Container stands and empty containers that are clean / out of service (do not contain Champion Product – onsite for future projects). Secondary containment structures stored upside down. View: facing west</p>

All fluids within secondary containment structures have been pumped out into portable containers and sent offsite for disposal. All fluids were evaluated for hazardous characteristics prior to disposal. *See photos 9 and 10.*

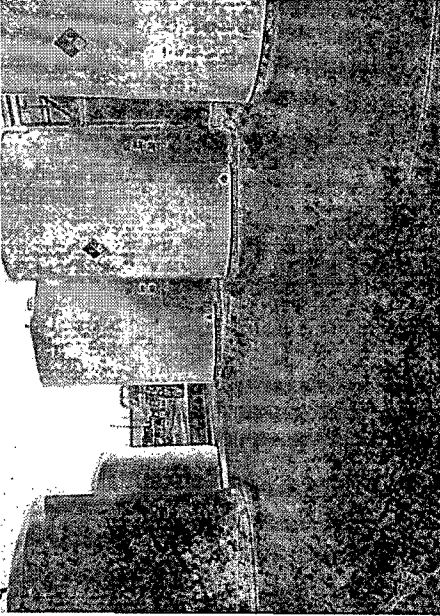
<p>Photo 11: Pumped out and dry bulk storage area. View: facing east</p>	<p>Photo 12: Pumped out and dry bulk storage area. Note: due to sand in area and high winds, sand accumulates in secondary containment structure daily. View: facing west</p>

All fluids within secondary containment structures have been pumped out into portable containers and sent offsite for disposal. All fluids were evaluated for hazardous characteristics prior to disposal. In the future, fluids in secondary containment will be evaluated, recorded, and disposed of to prevent accumulation (see # 8 for additional storm water management at the facility). *See photos 11 and 12.*

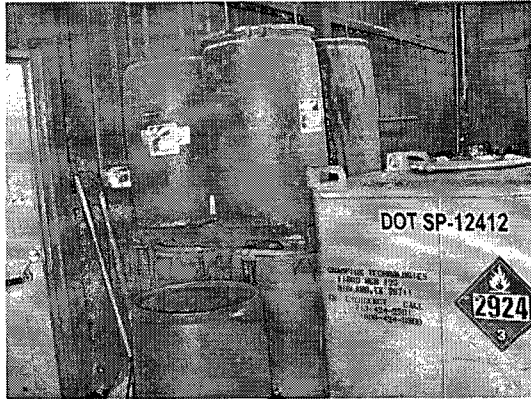
Photo 1: Unknown status of barrels.

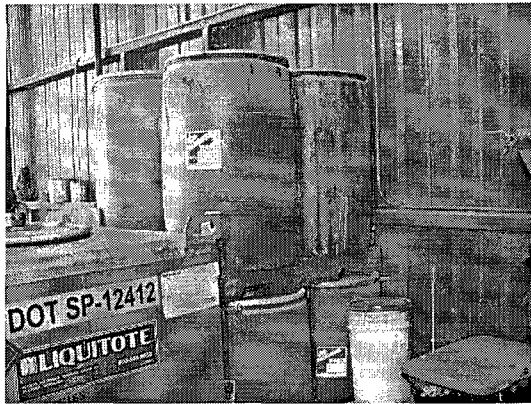
Photo 2: Unknown status, assumed to have soil contents. Time frame and history unknown.

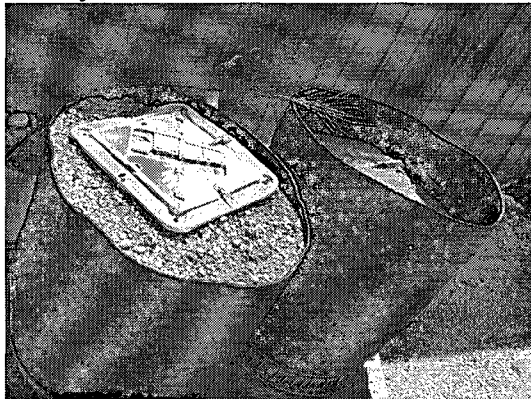
Photo 3: Containers filled with contaminated soil? Located behind building.

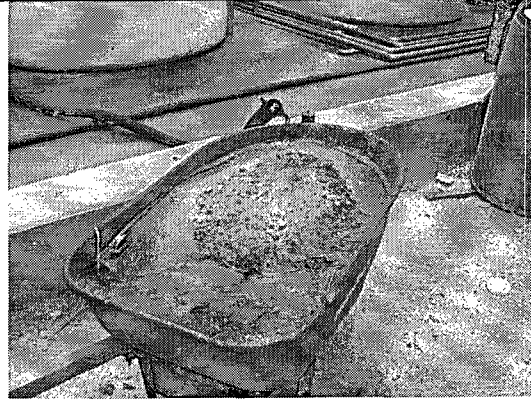
Photo 4: Wheel Barrow full of contaminated soil?

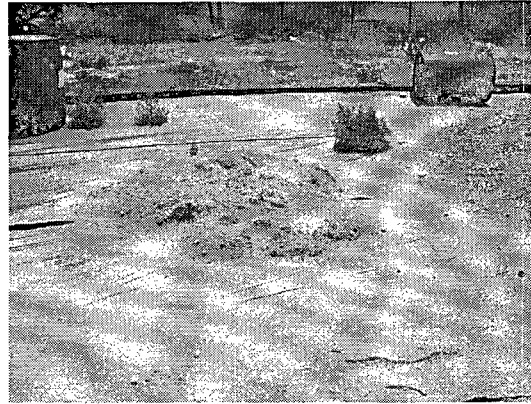
Photo 5: Contaminated soil holding area with unknown status.

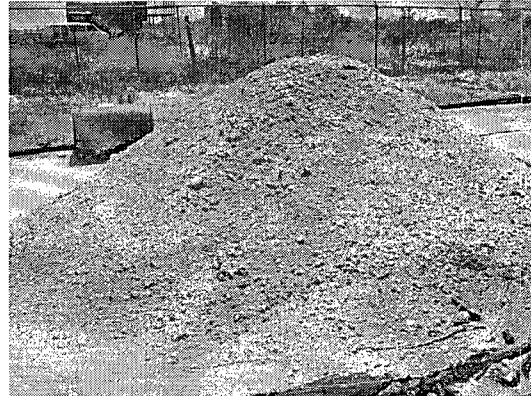
Photo 6: Contaminated soil. Liner for hold area appears to be torn.

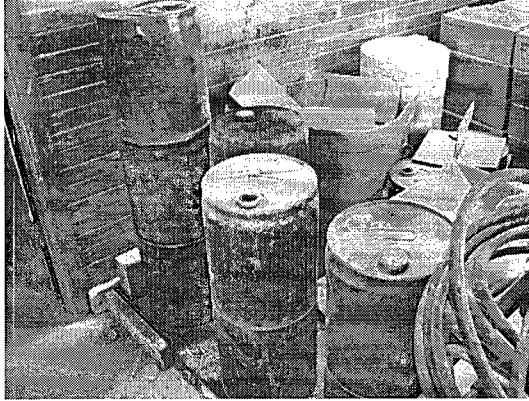
Photo 7: Unlabeled containers within building shop.

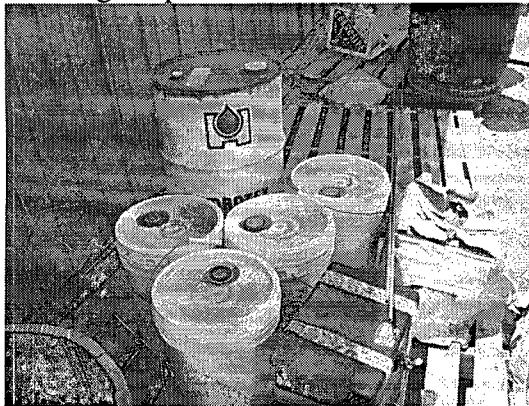
Photo 8: Unlabeled containers behind building with unknown history.

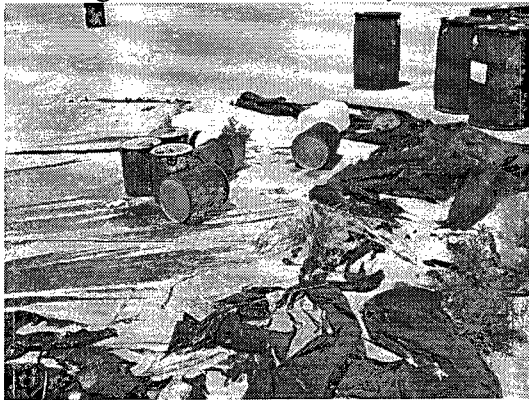
Photo 9: Unlabeled containers in yard.

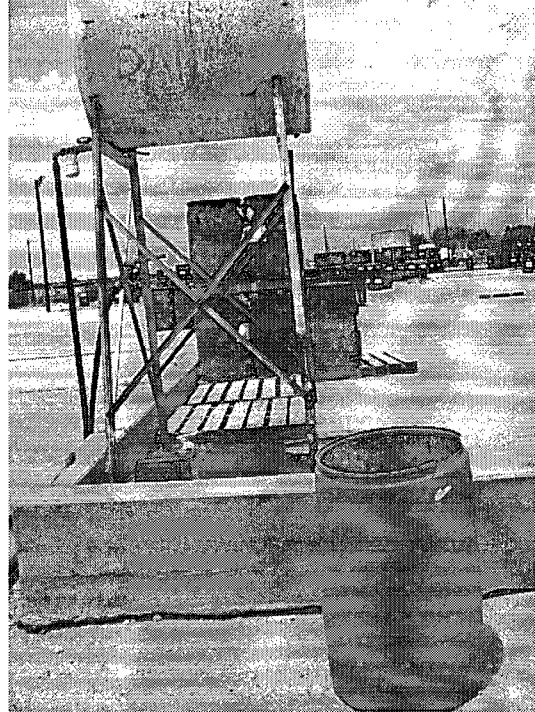
Photo 10: Unlabeled container.

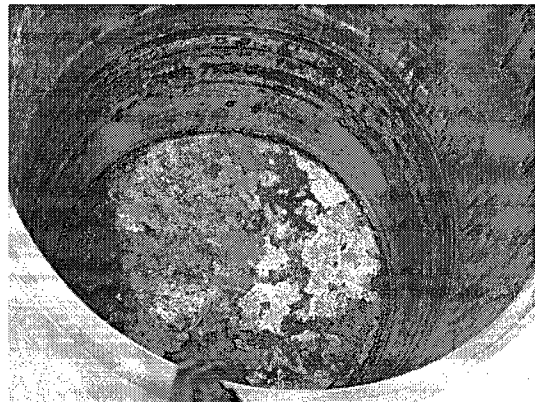
Photo 11: Internal view of unlabeled barrel.

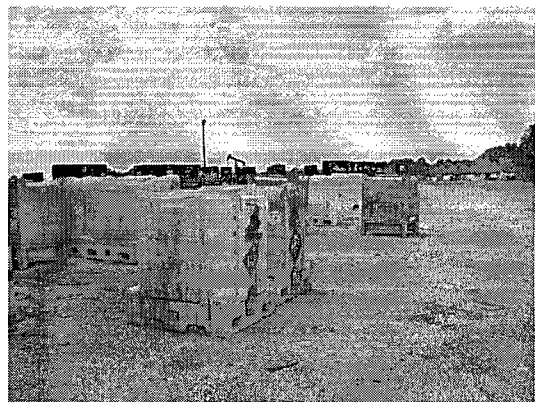
Photo 12: Tote tank located directly on ground.

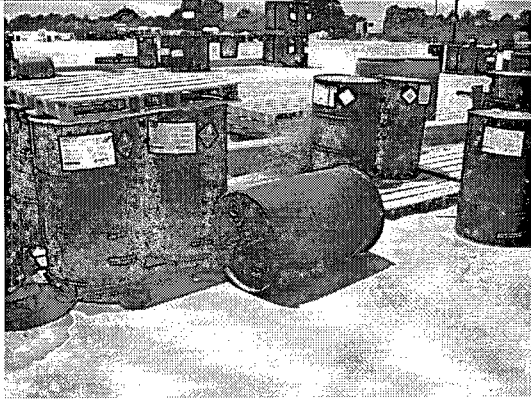
Photo 13: Partially full tank on its side within containment area.

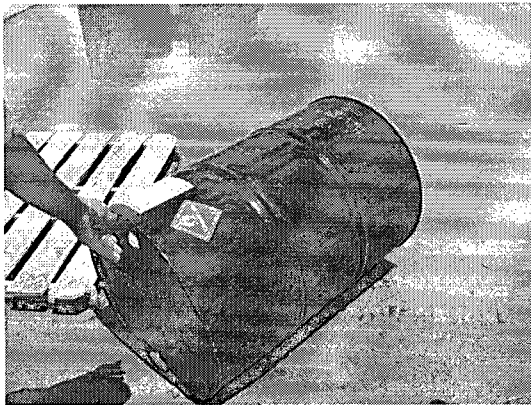
Photo 14: Improper storage of barrel within secondary area.

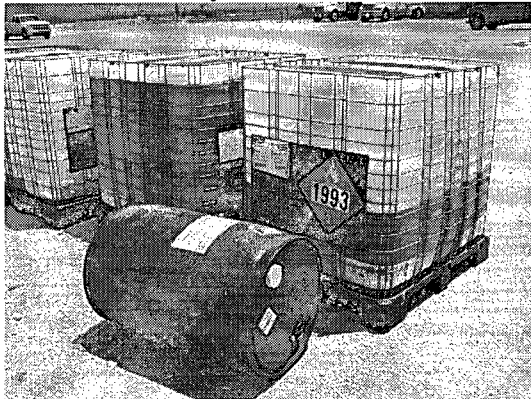
Photo 15: Empty barrel with missing bung stored improperly.

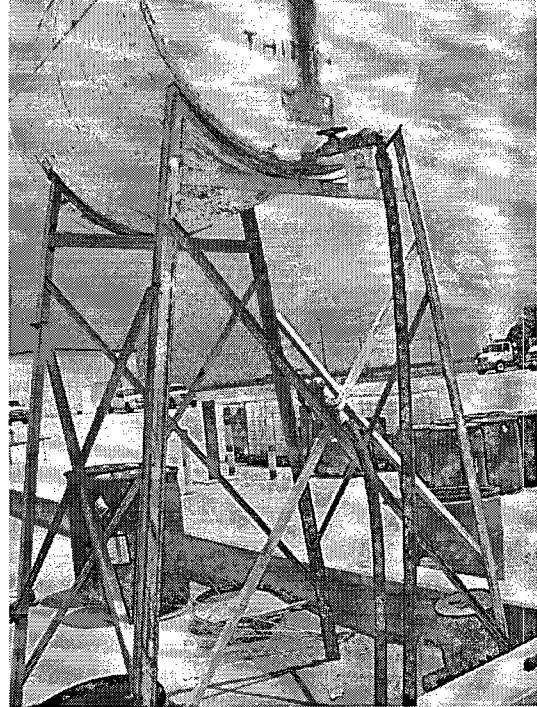
4. Photo 16: Saddle tank needs to be moved further back in its secondary containment where the valve is within containment area. If the valve were to fail, released fluids would discharge directly to the ground. Properly set the saddle tank.

Photo 16: Saddle tank needs to be properly situated.

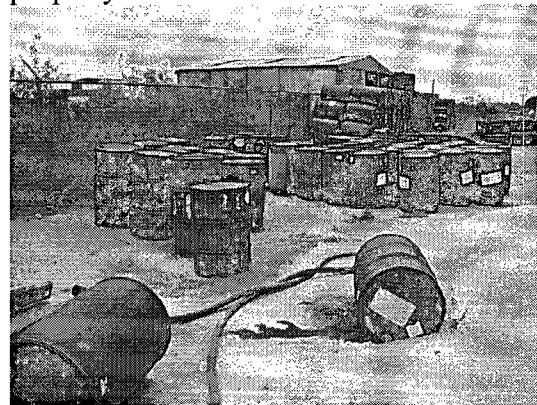
Photo 17: Improper partially full barrel on its side with liquids on ground.

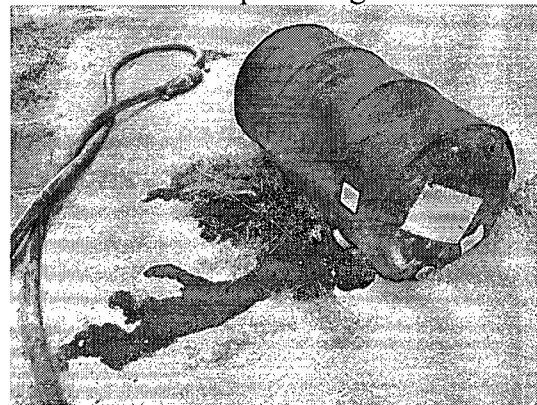
Photo 18: Close up of liquids from barrel

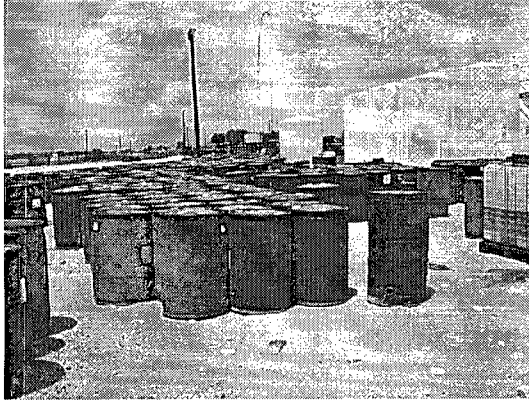
Photo 19: Barrels in yard area on ground.

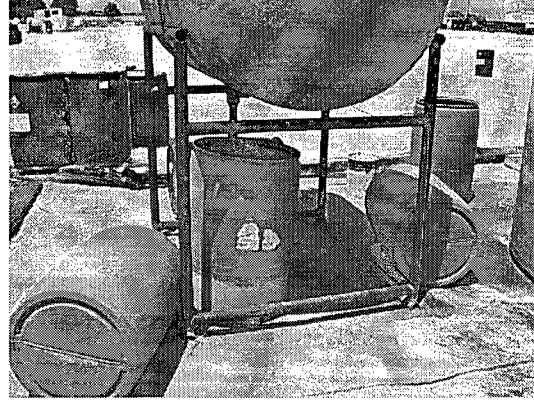
Photo 22: Unknown history of unlabeled empty barrels

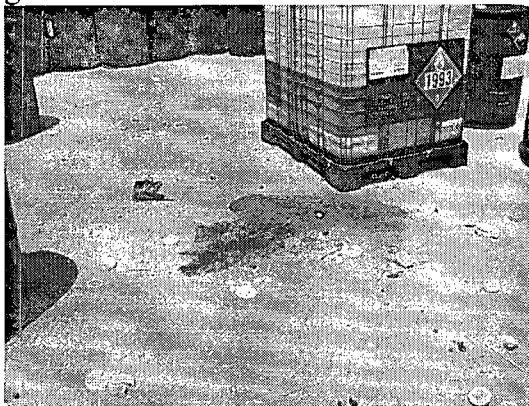
Photo 20: Contaminated soil near tote and drum storage area.

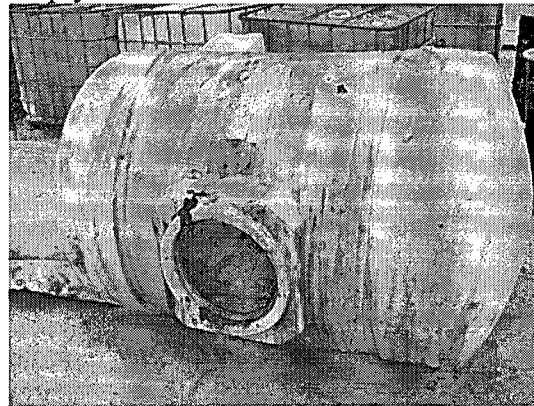
Photo 23: Empty saddle tank with out cover located in yard.

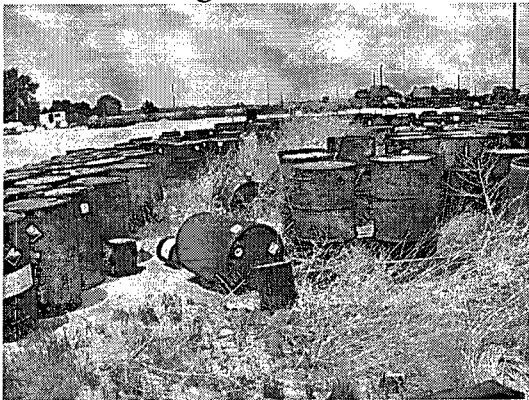
Photo 21: Improper storage of barrels in yard.

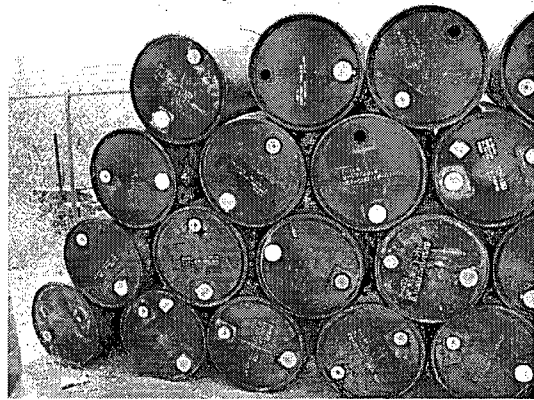
Photo 24: Stacked empty barrels with missing bungs and not horizontal.

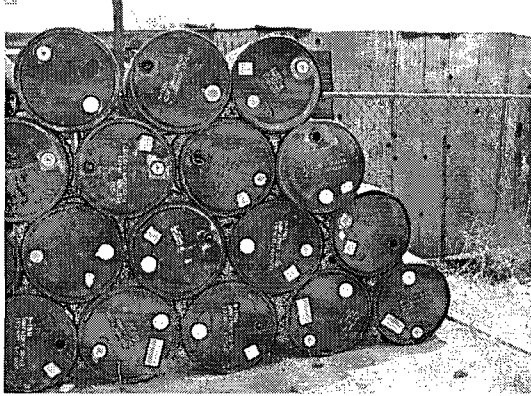
Photo 25: More empty barrels without bungs in place and no curbed containment.

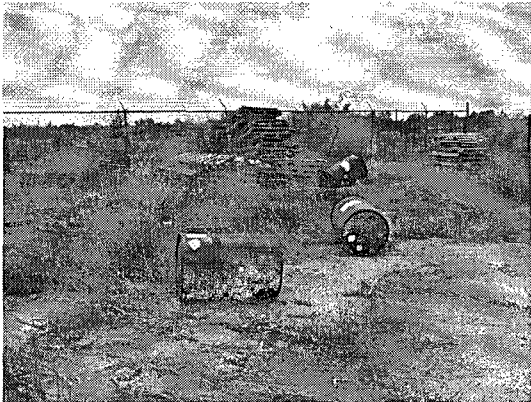
Photo 26: Empty barrels located improperly at yard edge.

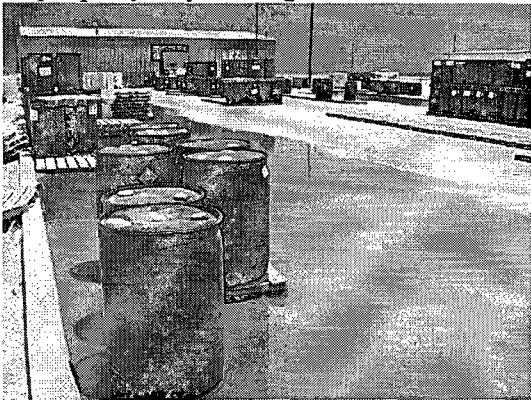
Photo 27: Large amount of fluids in tank holding area.

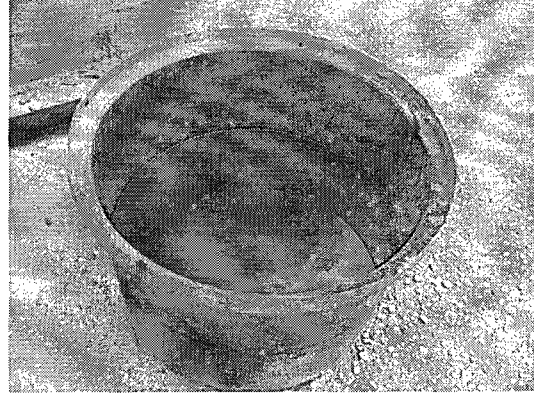
Photo 28: Fluids of unknown status situated near saddle tank.

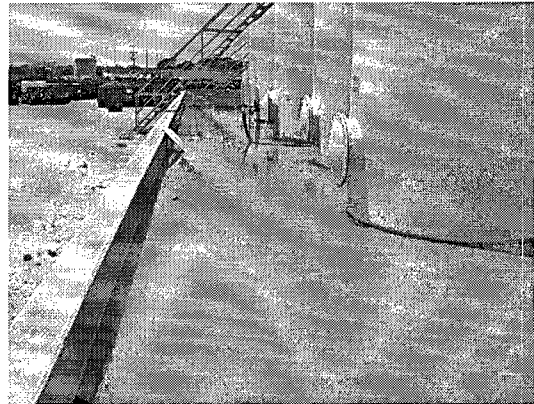
Photo 29: Large amount of fluids static in secondary containment area.

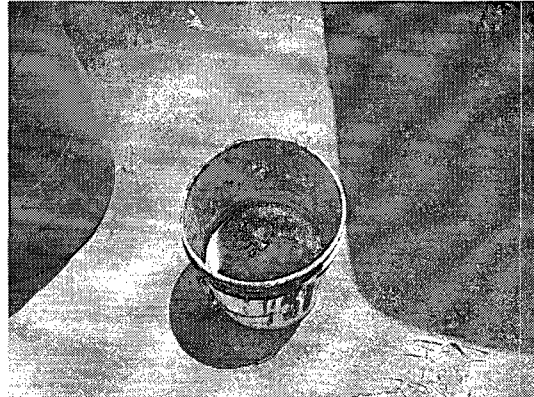
Photo 30: Questionable fluids in unmarked container in yard.

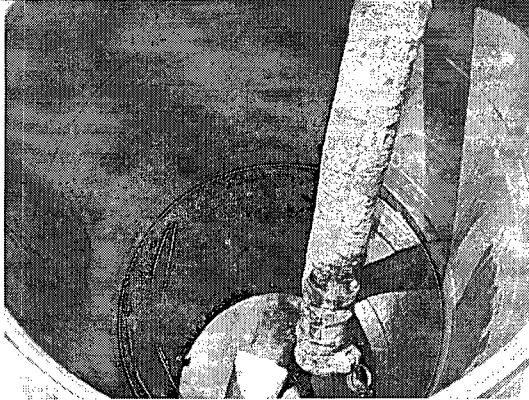
Photo 31: Questionable static fluids in open top barrel in yard.

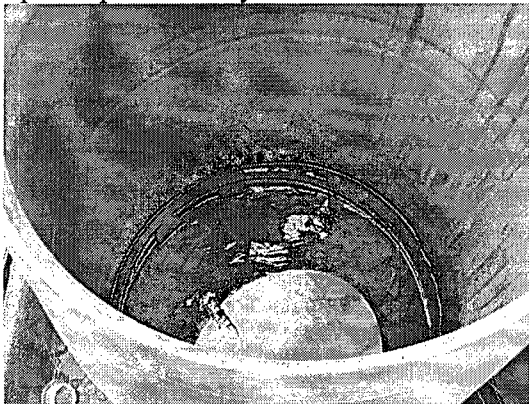
Photo 32: Fluids in open top barrel

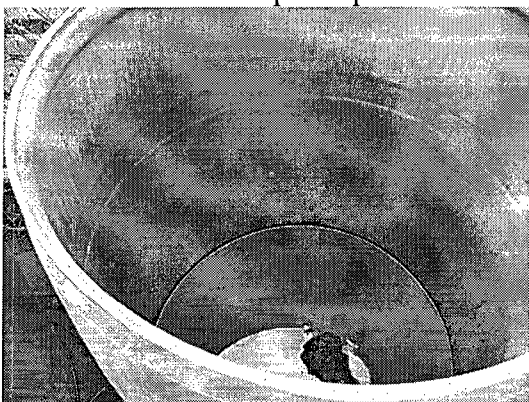
Photo 33: More fluids in open top barrel

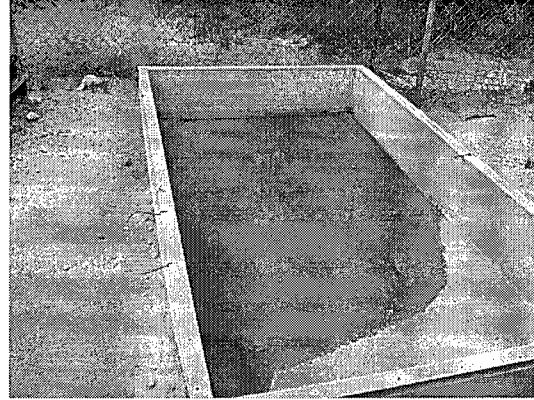
Photo 34: Static fluids in secondary bin.

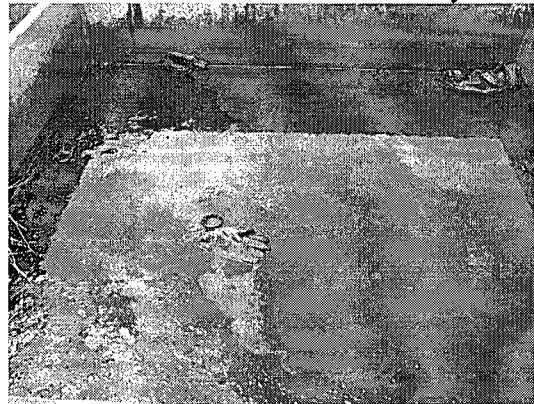
Photo 35: Questionable static fluids in yard.

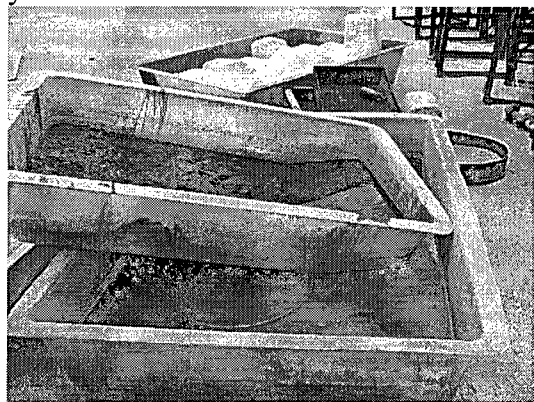
Photo 36: Static fluid

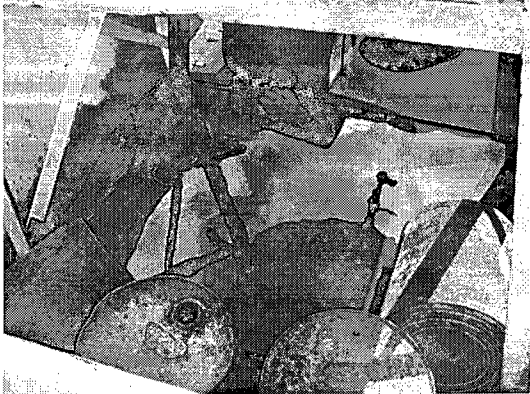
Photo 37: Static fluids with empty containers

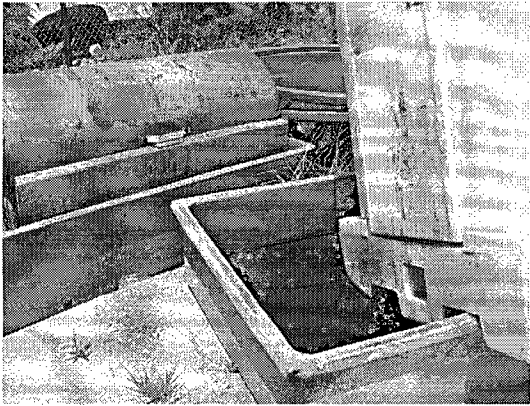
Photo 38: More static fluids in yard.

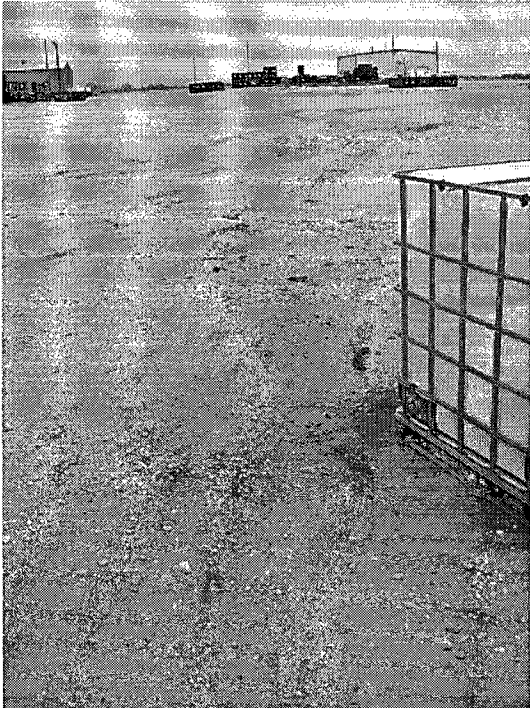
Photo 39: Facility drainage on the west side of the facility.

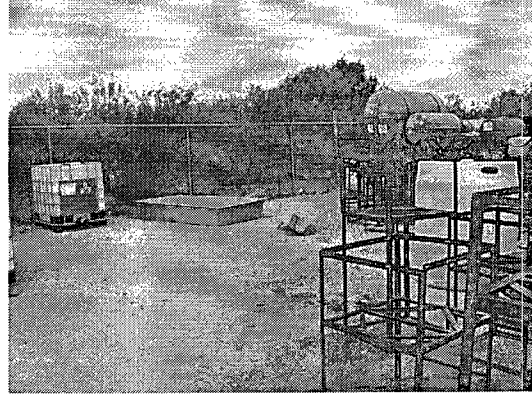
Photo 40: Facility drainage exits beyond existing fence.

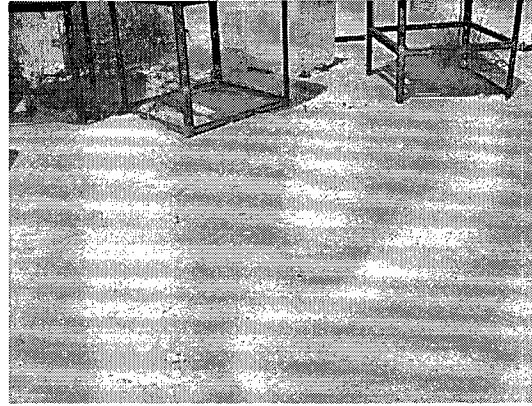
Photo 41: Facility drainage.

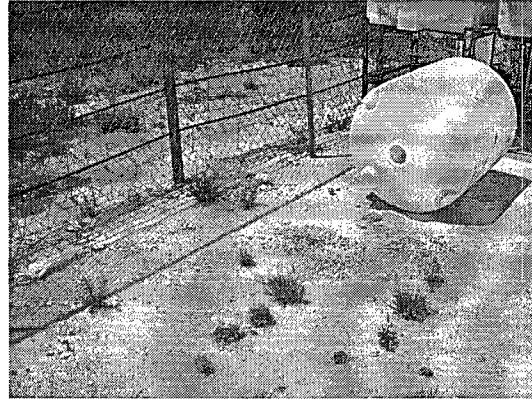
Photo 42: Drainage near fence.
