GW - 246

**Re: Closure Inspection Report, GW-246
Axis # 2 Compressor Station
Chavez County, New Mexico**

OCD Inspection: EPCO Axis # 2, GW - 246

Attachment B – Axis #2 Site Photos

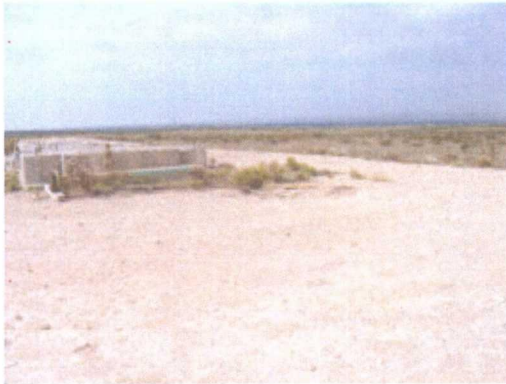
1. **Photos 1 - 4:** Remove all concrete slabs and existing underground conduits not in use at this location.

Photo 1: Slab of concrete.

The Oil Conservation Division has concluded that due to the remaining above referenced items the facility has yet to be properly closed. Therefore the OCD request that Enterprise Field Services remove all remaining cement slabs and underground conduits within **45 days, by October 30, 2008**, of this dated letter. Once removed submit photos and a final report to Mr. Jim Griswold of the Santa Fe OCD Environmental Bureau office, the current Enterprise permit reviewer.

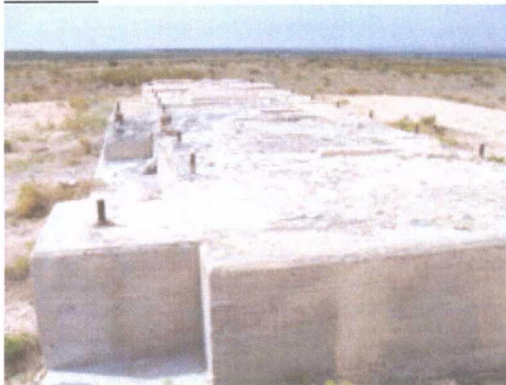
Photo 2: Concrete remaining.

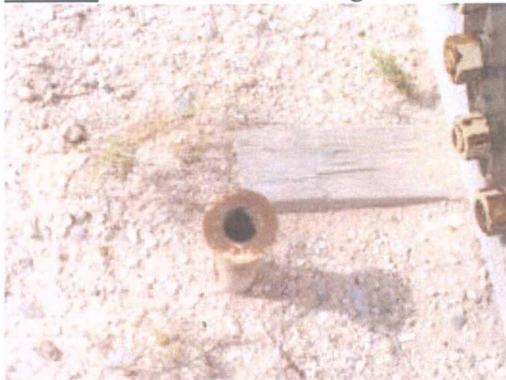
Photo 3: Underground conduit protruding from ground level near concrete slab.

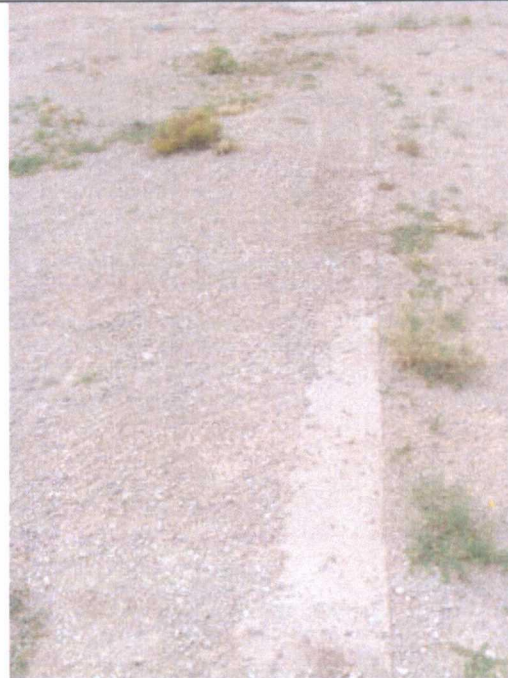
Photo 4: Ground level concrete slab located on the east side of above ground slab noted in Photo 1.

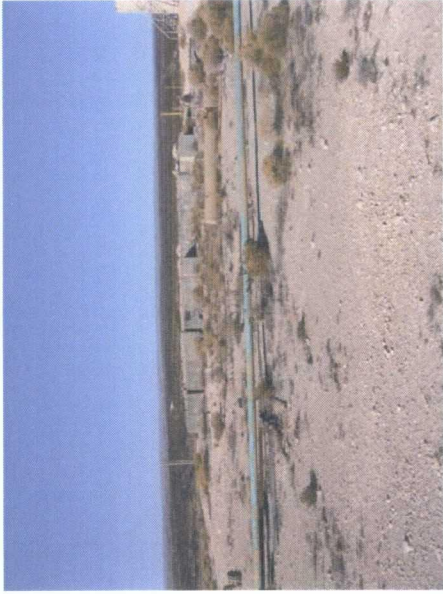
Photo 1 – Compressor Pad (background)

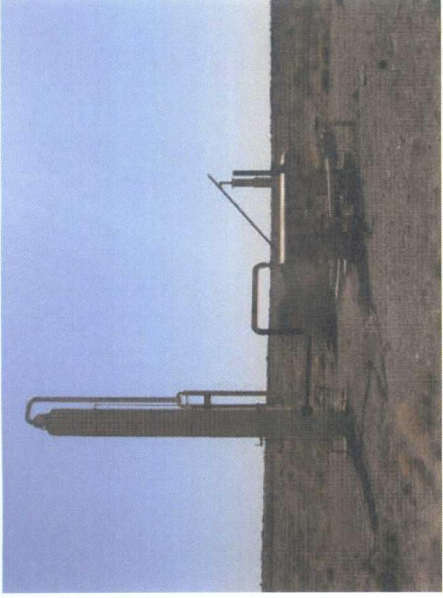
Photo 2 – Idled Dehydration Unit

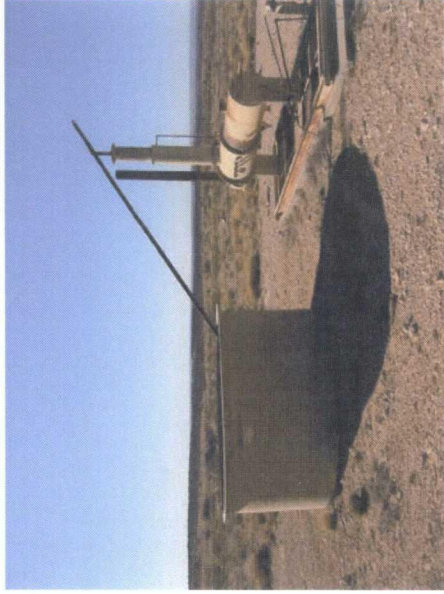
Photo 3 – Idled Dehydrator Tank

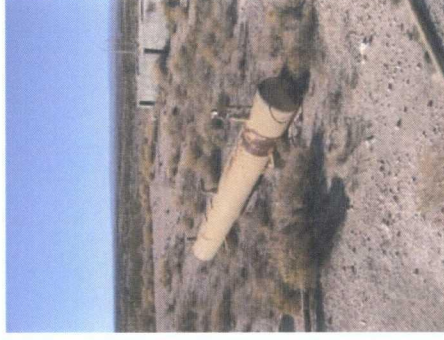
Photo 4 – Idled Separator

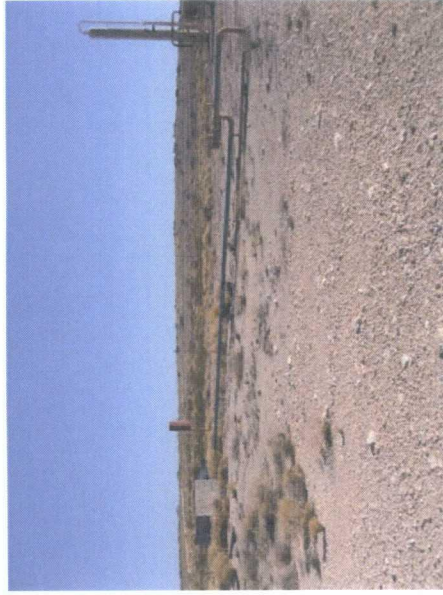
Photo 5 – Above Ground Idled Piping

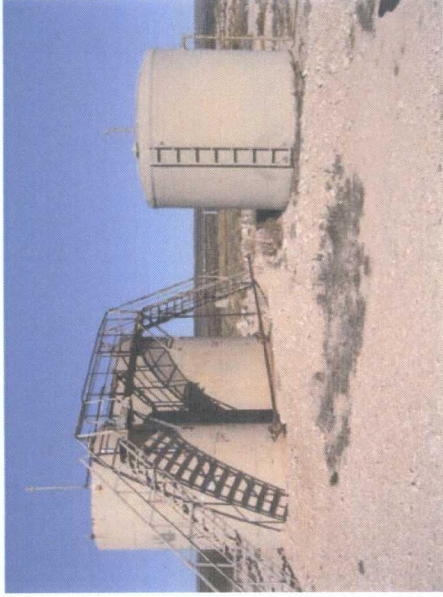
Photo 6 – Out-of-Service Tanks

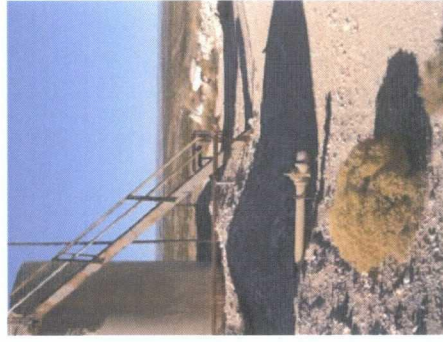
Photo 7 – Tanks Unloading Area
