Release Notification and Corrective Action

Parton BGY St #2

Spill Remediation Report

Phoenix Environmental, LLC.

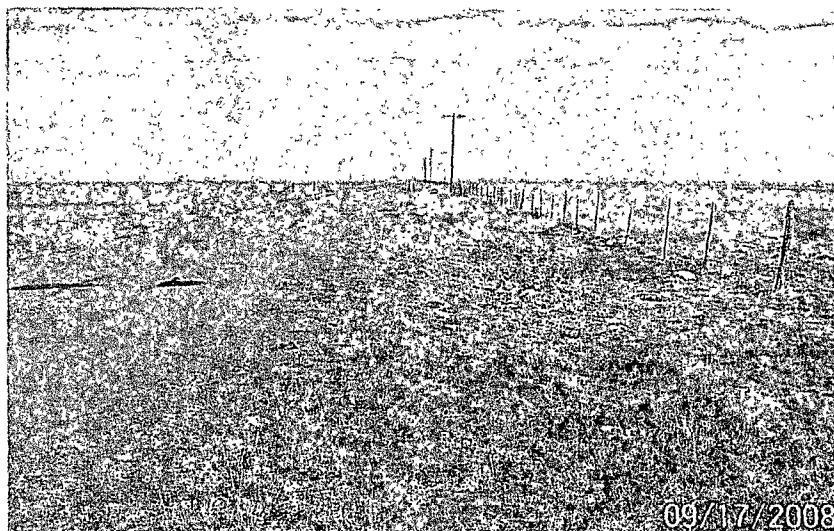
Photo #1 Beginning View of Spill Site

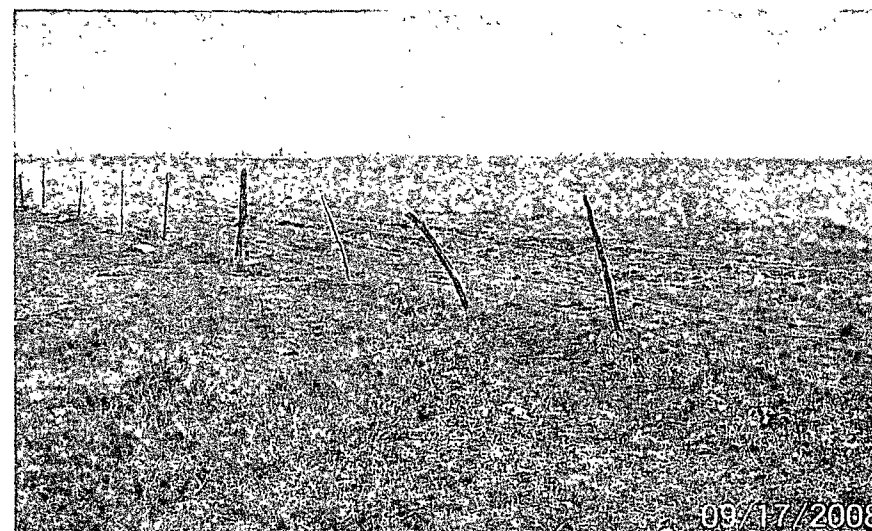
Photo # 2 Beginning View of Spill Site

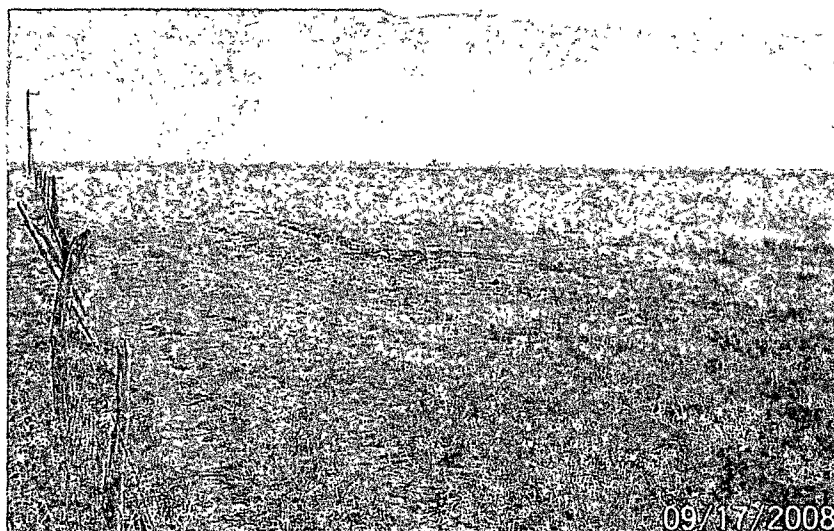
Photo #3 Beginning View of Spill Site

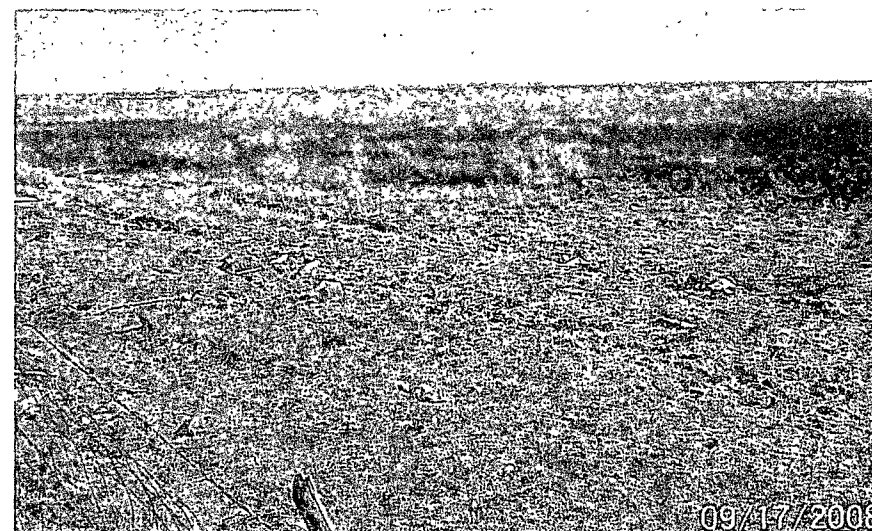
Photo #4 Beginning View of Spill Site

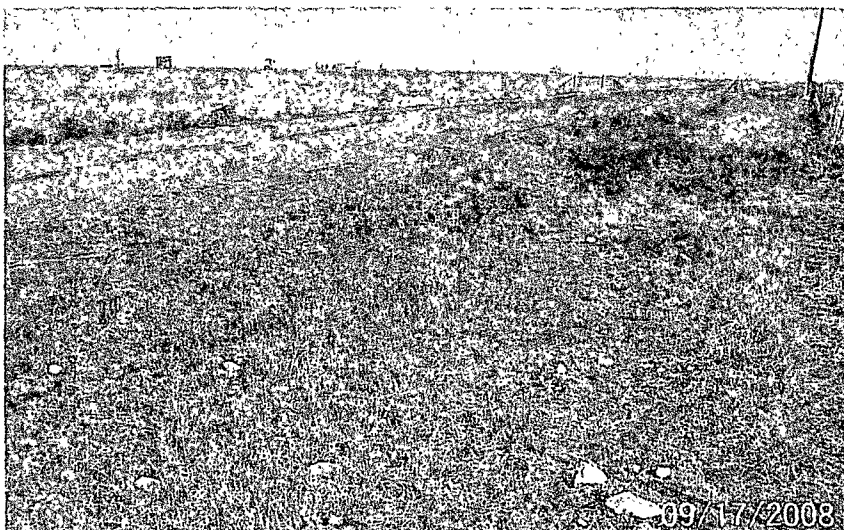
Photo #5 Beginning View of Spill Site

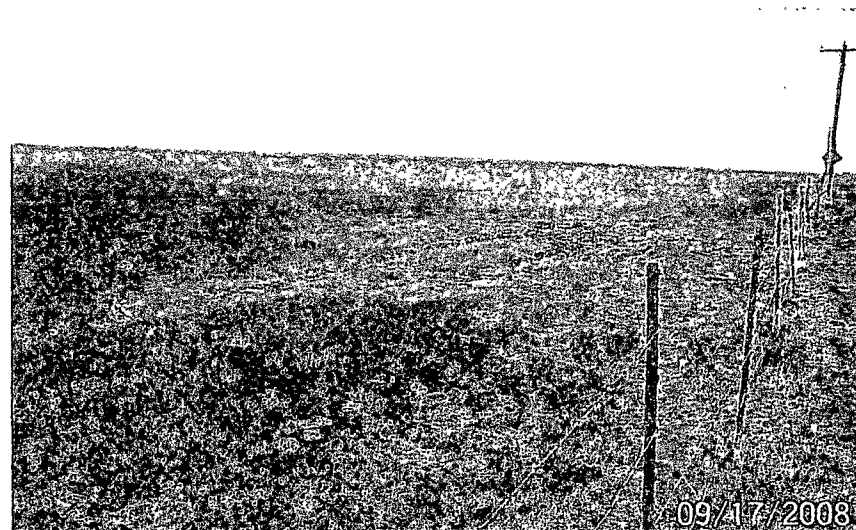
Photo #6 Beginning View of Spill Site

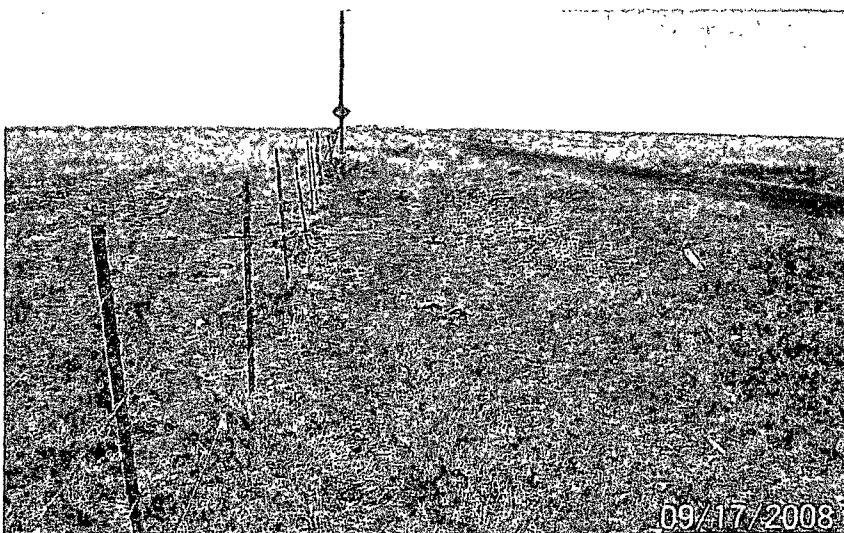
Photo #7 Beginning View of Spill Site

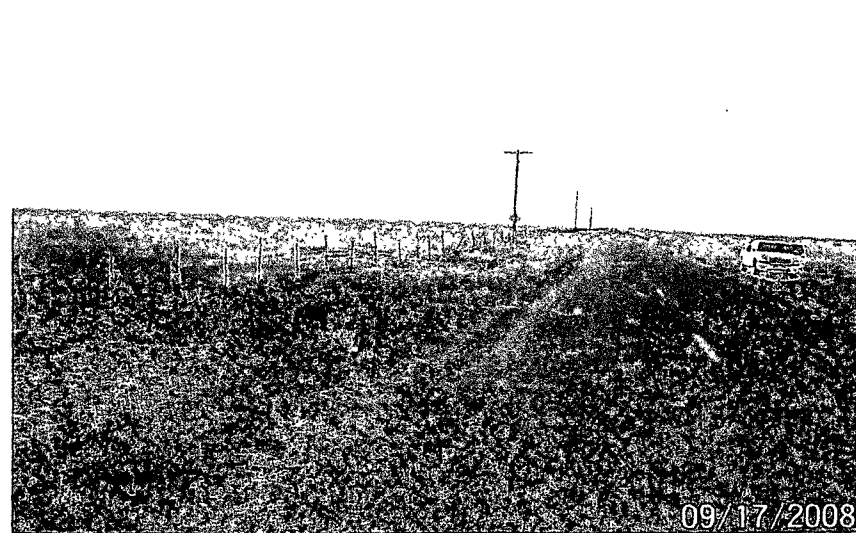
Photo #8 Beginning View of Spill Site

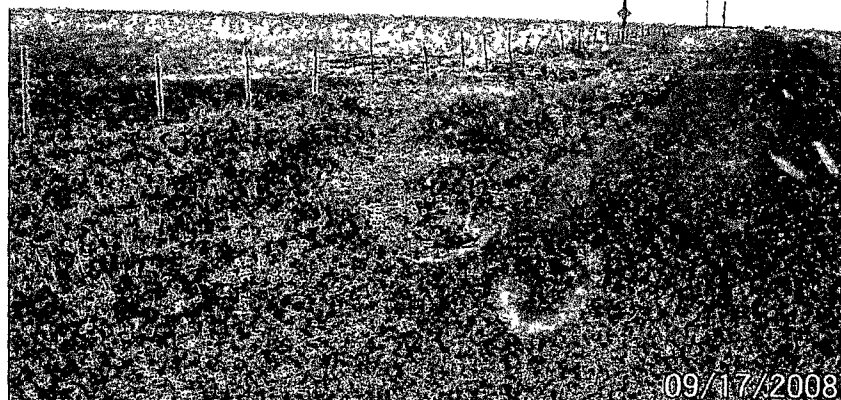
Photo #9 Beginning View of Spill Site

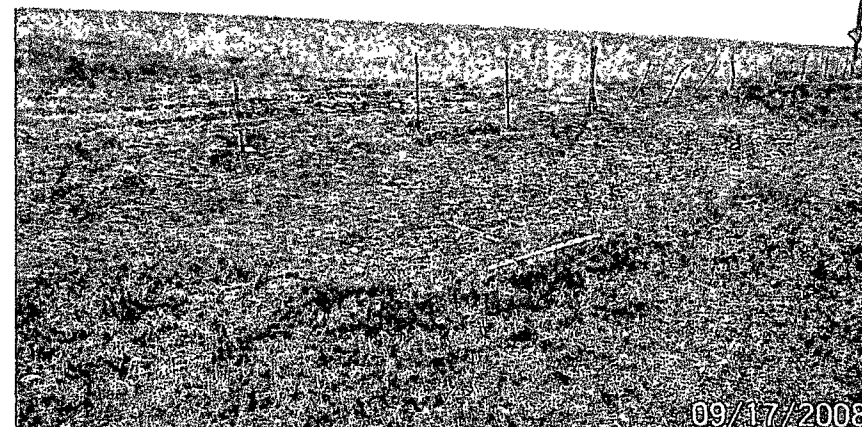
Photo #10 Beginning View of Spill Site
