Release Notification and Corrective Action												
OPERATOR Initial Report Final Report												
Name of Co				ven M. Bishop								
			, N.M. 88240		Telephone No. (575) 397-8251							
Facility Nar	ne South	Hobbs Unit	System		Facility Type Production							
Surface Ow		· 1 D	Mineral C		т:	Deutuenalein		Lease No. (SHU #152 Inj Well)				
Occidental I	Permian Li	imited Partn	Occidenta	ll Permi	nian Limited Partnership			API No. 30-025-28355				
LOCATION OF RELEASE												
Unit Letter	Section	Township	Range	Feet from the	North/	h/South Line Feet from the East/West Line County			County			
'A'	9	19 - S	38-E							LEA		
Latitude North 32°40'52.20" Longitude West 103°06'51.50"												
NATURE OF RELEA'SE												
Type of Rele	ase	·····			UTLL	Volume of Release Volume R				lecovered		
Injection War	ter					Estimated 100 BW			0 Bbls			
Source of Re		jection trunk	lina			Date and Hour of Occurrence 12/05/2008 05:00 PM			Date and Hour of Discovery 12/05/2008 05.00 PM

SPILL MAP

RE: Remediation Plan South Hobbs Unit 10" Injection Trunk line from Central T/B to Injection Building #1 SHU #152 Closest Injector API No 30-025-28355 UL 'A', Sec. 9, T-19-S, R-38-E

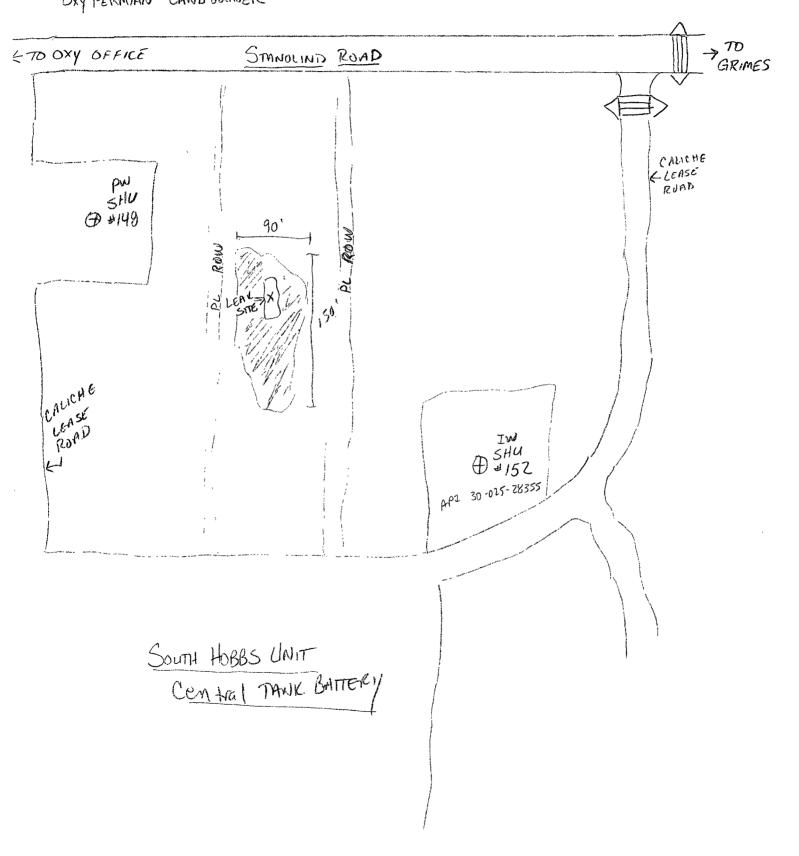
12/05/2008 5:00pm 10" Comment lined Steel INJECTION TELLINE NOD# PSZ LIL'A', SEC. 9, T-1.9-S, R-38-E, N 320 40' 52.20", W103006'51.50" N O X 100 BW - ØBBL Recovered. MARK WHITAKOR 5:23PM DXY PERMIAN LAND DUINER

Leak occurred on 12/05/2008, at approximately 05:00 PM. A 10" cement lined steel trunk line used to transfer injection water from South Hobbs Unit Central T/B to South Hobbs Unit Injection Building #1 split causing spill. Valves on both ends of the trunk line were shut to isolate leak. The line operates at approximately 1100 pounds with an unknown bbls per day rate, due to several lines delivering approximately 90,000 bbls to the South Hobbs Unit Injection System. The area affected by this spill is an area measuring approximately 90' X 150' to the north and south of the leak site in the pasture. An estimated 100 barrels of injection water was spilled with none recovered. Occidental Permian Limited Partnership is the surface owner and utilizes the area for oil and gas production exclusively. Depth to ground water according to State Engineers Office is an average of 53', for all wells in the area, giving this spill site a ranking of 10. Remediation of the spill site will be as follows:

- 1. Piping has been excavated and repaired.
- 2. Affected area will be excavated and affected soil will be disposed of at Sundance Services, Parabo facility near Eunice, NM.
- 3. Soil samples will be gathered from affected area.
- 3. NMOCD guidelines will be used to insure entire site is in compliance with guidelines.
- 4. Soils removed will be replaced with clean fresh soils, where needed.
- 5. Soil analysis data will be submitted with final closure letter.
