**GW - 126**

**INSPECTION  
&  
DATA**

Re: OCD Discharge Plan # GW-126---OCD Inspection Items Requiring  
Attention---Discharge Plan Renewal Inspection 1-15-08---GW-126 for  
Weatherford U.S., L.P. CPD Located at 5432 Highway 64, Farmington, New  
Mexico

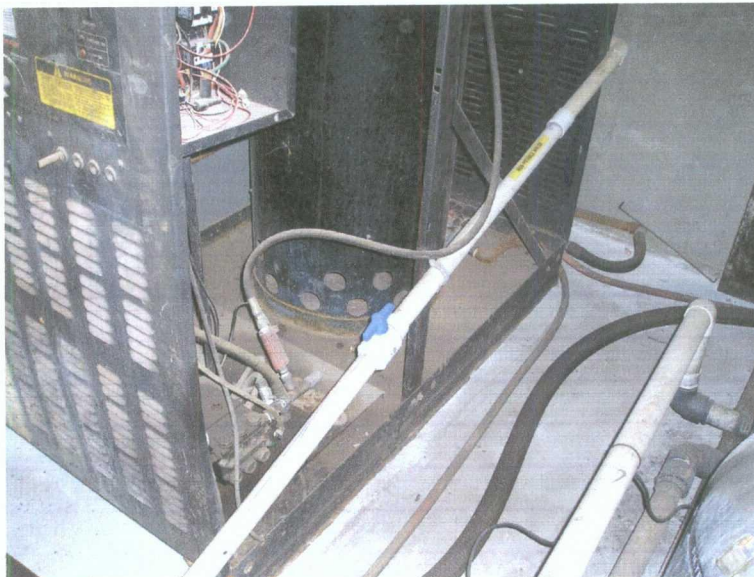
*Item 1. Sump underground pipe from outside building One needs to be tested, See condition 12.*

Photo 1. Test Valve for Underground Pipe

As discussed with Mr. Lowe and Mr. Powell during the OCD Site Inspection, Weatherford installed a valve in the pipe line within building One's wash water containment area to tests the integrity of the buried pipe (See Photo 1). The test method includes closing this valve and filling the outdoor sump to a level two inches above the outlet pipe, marking the water level in the sump, and letting the sump stand overnight. The water level in the sump is inspected in the morning to determine if the level has dropped. The underground pipe was last tested following this procedure on September 19<sup>th</sup>, 2008. No drop in the sump water level was observed and the pipe and sump were determined to be sound with no leak. This test procedure will be conducted once every year and documented on the Facility Weekly Inspection Log.

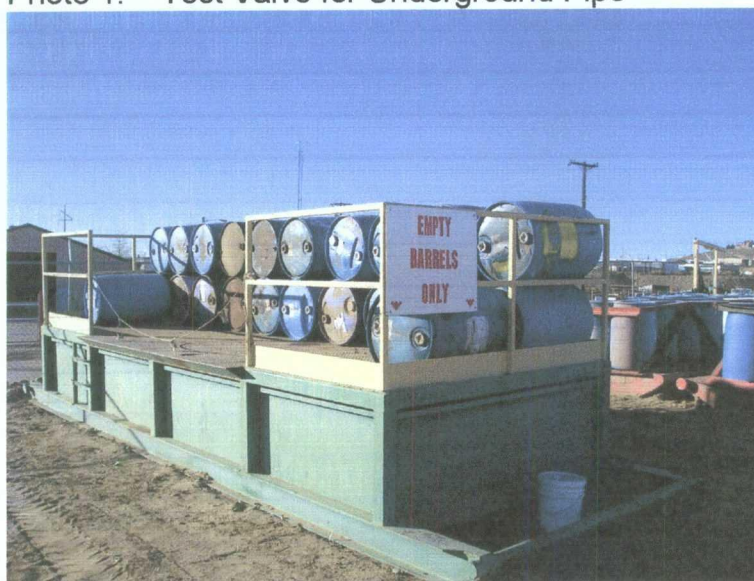
*Item 2. Drums, full or empty need to be properly placed. See condition 7 of permit conditions. The majority of drums located on the west side of facility grounds need to be placed within secondary containment and proper curbing. Leaking fluids may leave facility grounds on to adjacent road.*

Photo 2. Empty Drum Storage Structure

First, Weatherford addressed the empty drum storage area (See Photo 2). All empty drums are stored on their sides with the bunds aligned horizontally (See Photo 3). The empty drum storage area is contained within a 4 inch steel curb on three sides which drains into a secondary containment bin (See Photos 4 and 5). The containment structure will be blocked to slant toward the curbed side thus completing the containment of the empty drums. A valve is located on the back corner of the skid to allow removal of accumulated precipitation.

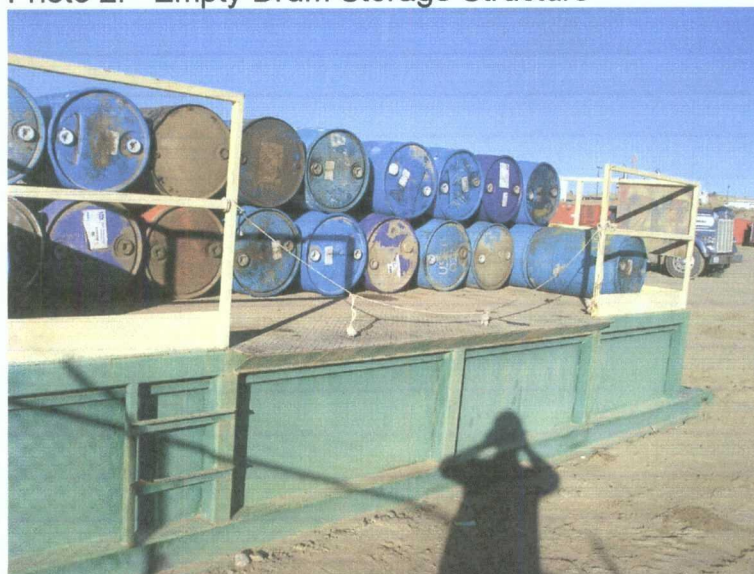
Photo 3. Empty Drum Containment Sloped Back Toward Drums

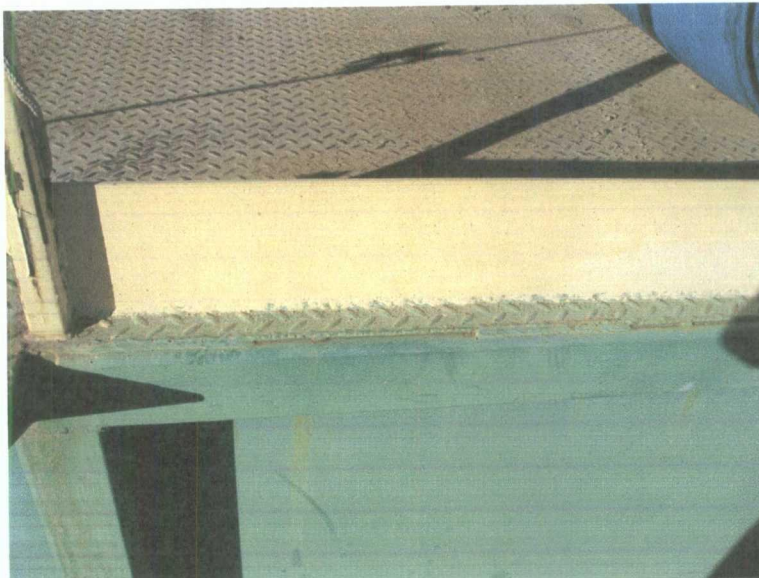
Photo 4. Continuous Welded Curb for Empty Drum Containment

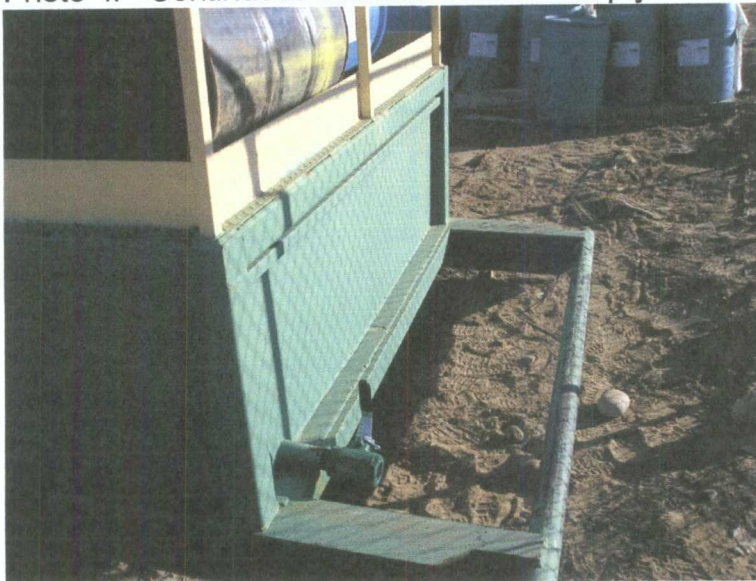
Photo 5. Valve to Drain Containment Bin for Empty Drums

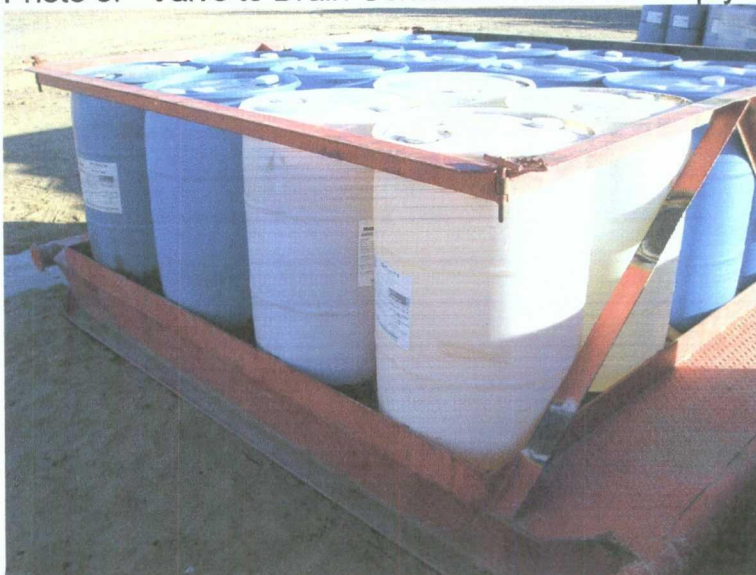
Photo 6. Field Skid Drum Containment

Second, Weatherford plans to alter the curbing around the three field drum containment skids to satisfy the OCD secondary containment volume. The skids will be modified to have an 8 inch curb around the entire skid. This will be completed before June, 2009, or the skids will not be used to store chemicals at the facility (See Photo 6).

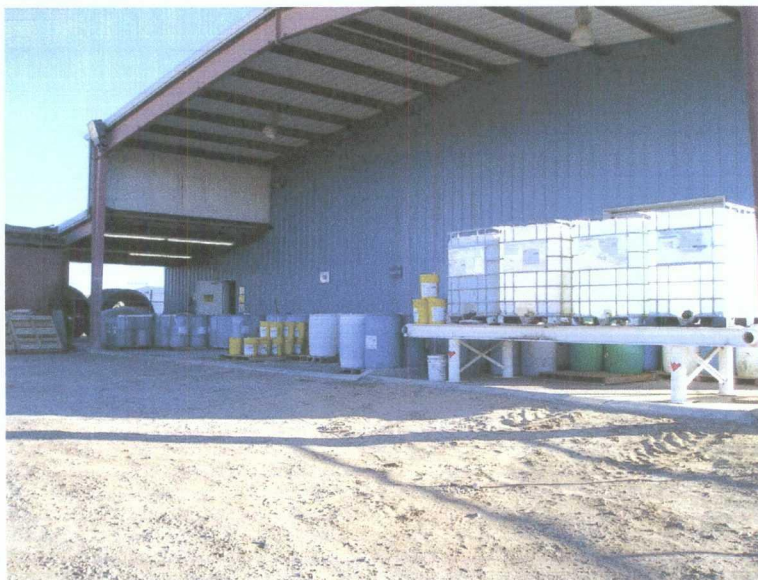
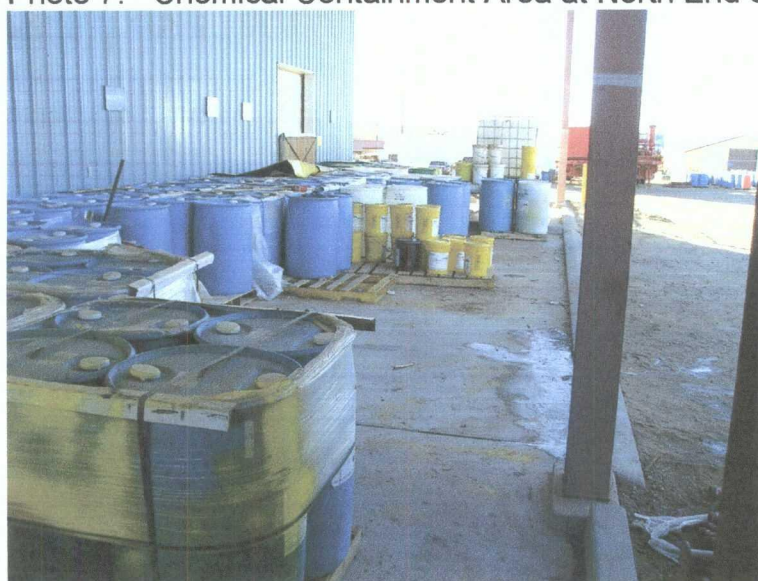
Photo 7. Chemical Containment Area at North End of Building One

Third, Weatherford has relocated the majority of the chemical containers stored on the west side of the property to contained storage areas within building Two and under the awning at the north end of building One (See Photos 7,8,9, and 10). The remaining chemicals stored on the west side will be moved into the two storage areas after additional space is made available by more efficient chemical inventory and space usage modifications. All chemicals will be stored in secondary containment by Jun, 2009, as required by condition 7 of the permit.

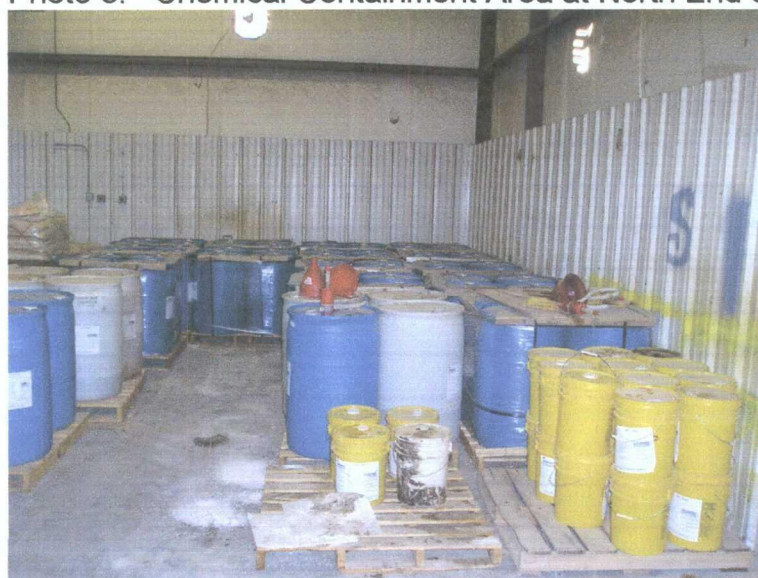
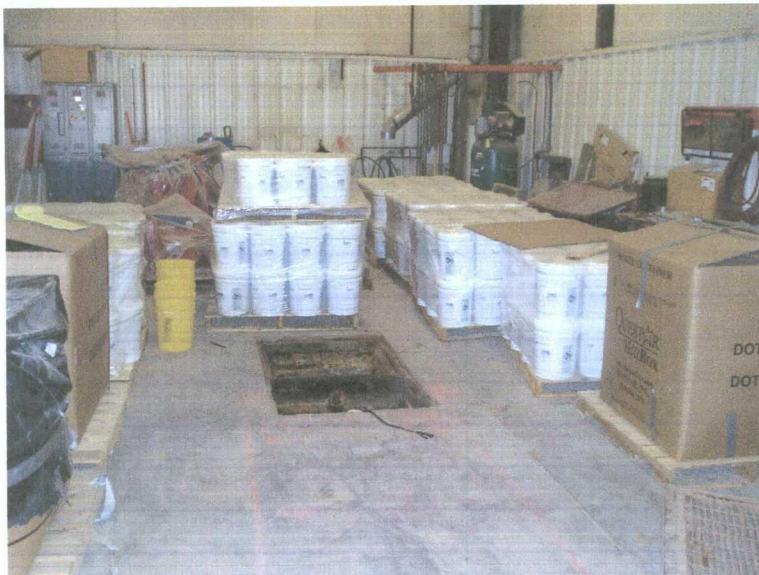
Photo 9. Chemical Containment Area in Building Two

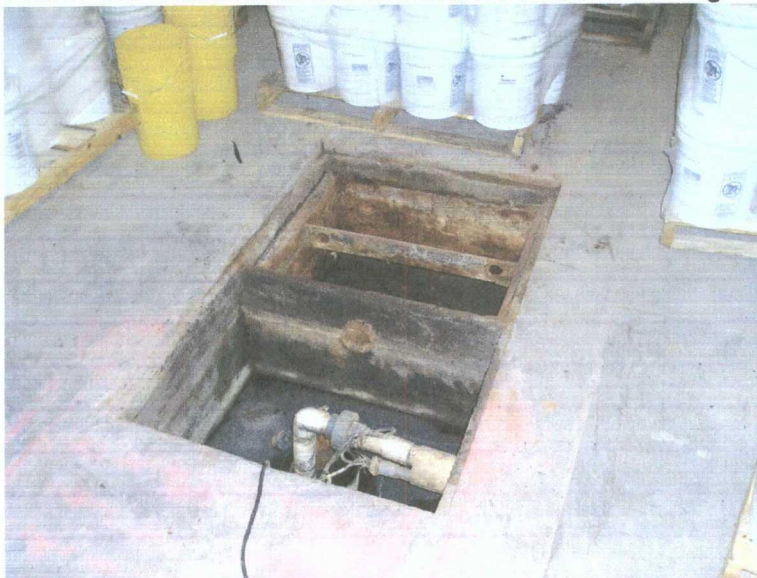
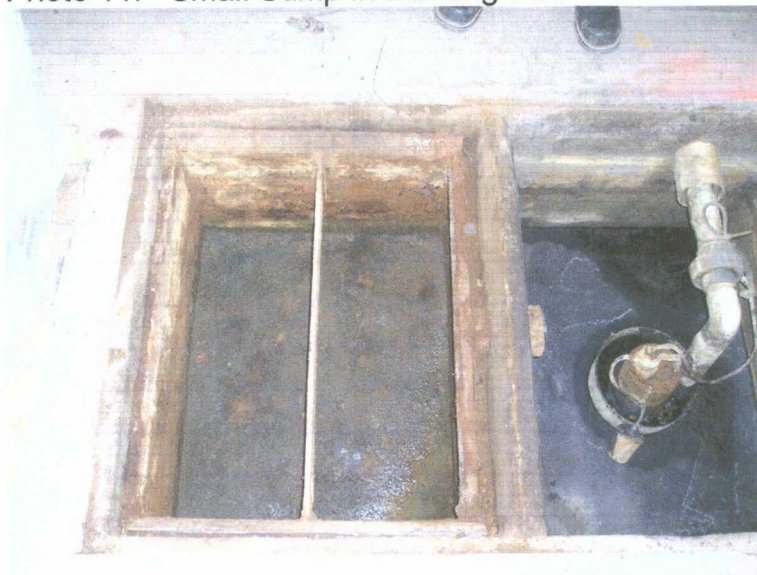
*Item 3. Sump in second building needs to be annually inspected and fluids need to be properly drained. See condition 11.*

Photo 11. Small Sump in Building Two

Weatherford has drained all fluids from both sections of the small sump in the second building. The sump was pressure washed to clean the walls and floor for inspection. The sump pump located in the second section has been disabled and the sump will not be used. The attached photos of the sump were taken on December 10, 2008 as part of the sump inspection (See Photos 11 and 12). The sump was found to be in sound condition and the inspection was recorded on the Facility Weekly Inspection Log. Weatherford will inspect the sump once every year and will record this inspection on the inspection log.

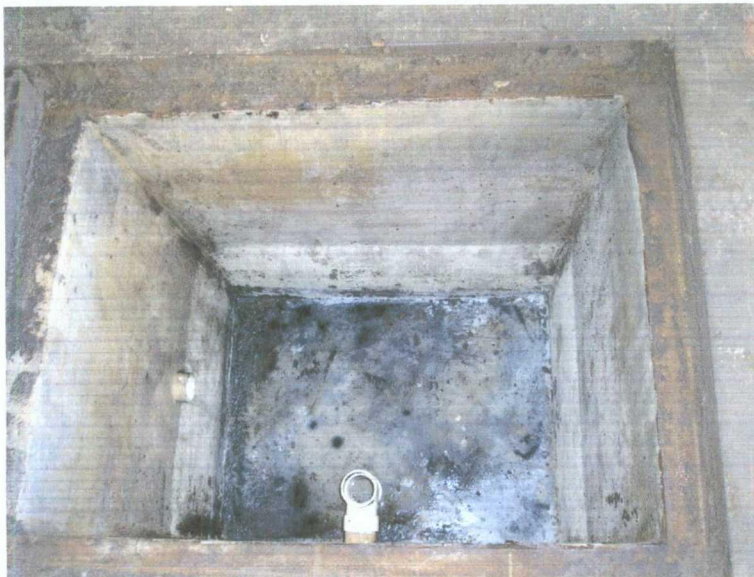
In addition to inspecting the sump in building Two, Weatherford also inspected the three large sumps in building One on December 10, 2008 (See Photos 13, 14, and 15). No conditions that could be expected to compromise the integrity of the sumps were observed. During the inspection, Weatherford located the monitoring well that was installed when the sumps and wash area were built. The monitoring well was opened and found to be free of accumulated leachate. The bottom of the monitoring well is 24 inches below the bottom of the sumps. Weatherford has been looking for the monitoring well for the past year in preparation for the renewal of the

Photo 13. East Section of North Sump in Building One

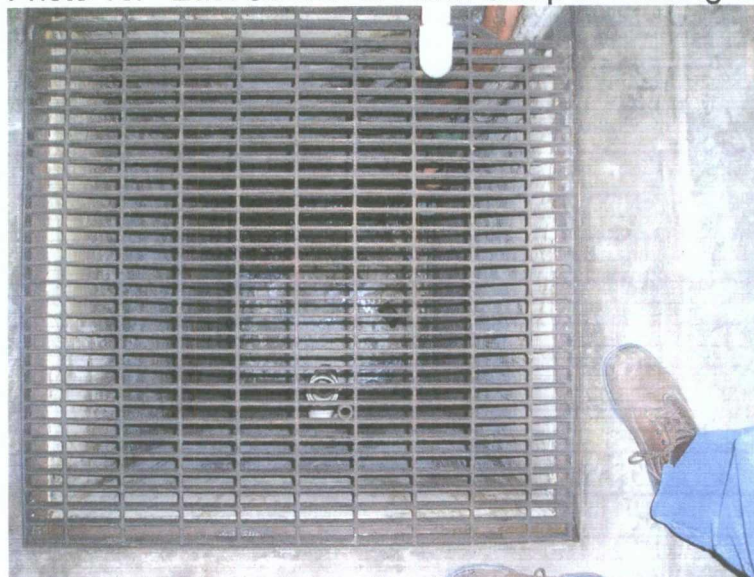
Photo 14. Pump Out Sump in Building One

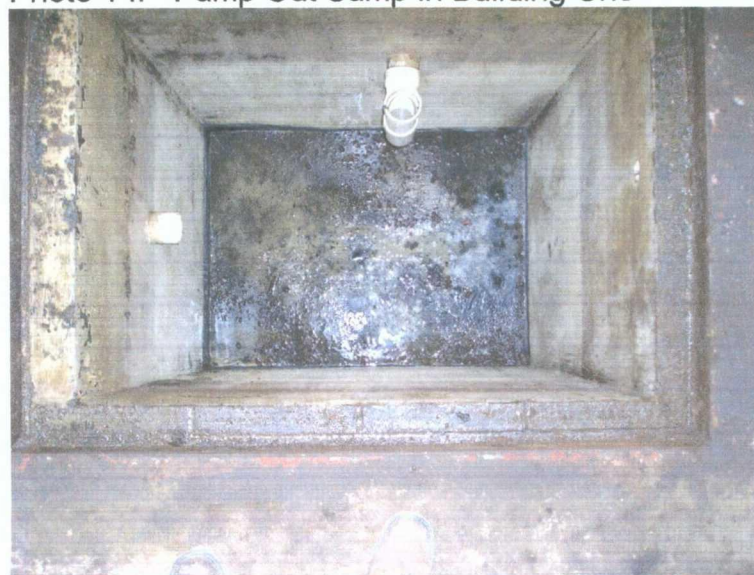
Photo 15. Second Section of South Sump in Building One

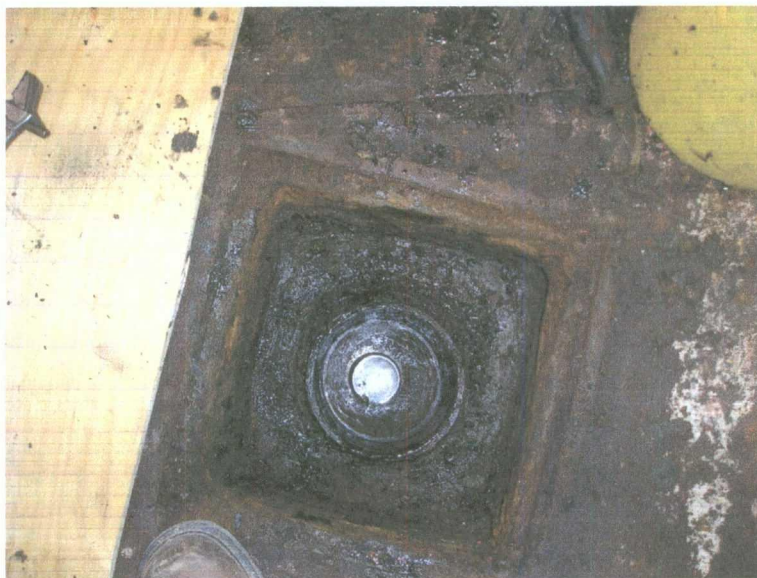
Photo 16. Monitoring Well, East End of South Sump

Weatherford will continue to check the monitoring well monthly and will document the inspection on the Facility Weekly Inspection Log. See attached photo 17 for the monitoring well.
