Release Notification and Corrective Action

Name of Company: Targa Midstream Services L P	Contact: James Lingnau 505.394 2534, Chuck Tolsma 505 631.6026
Address: PO Box 1909 Eunice, NM 88231	Telephone No. (505) 394-2534
Facility Name: Eunice Gathering System	Facility Type

Vivian 8"

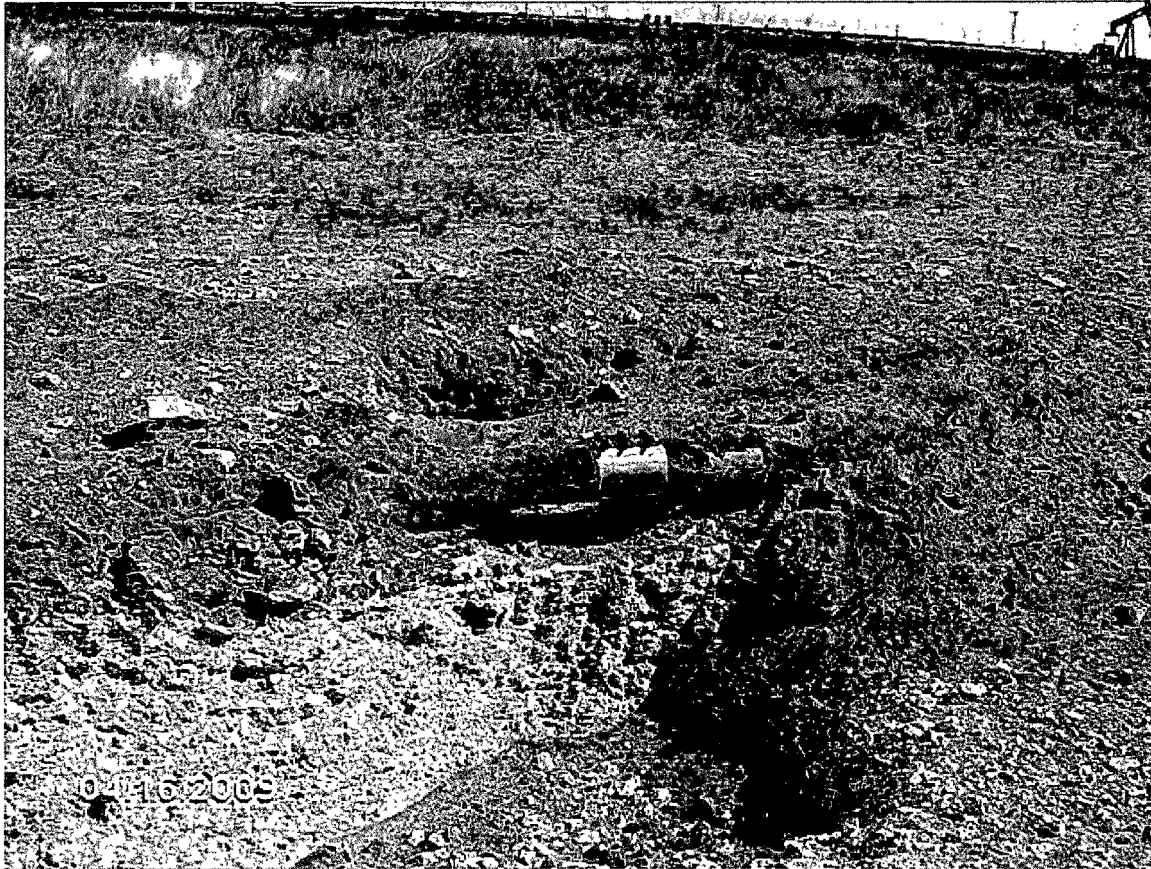
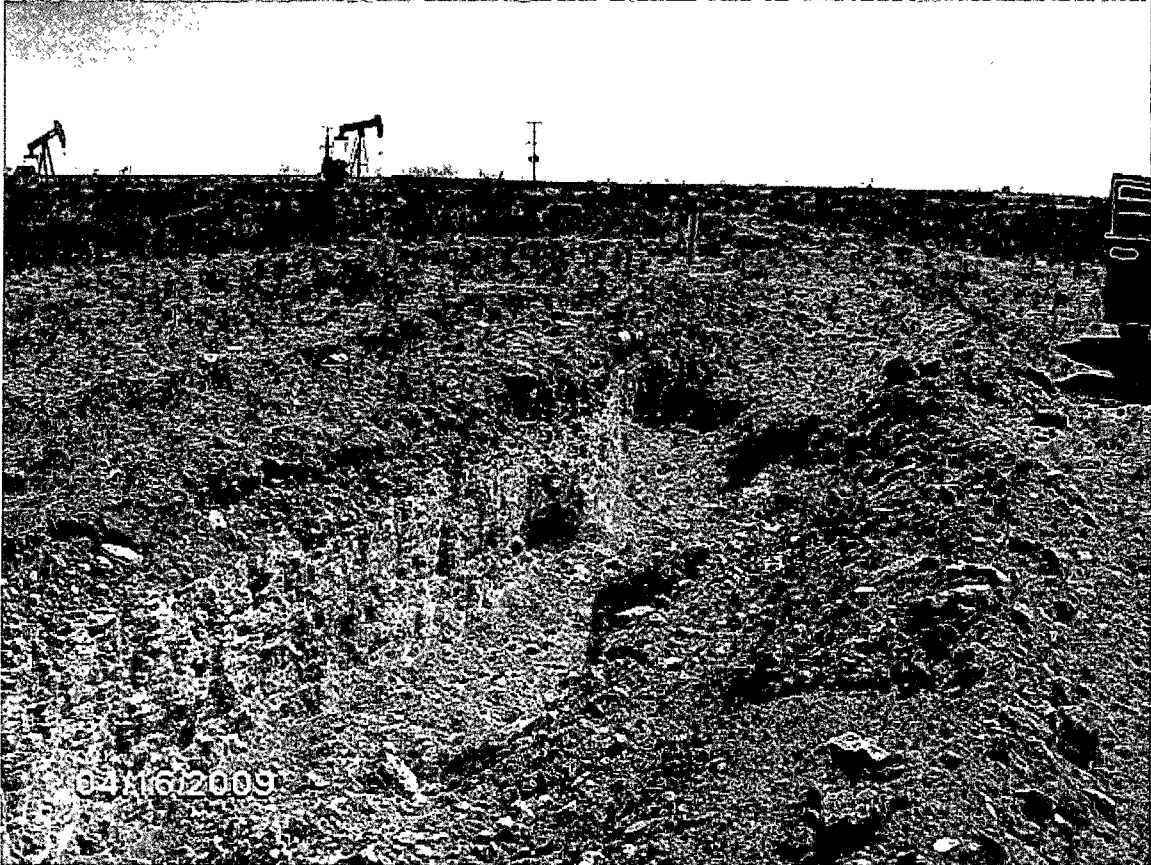
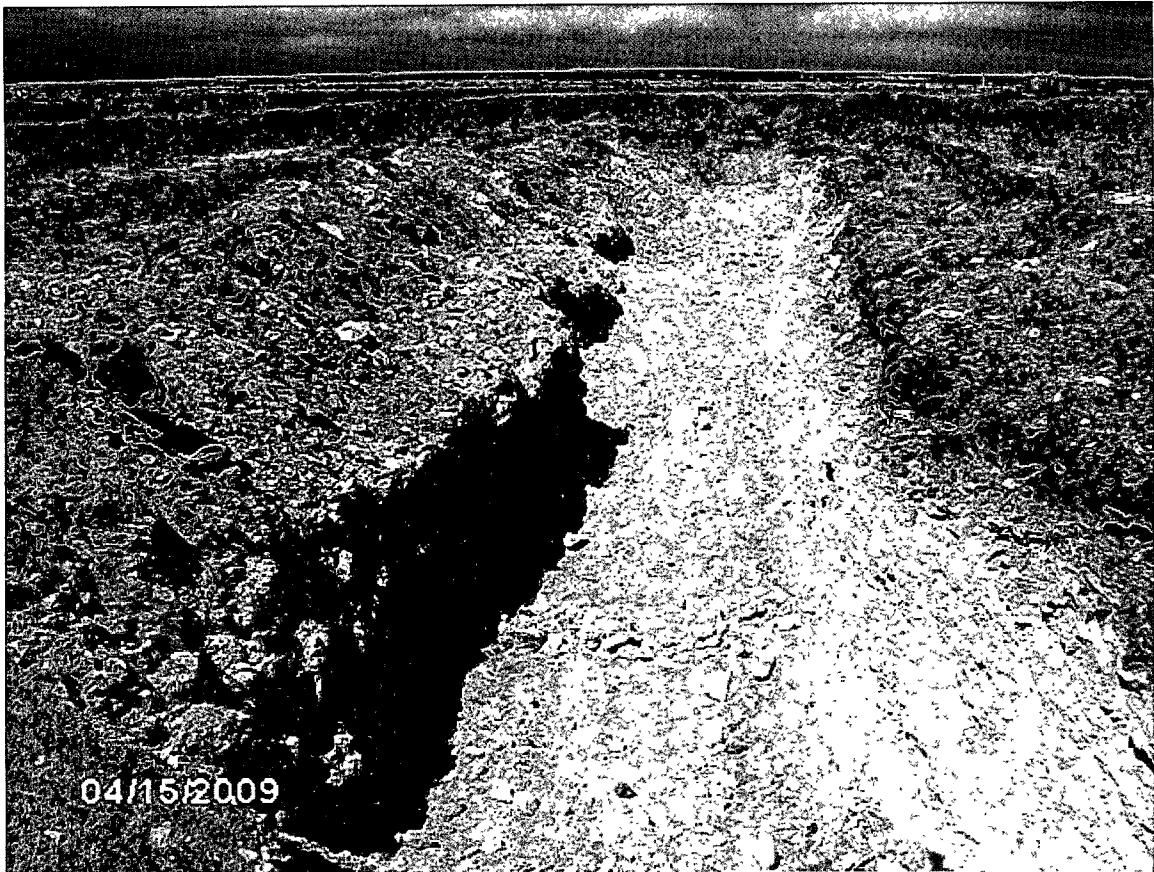
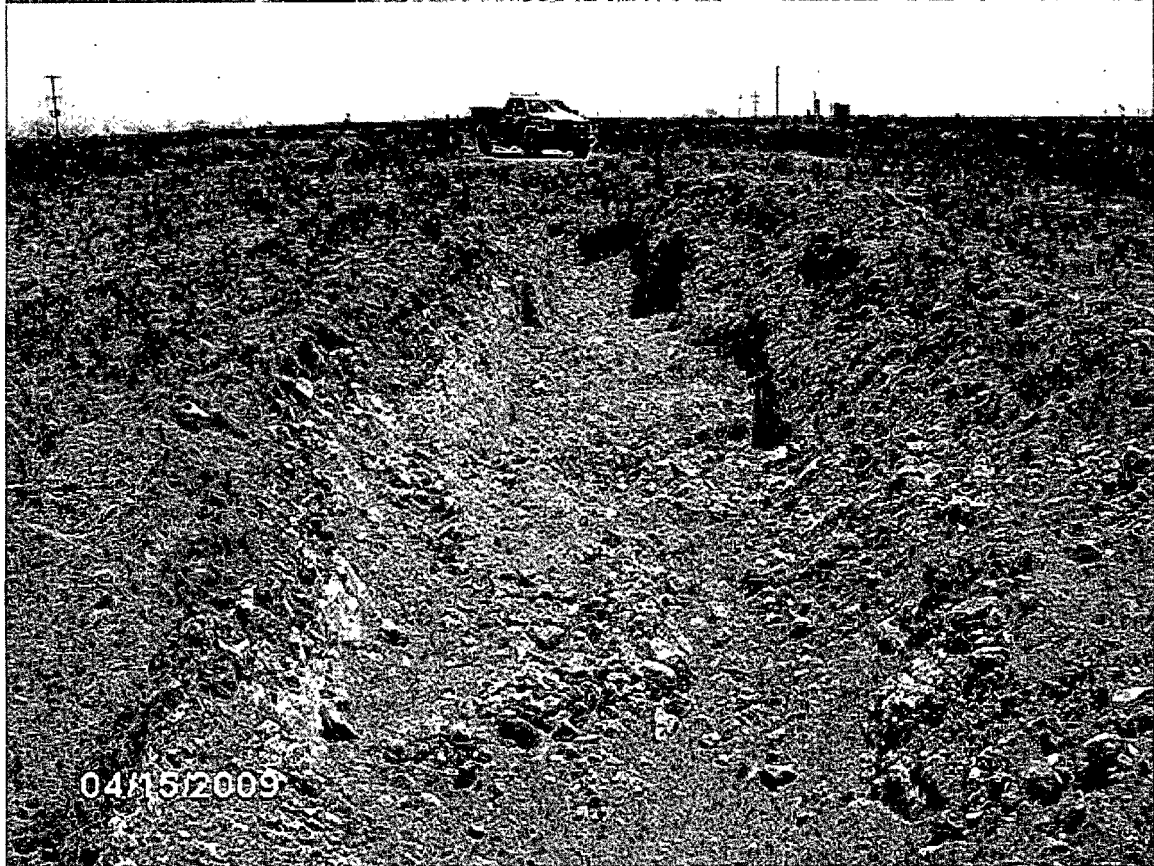
An 8 inch gathering line had a leak and released gas and any produced liquids that were lying in the line. Line was repaired with clamp. Contaminated soil was scraped and hauled to an approved landfill. 1000 feet of 6" poly pipe was inserted in 8" pipe to improve pipeline integrity. Area cleaned to meet OCD guidelines. Line monitor aircraft discovered leak.

2 clamps

Targa excavated the contaminated area from leak to include runoff. 75 yards of contaminated soil was hauled to an approved landfarm. Site was minimum top soil and layer of solid rock.
