**Whole Earth Environmental, Inc.**

Enclosed, please find a copy of our site investigation results and planned remediation protocol for the Gandy Wasserhund Eidson brine station spill located approximately 12 miles west of Lovington.

## Executive Summary

**Release Notification and Corrective Action**

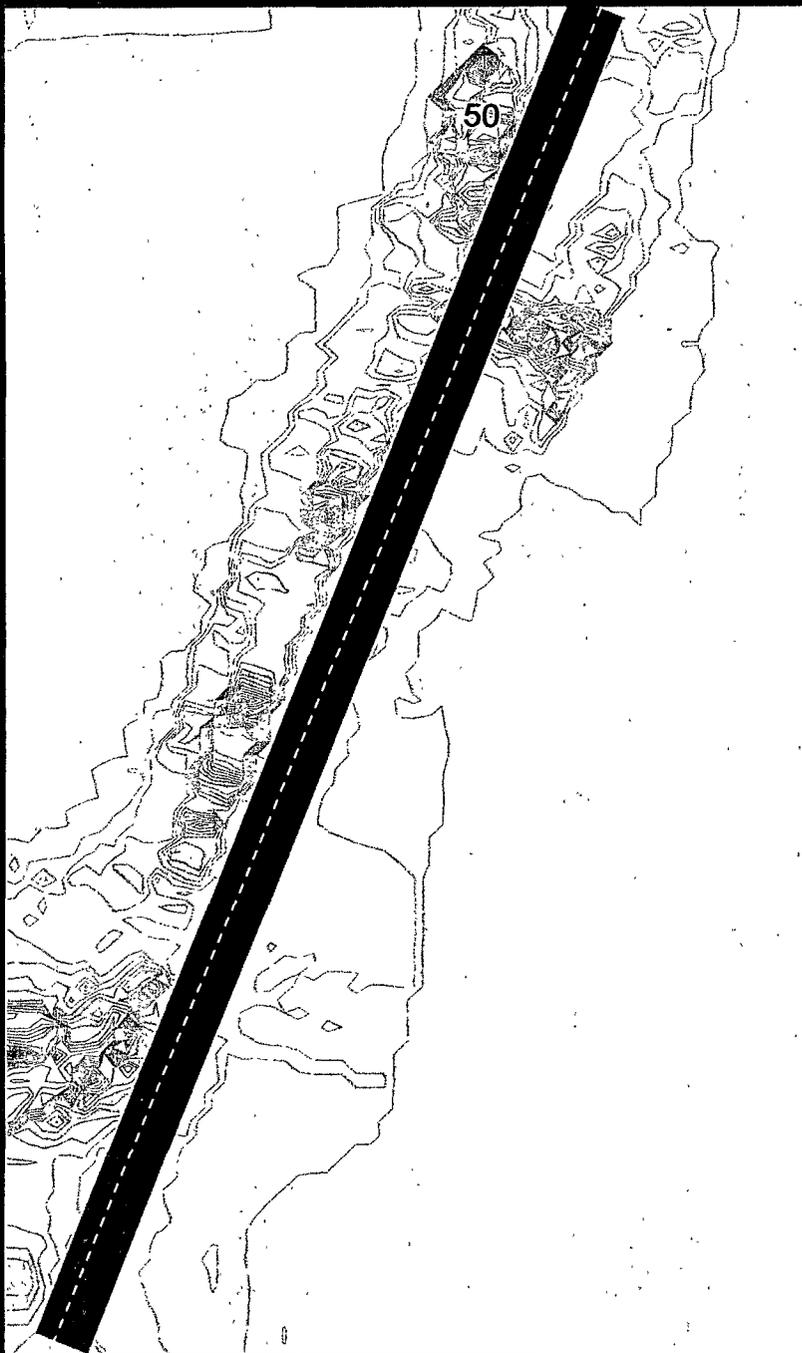
Gandy Wasserhund Eidson  
EM-31 Electromagnetic Survey  
0-17' Below Ground Surface

Whole earth collected soil samples from the pad area and conducted a series of field electrical conductivity tests on the apparently affected areas. The EM-38 survey revealed high chloride concentrations generally at depths less than three feet below ground surface. Coring the site revealed elevated but generally superficial chloride concentrations within the spill area.

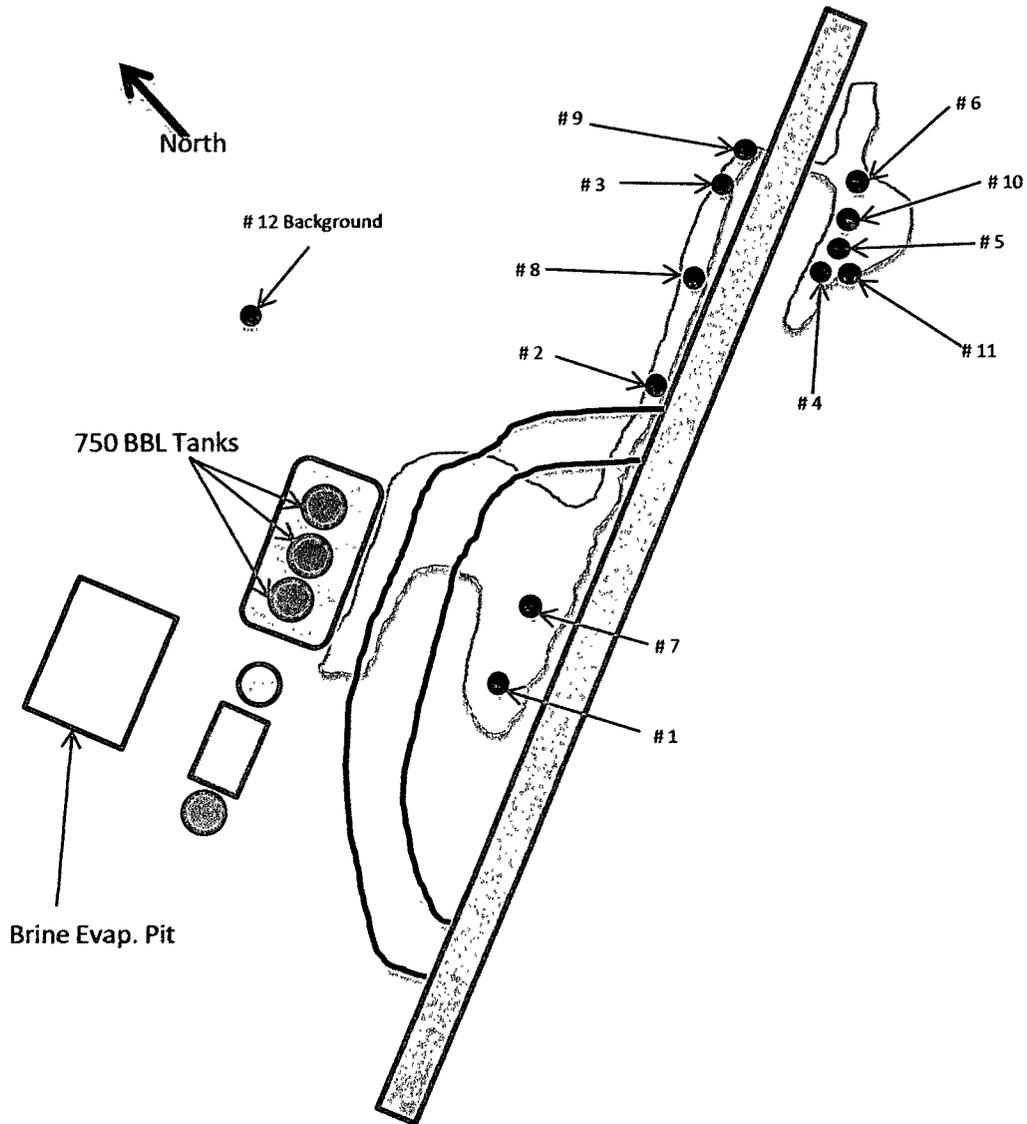
Gandy Wasserhund Eidson Brine Station  
Spill Diagram  
Bore Hole Locations

The site has an extensive history of similar spills under previous ownership. The most recent spill was generally confined to the first 10 feet of vertical depth. Two deep corings utilizing split spoon sampling revealed one area of potential concern.

The area immediately adjacent to the most recent spill to include the western ditch was previously excavated and a layer of clay installed. The clay significantly retarded the vertical migration of fluids revealing only minor concentrations at depths up to 15' below ground surface, (bgs). However the area east of the culvert located approximately 300' northeast of the facility revealed significant chloride concentrations to depths of up to 15' bgs.

To date, 980 cubic yards of salt impacted soils have been excavated and sent to commercial disposal at the Gandy / Marley processing facility. An equivalent volume of proctored clay has been backhauled to re-fill the excavated areas. We propose to set a clay liner beneath all affected areas to a minimum thickness of 6" and backfill atop the clay with a minimum of 2' of compacted topsoil.
