GW - 255

GW-255, Teppco Buena Vista CS

Val Verde Gas Gathering L.P. Buena Vista Compressor Station New Mexico Oil Conservation Division Inspection Report, GW-255

OCD Inspection: Teppco Buena Vista CS, GW - 255

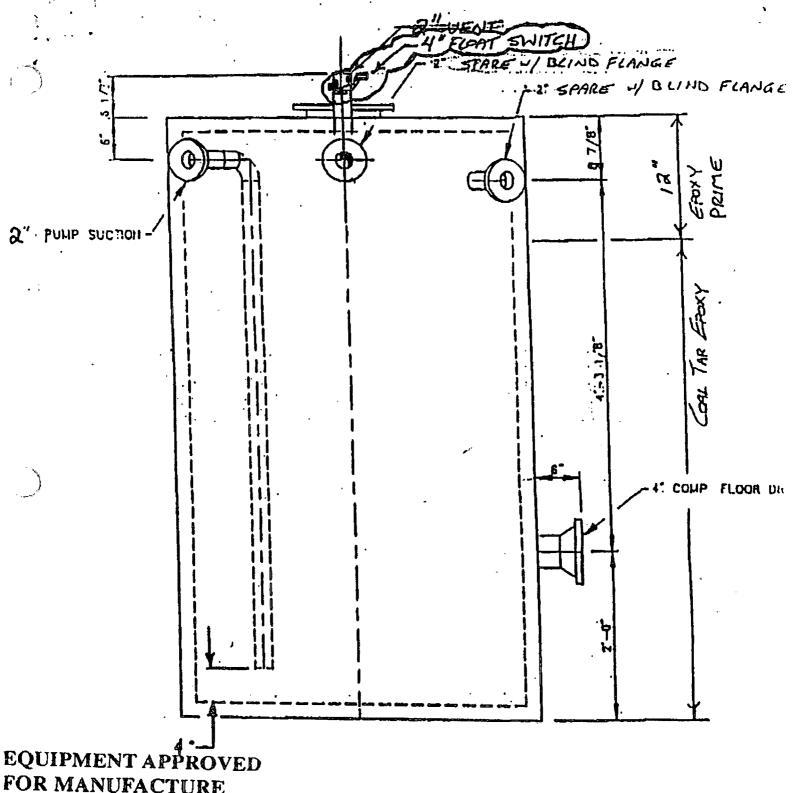
Attachment A

Response: Please find the attached construction specification (Attachment A) for the below grade tank installed at the Buena Vista Compressor Station. This below grade tank has an alarm that actuates if liquids are detected in the interstitial space between the primary tank and secondary wall. Monthly inspections are also conducted to determine the integrity of the sub-grade tank, please find a copy (Attachment B) of a representative inspection.
