# GW - 028

# INSPECTIONS & DATA

# **REFINERY TANK CONSTRUCTION INSPECTION**

# **REFINERY INSPECTION**

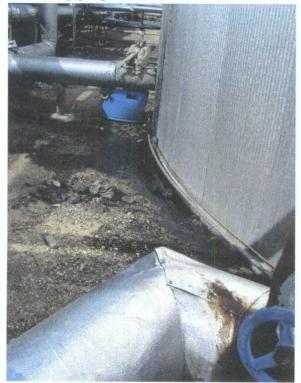
Pitch tar piping leak evident

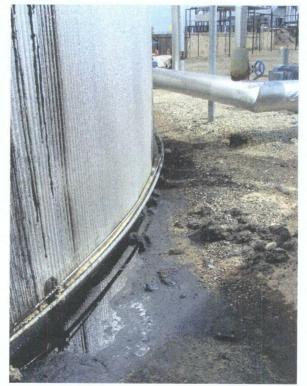
Pitch Tank 814 Investigate leaking bottom?

3) Tank 814 leak needs to be cleaned up and investigated.

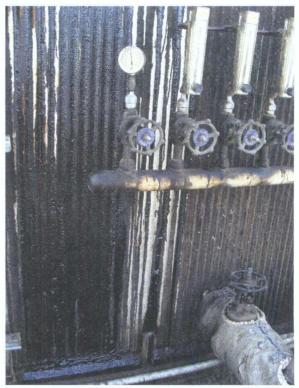
Pitch Tank 814 Tank gauging station at tank

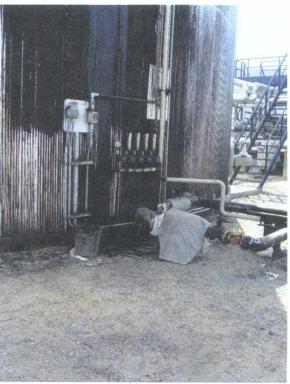
Pitch Tank 814 Close up on tank gauging station

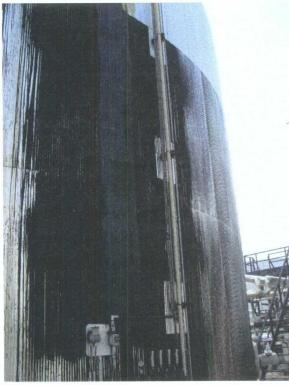
Pitch Tank 814 Overflow spill evident on walls where tank gauging station is located

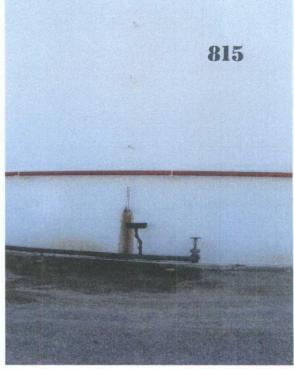
Tank 815 low-sulfur diesel leak from water withdrawal location

2) Cleanup and investigate source of leak on Tank 815.

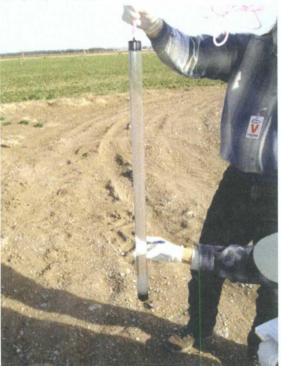
KWB-13 Milky turbidity appearance of GW w/ SWL  $\sim$  22 ft.

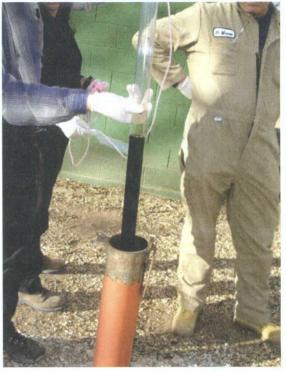
KWB-8 Approx. 16-18 in. PSHs in GWoperator currently bailing to remove product

11) Automatic 24/7 free-product recovery system to remove the source of ground water contamination required from 2/19/07 inspection has not been installed yet.

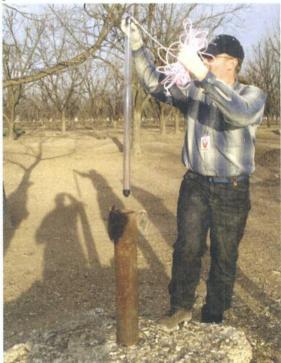
KWB-8 Gas odor touch bottom of well, pure product in well

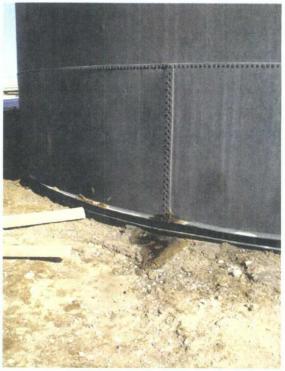
Tank# 61 signs of Carbon Blk. Oil leaks

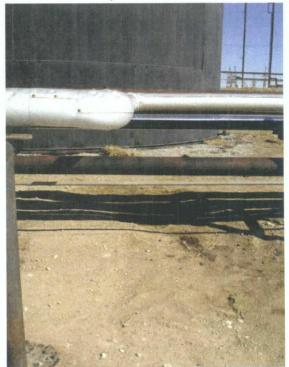
Small leak in one of the Carbon Black Oil lines beside slurry oil treatment area

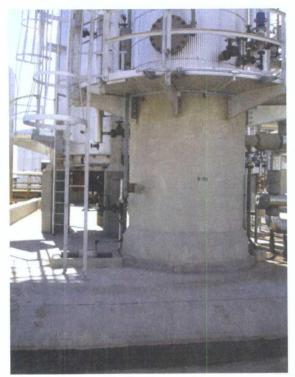
New small leak in carbon black oil line beside Tank# 58

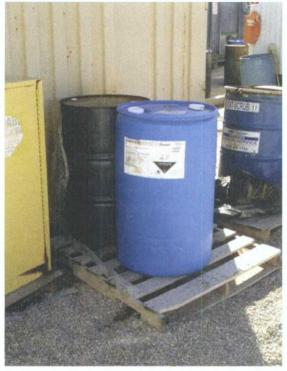
Improper storage of totes (no secondary containment) WWTP

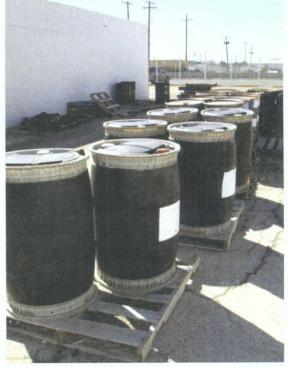
Gas Company of NM yard - improper storage, no secondary containment

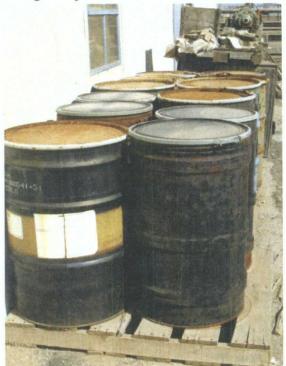
Gas Company of NM yard - improper storage of spent material

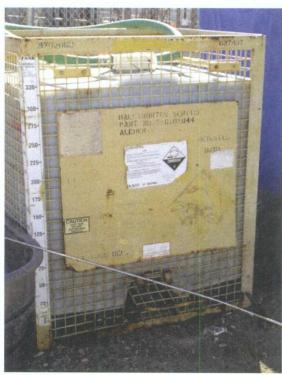
Gas Company of NM Pipeline Group yard improper storage, no 2nd containment

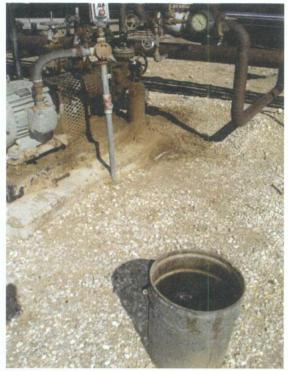
Contamination on ground from leaky crude oil transfer pump in need of cleanup & secondary containment.

5) Tank 437 oil leakage to ground on E side from crude oil transfer pump w/ cleanup & secondary containment needed under pump. Cleanup needed (see photos).

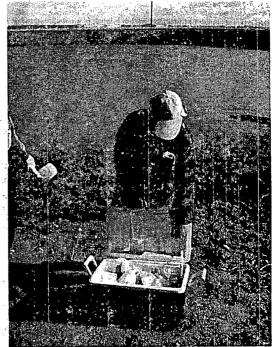
Flush mount wells along S Bolton Rdunlocked

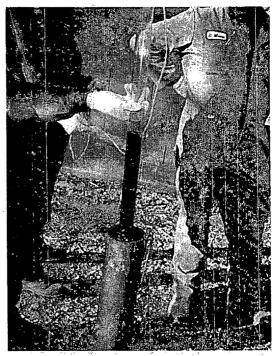
KWB-8 Approx. 16-18 in. PSHs in GWoperator currently bailing to remove product

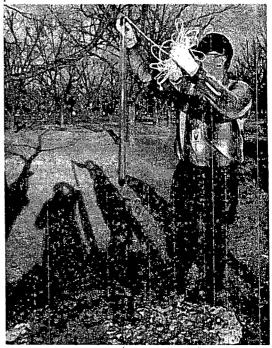
KWB-8 Gas odor touch bottom of well, pure product in well

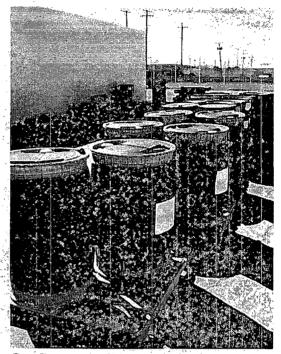
Gas Company of NM yard - improper storage, no secondary containment

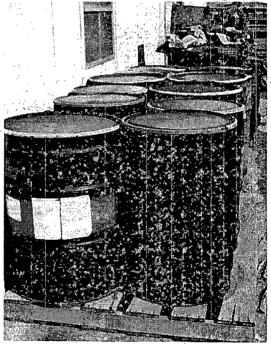
Gas Company of NM yard - improper storage of spent material
