R. T. HICKS CONSULTANTS, LTD.

August 12, 2009

RE: Seven Produced Fluid Releases at sites operated by Marks and Garner Production Ltd, Company in Eddy County, NM as follows:

R.T. Hicks Consultants is pleased to submit the results of the initial characterization activities on the behalf of Marks and Garner Production Ltd. The production area is approximately 6.5 miles northwest of Loco Hills, New Mexico. Plate 1 depicts the location of each site relative to lease roads, sections lines, and Bear Grass Draw. On June 22 and 23, 2009 Hicks Consultants inspected each of the sites to document the source and type of release, describe the resulting environmental impact, and recover "worst case" soil samples in order to determine the corrective actions required under NMOCD Rule Part 29.

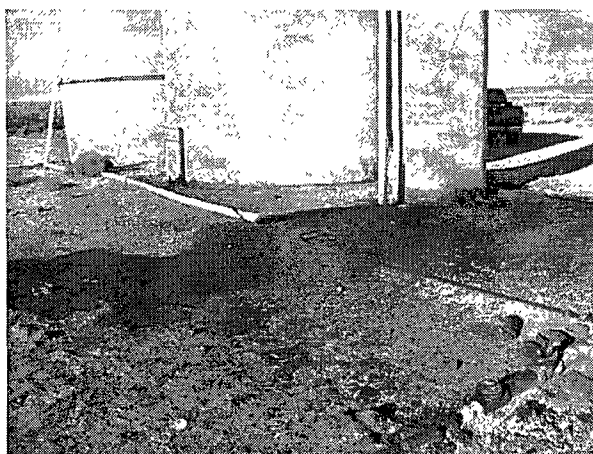
Levers Federal No. 7 Battery (OCD Reference No. 2RP-304)

A release of heavy “tank bottom” oil occurred from a broken valve at the base of a large separator and extends approximately 30 feet down slope. We used a hand auger to obtain soil samples at depths of 0.5, 1.0, and 3.0 feet below the free liquid. Results of laboratory analyses on selected samples for benzene, toluene, ethylbenzene, xylenes; and gasoline, diesel, and oil range hydrocarbons as well as field screening and laboratory results are provided on the table below:

None of the hydrocarbon concentrations measured at the Levers Federal No. 7 site exceeds the 1993 NMOCD or 2006 NMED Guideline soil screening levels. The fact that the concentrations of regulated constituents do not exceed NMED Guidelines allows us to conclude that the impacted soil does not represent a threat to fresh water or public health. The recommended corrective action for this site is:

1. Remove out-of-service vessels or repair all leaks
2. Excavate the upper 6-inches of earth within the spill footprint
3. Mix the excavated spill material with 2-5 parts clean soil

4. Use this blended soil for the construction of firewalls around tank batteries (use now or stockpile on site for future use)
5. At abandonment of the site the surface will be restored according to the landowner's specifications

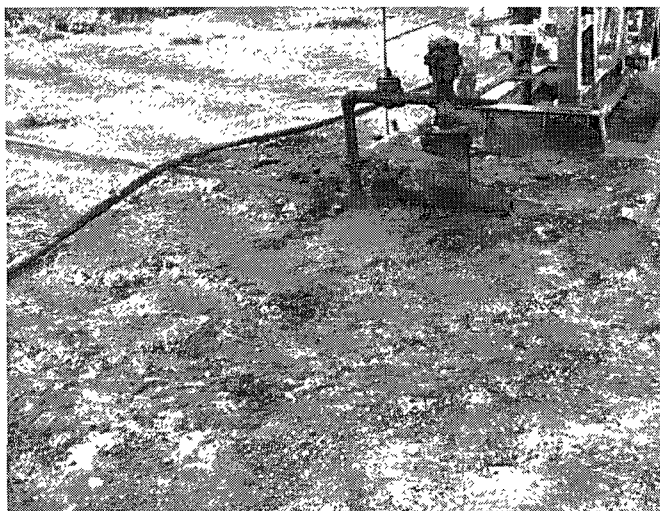
Levers No. 3 Well (OCD Reference No. 2RP-305)

A release of oil occurred from the well head which extends approximately 10 feet in all directions. The table below presents field screening and the laboratory results from soil samples at the surface and at depths of 2.0, 3.0, 4.0, 5.0 and 6.0 feet below the stained area.

Total Petroleum Hydrocarbon (TPH) concentrations measured at the Levers No. 3 site exceeds the 1993 NMOCD Guideline levels but concentrations generally decrease from the surface to the auger refusal depth (6 feet below the surface). Most importantly, none of the regulated hydrocarbon concentrations exceed the 2006 NMED Guideline levels. The fact that the concentrations of regulated constituents do not exceed NMED Guidelines allows us to conclude that the impacted soil does not represent a threat to fresh water or public health. The recommended corrective action for this site is:

1. Remove out-of-service vessels or repair all leaks
2. Excavate the upper 1-2 feet of earth within the spill footprint
3. Mix the excavated spill material with 2-5 parts clean soil
4. Use this blended soil for the construction of firewalls around tank batteries (use now or stockpile on site for future use)
5. Collect a composite sample of the blended soil to demonstrate that constituents are at concentrations that comply with NMOCD Rules and provide letter report to NMOCD
6. At abandonment of the site the surface will be restored according to the landowner's specifications

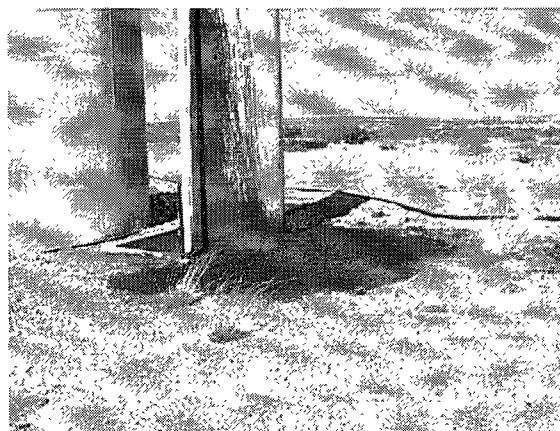
Red-12 Federal No. 1 Battery (OCD Reference No. 2RP-306)

A release of heavy "tank bottom" oil occurred from a broken valve at the base and from a pipe joint near the top of the separator. The spill area extends approximately 30 feet down slope. Laboratory results of soil samples recovered using a hand auger at depths of 0.5, 1.0, and 3.0 feet below the free liquid and field screening are provided on the table below:

TPH concentrations measured from near the surface at the Red-12 Federal No. 1 site exceeds the 1993 NMOCD Guideline levels but decreases to below the guideline levels at 3 feet below the surface. None of the regulated hydrocarbon concentrations exceed the 2006 NMED Guideline levels. The fact that the concentrations of regulated constituents do not exceed NMED Guidelines allows us to conclude that the impacted soil does not represent a threat to fresh water or public health. The recommended corrective action for this site is:

1. Remove out-of-service vessels or repair all leaks
2. Excavate the upper 6-12 inches of earth within the spill footprint
3. Mix the excavated spill material with 2-5 parts clean soil
4. Use this blended soil for the construction of firewalls around tank batteries (use now or stockpile on site for future use)
5. Collect a composite sample of the blended soil to demonstrate that constituents are at concentrations that comply with NMOCD Rules and provide letter report to NMOCD
6. At abandonment of the site the surface will be restored according to the landowner's specifications

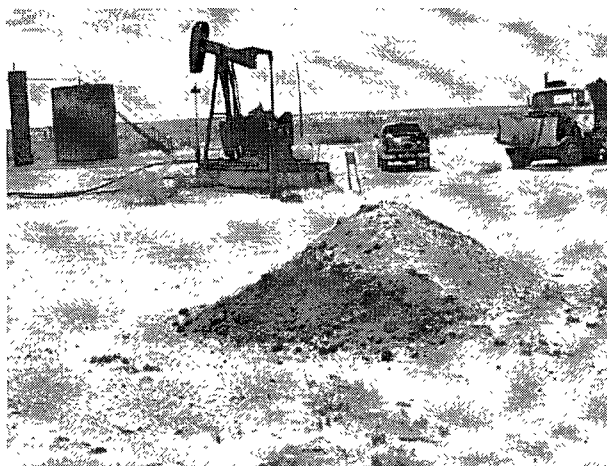
Cave State No. 4 Well (OCD Reference No. 2RP-307)

The operator excavated and stockpiled soil from an apparent release of oil that occurred prior to our characterization. Laboratory and field results from soil samples recovered from the stockpile and below the spill footprint are provided on the table below:

The hydrocarbon concentrations from the removed stockpiled soil at Cave State No. 4 site exceeds the 1993 NMOCD Guideline levels for TPH and the 2006 NMED Guideline levels for benzene. None of the hydrocarbon concentrations measured from the remaining (deeper) soil exceeds either the 1993 NMOCD or 2006 NMED Guideline soil screening levels.

The fact that the concentrations of regulated constituents do not exceed NMED Guidelines allows us to conclude that the impacted soil below the original spill footprint does not represent a threat to fresh water or public health.

We recommend that the operator mix the stockpile with clean soil and utilize it for the construction of a firewall at one of the active tank batteries.

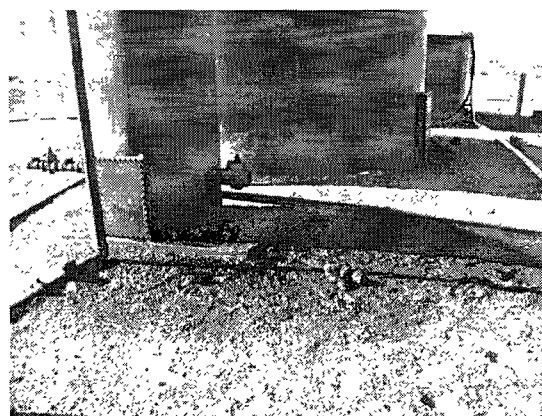
Red-12 State No. 2 Battery (OCD Reference No. 2RP-308)

A release of heavy "tank bottom" oil occurred from a broken valve at the base of a separator and extends approximately 20 feet down slope. Results of laboratory and field analyses of soil samples recovered using a hand auger at depths of 0.5, 1.0, and 3.0 feet below the free liquid are provided on the table below:

TPH concentrations measured from near the surface at the Red-12 State No. 2 site exceeds the 1993 NMOCD Guideline levels but decreases to below the guideline levels at 3 feet below the surface. None of the measured hydrocarbon concentrations exceed the 2006 NMED Guideline levels. The fact that the concentrations of regulated constituents do not exceed NMED Guidelines allows us to conclude that the impacted soil does not represent a threat to fresh water or public health. The recommended corrective action for this site is:

1. Remove out-of-service vessels or repair all leaks
2. Excavate the upper 6-12 inches of earth within the spill footprint
3. Mix the excavated spill material with 2-5 parts clean soil
4. Use this blended soil for the construction of firewalls around tank batteries (use now or stockpile on site for future use)
5. Collect a composite sample of the blended soil to demonstrate that constituents are at concentrations that comply with NMOCD Rules and provide letter report to NMOCD.
6. At abandonment of the site the surface will be restored according to the landowner's specifications.

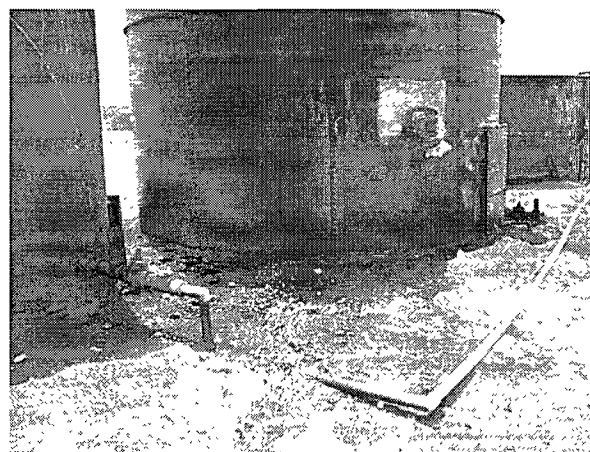
Red-12 State No. 3 Battery (OCD Reference No. 2RP-309)

A release of heavy "tank bottom" oil occurred from leaks located at the base of a 500-bbl oil tank and a separator. The surface staining is present in an area of approximately 500 ft². A composite surface soil sample was recovered from the stained area and subsurface soil samples were recovered from two hand auger borings at depths of 1.0 and 2.0 feet below the free liquid. Laboratory analyses were performed to determine the concentrations of benzene, toluene, ethylbenzene, xylenes; and gasoline, diesel, and oil range hydrocarbons. Field screening and laboratory results are provided on the table below:

TPH concentrations measured from near the surface at the Red-12 State No. 3 site exceeds the 1993 NMOCD Guideline levels but decreases to below the guideline levels at 1 and 2 feet below the surface. None of the measured hydrocarbon concentrations exceed the 2006 NMED Guideline soil screening levels. The fact that the concentrations of regulated constituents do not exceed NMED Guidelines allows us to conclude that the impacted soil does not represent a threat to fresh water or public health. The recommended corrective action for this site is:

1. Remove out-of-service vessels or repair all leaks
2. Excavate the upper 1-2 feet of earth within the spill footprint
3. Mix the excavated spill material with 2-5 parts clean soil
4. Use this blended soil for the construction of firewalls around tank batteries (use now or stockpile on site for future use)
5. Collect a composite sample of the blended soil to demonstrate that constituents are at concentrations that comply with NMOCD

Rules and provide letter report to NMOCD

6. At abandonment of the site the surface will be restored according to the landowner's specifications.

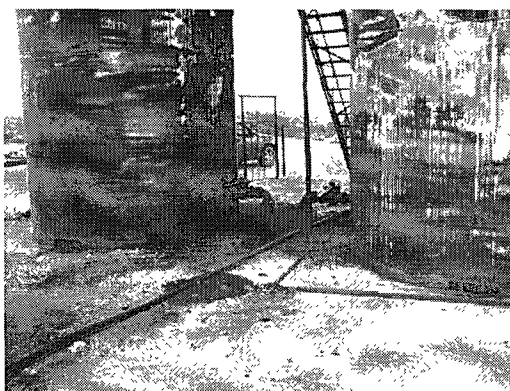
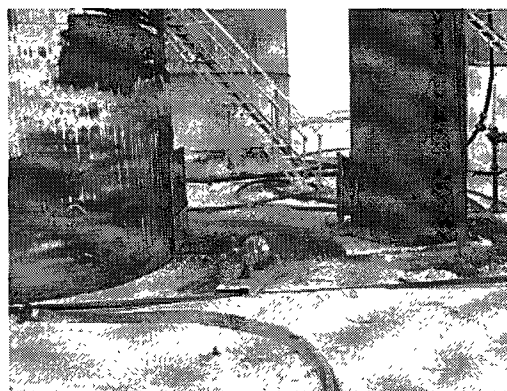
Red-12 State No. 4 Battery and Injector (OCD Reference No. 2RP-310)

Historic spills within the tank battery have occurred resulting in an "asphalt-like" stained soil area of approximately 400 ft². A composite surface soil sample was recovered from the stained area and laboratory analyses were performed to determine the concentrations of benzene, toluene, ethylbenzene, xylenes; and gasoline, diesel, and oil range hydrocarbons. Laboratory results are provided on the table below:

TPH concentrations measured from near the surface at the Red-12 State No. 4 battery site exceed the 1993 NMOCD Guideline levels but none of the measured hydrocarbon concentrations exceed the 2006 NMED Guideline levels. The fact that the concentrations of regulated constituents do not exceed NMED Guidelines allows us to conclude that the hydrocarbon-impacted soil does not represent a threat to fresh water or public health. The recommended corrective action for this site is:

1. Repair all leaks
2. Excavate the upper 1-2 feet of earth within the spill footprint
3. Mix the excavated spill material with 2-5 parts clean soil
4. Use this blended-asphaltic soil for the construction of firewalls around tank batteries (use now or stockpile on site for future use)
5. Collect a composite sample of the blended soil to demonstrate that constituents are at concentrations that comply with NMOCD Rules and provide letter report to NMOCD
6. At abandonment of the site, disc hay and other organic material into hydrocarbon-impacted soil to open soil structure and permit infiltration of precipitation. Repeat tilling and addition of organic material or other soil amendments as necessary to meet landowner mandates for surface restoration and thereby eliminate the threat to the environment (i.e. soil and habitat) posed by the hydrocarbon-impacted soils

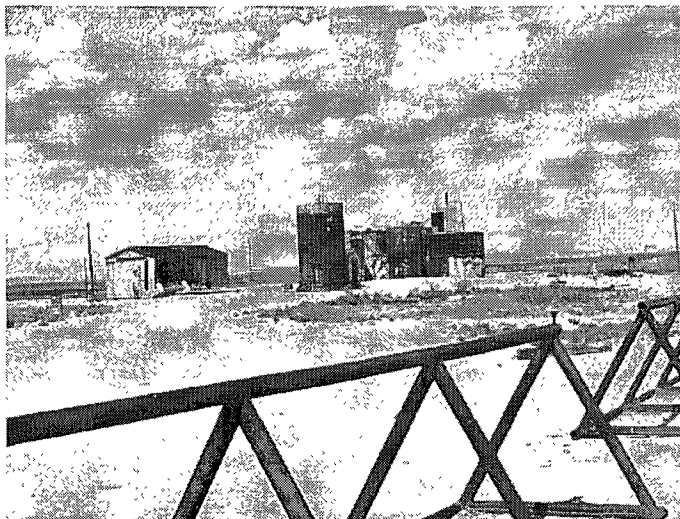
The tank battery is located on a topographically high area and much of the soil within the bermed area and the surrounding topographically low areas exhibit characteristics of one or more historic brine water releases. Three hand auger borings were installed in the low areas surrounding the tank battery in order to better characterize the extent of the chloride-impacted soil. Plate 2 is a site map drawn on a July 2005 satellite photograph that depicts the current extent of stressed vegetation, the location of the hand auger borings, and the laboratory results from soil samples recovered at the site. It should be noted that the extent of the stressed vegetation observed during the inspection has changed since 2005. Some of the vegetation to the north and south has decreased while areas to the west appear to have recovered.

At the topographically low areas to the north and west of the tank batteries chloride concentrations in soil prevent re-vegetation. The vertical extent of the impacted soil could not be determined due to auger refusal. Further investigations at the Red-12 State No. 4 site will be conducted to verify the vertical extent of the chloride-impacted soil in order to determine the potential threat to ground water. Following the completion of these activities a final report will be submitted to the NMOCD.
