**From:** Dale Littlejohn [dale@rthicksconsult.com]  
**Sent:** Wednesday, August 12, 2009 2:46 PM  
**To:** Bratcher, Mike, EMNRD  
**Cc:** qwelborn@valornet.com; 'Randy Hicks'  
**Subject:** Mark and Garner Loco Hills Sites OCD 2RP-304-310  
**Attachments:** M & G Loco Hills 8-12-09 Initial Characterization.pdf

RE: Seven Produced Fluid Releases at sites operated by Marks and Garner Production Ltd, Company in Eddy County, NM as follows:

R.T. Hicks Consultants is pleased to submit the results of the initial characterization activities on the behalf of Marks and Garner Production Ltd. The production area is approximately 6.5 miles northwest of Loco Hills, New Mexico. Plate 1 depicts the location of each site relative to lease roads, sections lines, and Bear Grass Draw. On June 22 and 23, 2009 Hicks Consultants inspected each of the sites to document the source and type of release, describe the resulting environmental impact, and recover "worst case" soil samples in order to determine the corrective actions required under NMOCD Rule Part 29.

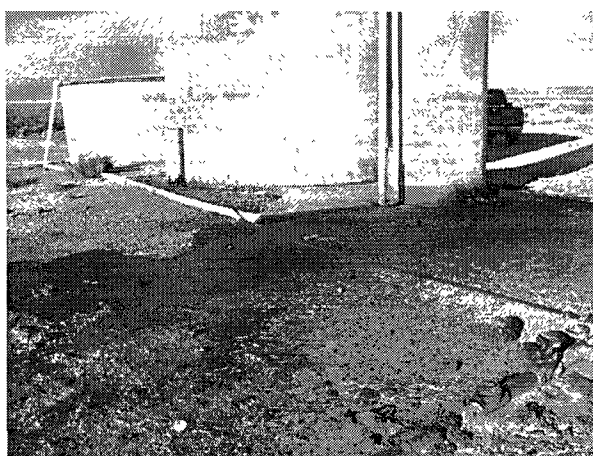
A release of heavy “tank bottom” oil occurred from a broken valve at the base of a large separator and extends approximately 30 feet down slope. We used a hand auger to obtain soil samples at depths of 0.5, 1.0, and 3.0 feet below the free liquid. Results of laboratory analyses on selected samples for benzene, toluene, ethylbenzene, xylenes; and gasoline, diesel, and oil range hydrocarbons as well as field screening and laboratory results are provided on the table below:

None of the hydrocarbon concentrations measured at the Levers Federal No. 7 site exceeds the 1993 NMOCD or 2006 NMED Guideline soil screening levels. The fact that the concentrations of regulated constituents do not exceed NMED Guidelines allows us to conclude that the impacted soil does not represent a threat to fresh water or public health. The recommended corrective action for this site is:

1. Remove out-of-service vessels or repair all leaks
2. Excavate the upper 6-inches of earth within the spill footprint
3. Mix the excavated spill material with 2-5 parts clean soil

4. Use this blended soil for the construction of firewalls around tank batteries (use now or stockpile on site for future use)
5. At abandonment of the site the surface will be restored according to the landowner's specifications

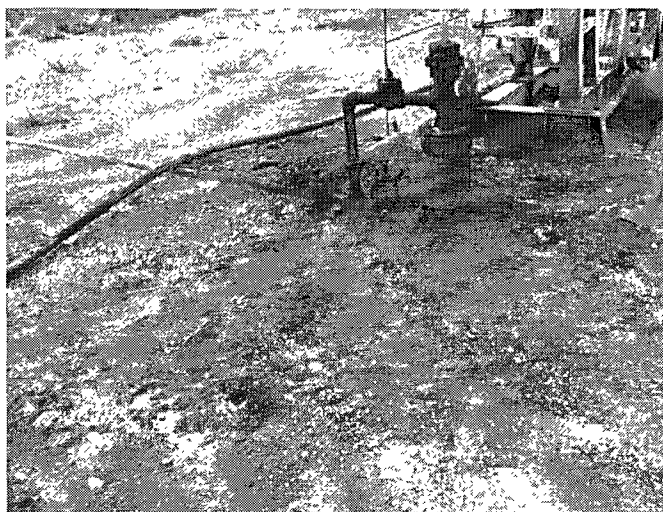
A release of oil occurred from the well head which extends approximately 10 feet in all directions. The table below presents field screening and the laboratory results from soil samples at the surface and at depths of 2.0, 3.0, 4.0, 5.0 and 6.0 feet below the stained area.

Total Petroleum Hydrocarbon (TPH) concentrations measured at the Levers No. 3 site exceeds the 1993 NMOCD Guideline levels but concentrations generally decrease from the surface to the auger refusal depth (6 feet below the surface). Most importantly, none of the regulated hydrocarbon concentrations exceed the 2006 NMED Guideline levels. The fact that the concentrations of regulated constituents do not exceed NMED Guidelines allows us to conclude that the impacted soil does not represent a threat to fresh water or public health. The recommended corrective action for this site is:

1. Remove out-of-service vessels or repair all leaks
2. Excavate the upper 1-2 feet of earth within the spill footprint
3. Mix the excavated spill material with 2-5 parts clean soil
4. Use this blended soil for the construction of firewalls around tank batteries (use now or stockpile on site for future use)
5. Collect a composite sample of the blended soil to demonstrate that constituents are at concentrations that comply with NMOCD Rules and provide letter report to NMOCD
6. At abandonment of the site the surface will be restored according to the landowner's specifications

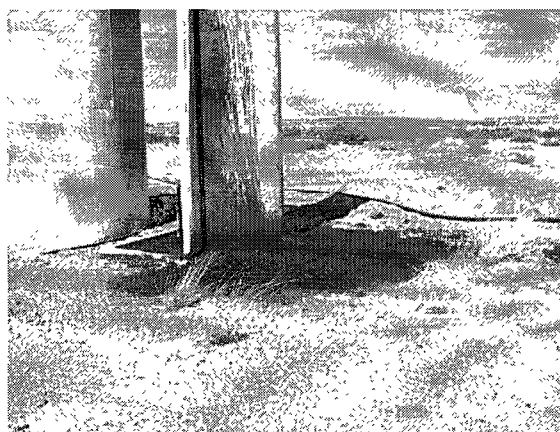
A release of heavy "tank bottom" oil occurred from a broken valve at the base and from a pipe joint near the top of the separator. The spill area extends approximately 30 feet down slope. Laboratory results of soil samples recovered using a hand auger at depths of 0.5, 1.0, and 3.0 feet below the free liquid and field screening are provided on the table below:

TPH concentrations measured from near the surface at the Red-12 Federal No. 1 site exceeds the 1993 NMOCD Guideline levels but decreases to below the guideline levels at 3 feet below the surface. None of the regulated hydrocarbon concentrations exceed the 2006 NMED Guideline levels. The fact that the concentrations of regulated constituents do not exceed NMED Guidelines allows us to conclude that the impacted soil does not represent a threat to fresh water or public health. The recommended corrective action for this site is:

1. Remove out-of-service vessels or repair all leaks
2. Excavate the upper 6-12 inches of earth within the spill footprint
3. Mix the excavated spill material with 2-5 parts clean soil
4. Use this blended soil for the construction of firewalls around tank batteries (use now or stockpile on site for future use)
5. Collect a composite sample of the blended soil to demonstrate that constituents are at concentrations that comply with NMOCD Rules and provide letter report to NMOCD
6. At abandonment of the site the surface will be restored according to the landowner's specifications

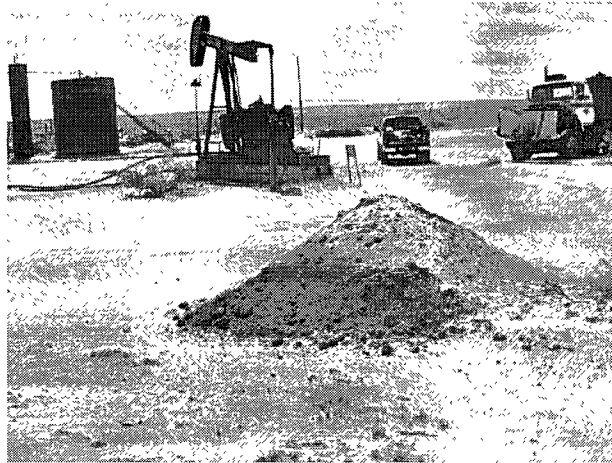
The operator excavated and stockpiled soil from an apparent release of oil that occurred prior to our characterization. Laboratory and field results from soil samples recovered from the stockpile and below the spill footprint are provided on the table below:

The hydrocarbon concentrations from the removed stockpiled soil at Cave State No. 4 site exceeds the 1993 NMOCD Guideline levels for TPH and the 2006 NMED Guideline levels for benzene. None of the hydrocarbon concentrations measured from the remaining (deeper) soil exceeds either the 1993 NMOCD or 2006 NMED Guideline soil screening levels.

The fact that the concentrations of regulated constituents do not exceed NMED Guidelines allows us to conclude that the impacted soil below the original spill footprint does not represent a threat to fresh water or public health.

We recommend that the operator mix the stockpile with clean soil and utilize it for the construction of a firewall at one of the active tank batteries.

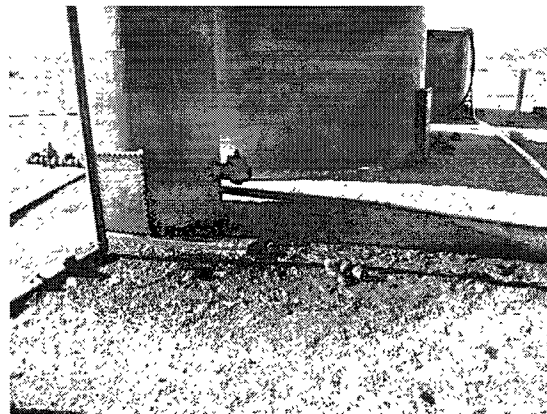
A release of heavy "tank bottom" oil occurred from a broken valve at the base of a separator and extends approximately 20 feet down slope. Results of laboratory and field analyses of soil samples recovered using a hand auger at depths of 0.5, 1.0, and 3.0 feet below the free liquid are provided on the table below:

TPH concentrations measured from near the surface at the Red-12 State No. 2 site exceeds the 1993 NMOCD Guideline levels but decreases to below the guideline levels at 3 feet below the surface. None of the measured hydrocarbon concentrations exceed the 2006 NMED Guideline levels. The fact that the concentrations of regulated constituents do not exceed NMED Guidelines allows us to conclude that the impacted soil does not represent a threat to fresh water or public health. The recommended corrective action for this site is:

1. Remove out-of-service vessels or repair all leaks
2. Excavate the upper 6-12 inches of earth within the spill footprint
3. Mix the excavated spill material with 2-5 parts clean soil
4. Use this blended soil for the construction of firewalls around tank batteries (use now or stockpile on site for future use)
5. Collect a composite sample of the blended soil to demonstrate that constituents are at concentrations that comply with NMOCD Rules and provide letter report to NMOCD.
6. At abandonment of the site the surface will be restored according to the landowner's specifications.

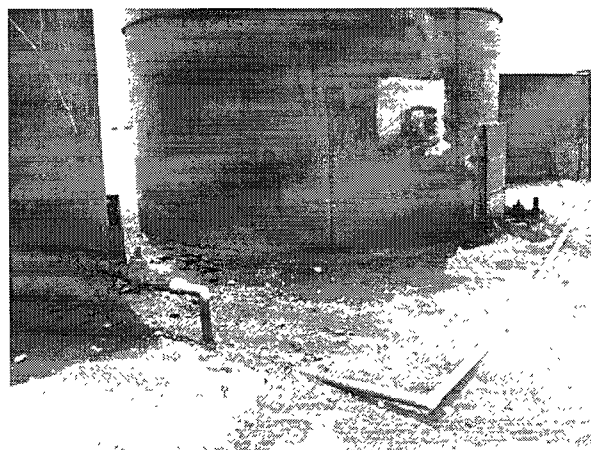
A release of heavy "tank bottom" oil occurred from leaks located at the base of a 500-bbl oil tank and a separator. The surface staining is present in an area of approximately 500 ft<sup>2</sup>. A composite surface soil sample was recovered from the stained area and subsurface soil samples were recovered from two hand auger borings at depths of 1.0 and 2.0 feet below the free liquid. Laboratory analyses were performed to determine the concentrations of benzene, toluene, ethylbenzene, xylenes; and gasoline, diesel, and oil range hydrocarbons. Field screening and laboratory results are provided on the table below:

TPH concentrations measured from near the surface at the Red-12 State No. 3 site exceeds the 1993 NMOCD Guideline levels but decreases to below the guideline levels at 1 and 2 feet below the surface. None of the measured hydrocarbon concentrations exceed the 2006 NMED Guideline soil screening levels. The fact that the concentrations of regulated constituents do not exceed NMED Guidelines allows us to conclude that the impacted soil does not represent a threat to fresh water or public health. The recommended corrective action for this site is:

1. Remove out-of-service vessels or repair all leaks
2. Excavate the upper 1-2 feet of earth within the spill footprint
3. Mix the excavated spill material with 2-5 parts clean soil
4. Use this blended soil for the construction of firewalls around tank batteries (use now or stockpile on site for future use)
5. Collect a composite sample of the blended soil to demonstrate that constituents are at concentrations that comply with NMOCD

Rules and provide letter report to NMOCD

- At abandonment of the site the surface will be restored according to the landowner's specifications.

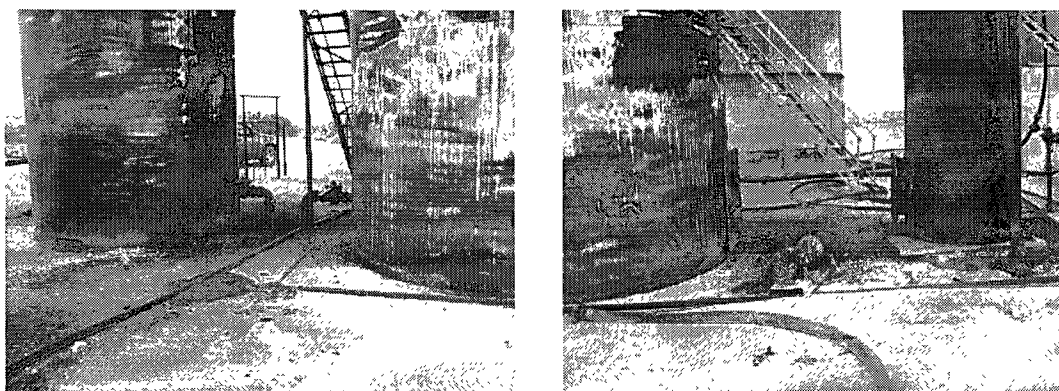
Historic spills within the tank battery have occurred resulting in an "asphalt-like" stained soil area of approximately 400 ft<sup>2</sup>. A composite surface soil sample was recovered from the stained area and laboratory analyses were performed to determine the concentrations of benzene, toluene, ethylbenzene, xylenes; and gasoline, diesel, and oil range hydrocarbons. Laboratory results are provided on the table below:

TPH concentrations measured from near the surface at the Red-12 State No. 4 battery site exceed the 1993 NMOCD Guideline levels but none of the measured hydrocarbon concentrations exceed the 2006 NMED Guideline levels. The fact that the concentrations of regulated constituents do not exceed NMED Guidelines allows us to conclude that the hydrocarbon-impacted soil does not represent a threat to fresh water or public health. The recommended corrective action for this site is:

- Repair all leaks
- Excavate the upper 1-2 feet of earth within the spill footprint
- Mix the excavated spill material with 2-5 parts clean soil
- Use this blended-asphaltic soil for the construction of firewalls around tank batteries (use now or stockpile on site for future use)
- Collect a composite sample of the blended soil to demonstrate that constituents are at concentrations that comply with NMOCD Rules and provide letter report to NMOCD
- At abandonment of the site, disc hay and other organic material into hydrocarbon-impacted soil to open soil structure and permit infiltration of precipitation. Repeat tilling and addition of organic material or other soil amendments as necessary to meet landowner mandates for surface restoration and thereby eliminate the threat to the environment (i.e. soil and habitat) posed by the hydrocarbon-impacted soils

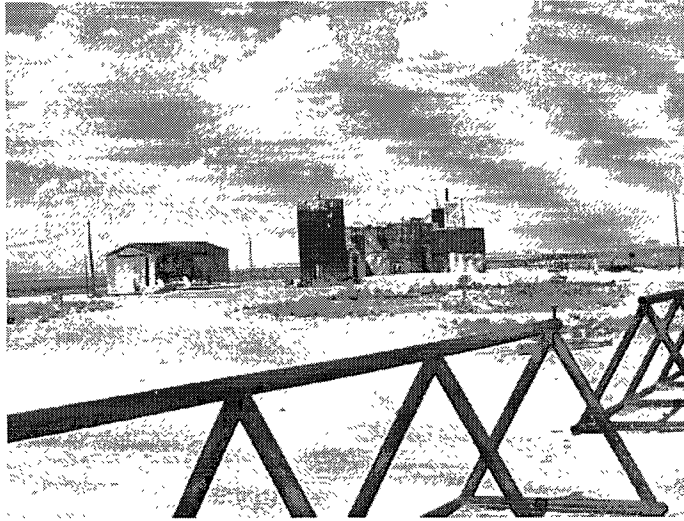
The tank battery is located on a topographically high area and much of the soil within the bermed area and the surrounding topographically low areas exhibit characteristics of one or more historic brine water releases. Three hand auger borings were installed in the low areas surrounding the tank battery in order to better characterize the extent of the chloride-impacted soil. Plate 2 is a site map drawn on a July 2005 satellite photograph that depicts the current extent of stressed vegetation, the location of the hand auger borings, and the laboratory results from soil samples recovered at the site. It should be noted that the extent of the stressed vegetation observed during the inspection has changed since 2005. Some of the vegetation to the north and south has decreased while areas to the west appear to have recovered.

At the topographically low areas to the north and west of the tank batteries chloride concentrations in soil prevent re-vegetation. The vertical extent of the impacted soil could not be determined due to auger refusal. Further investigations at the Red-12 State No. 4 site will be conducted to verify the vertical extent of the chloride-impacted soil in order to determine the potential threat to ground water. Following the completion of these activities a final report will be submitted to the NMOCD.
