Hester 12 Tank Battery

Located in Unit Letter N, SEC. 12, T20S, R38E of Lea Co., NM

API # 30-025-36795

Spill Remediation Report

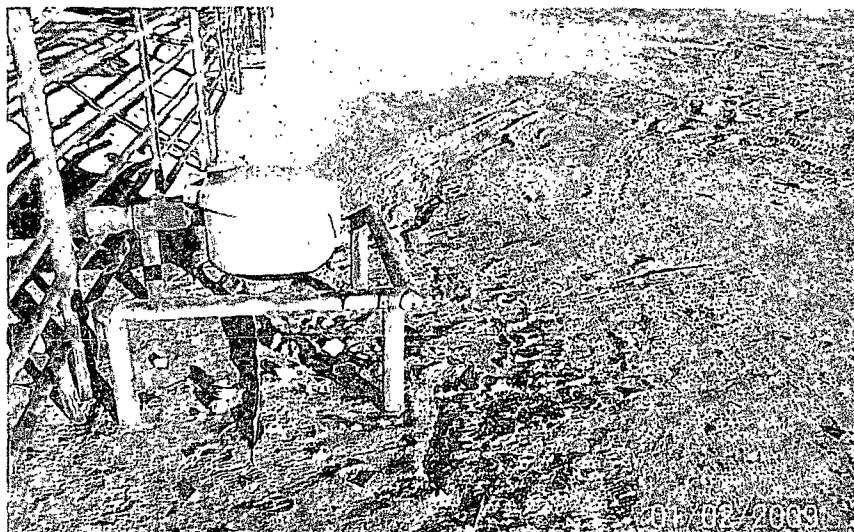
Photo #1 Beginning View of Spill Site

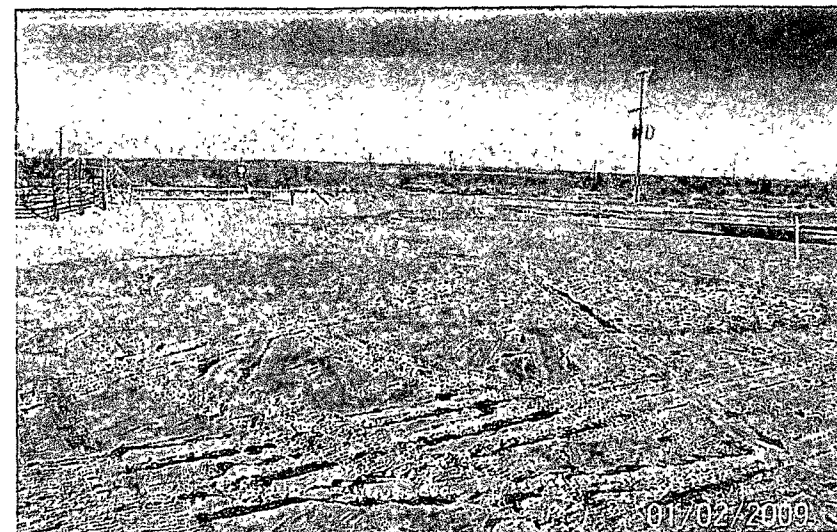
Photo #2 Beginning View of Spill Site

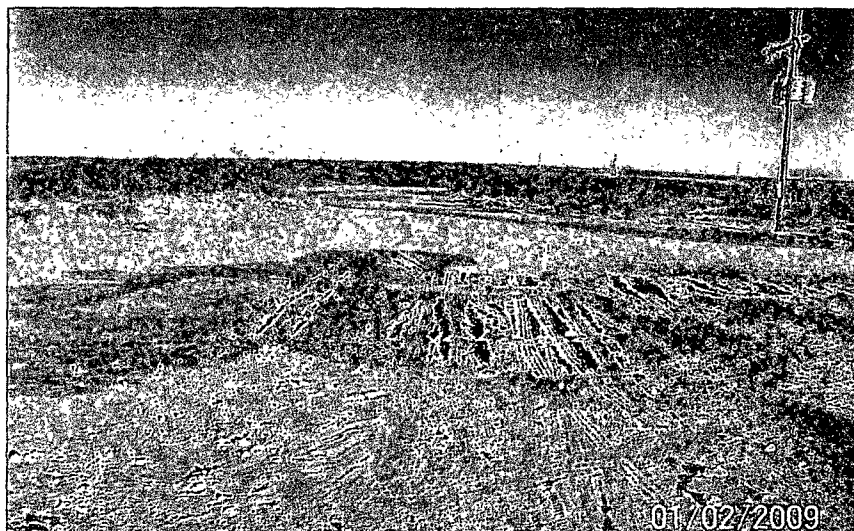
Photo #3 Beginning View of Spill Site

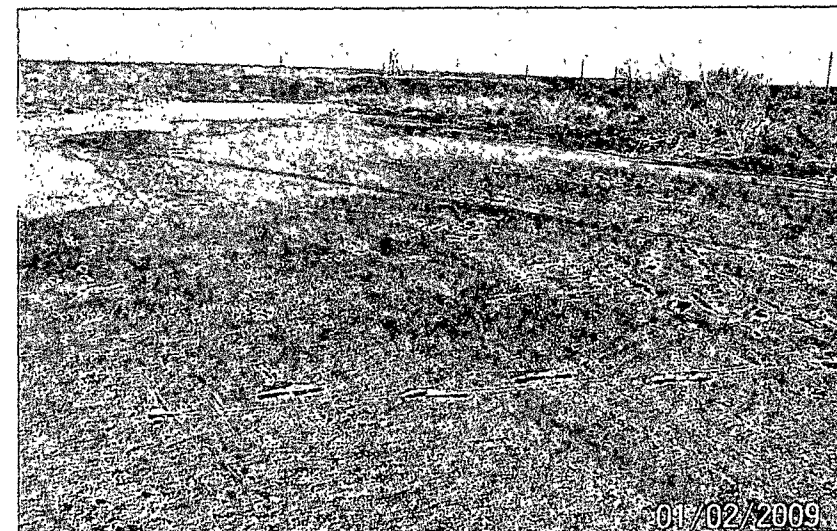
Photo #4 Beginning View of Spill Site

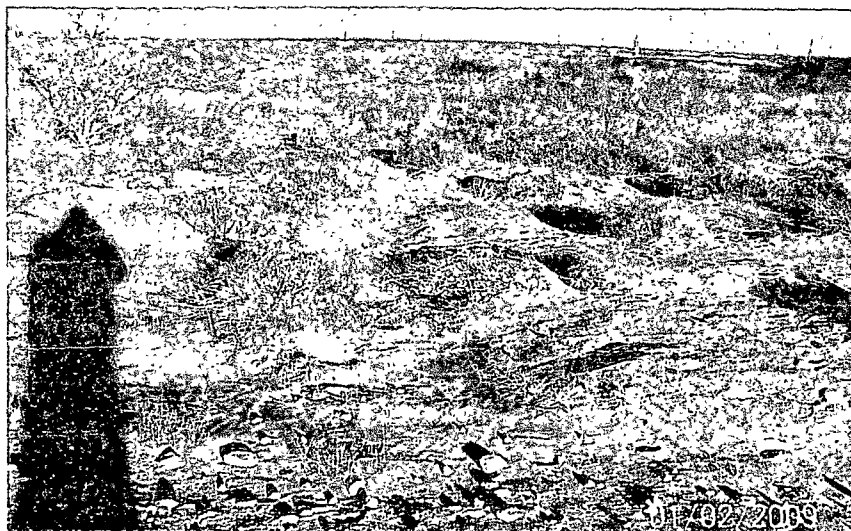
Photo # 5 Beginning View of Spill Site (Pasture)

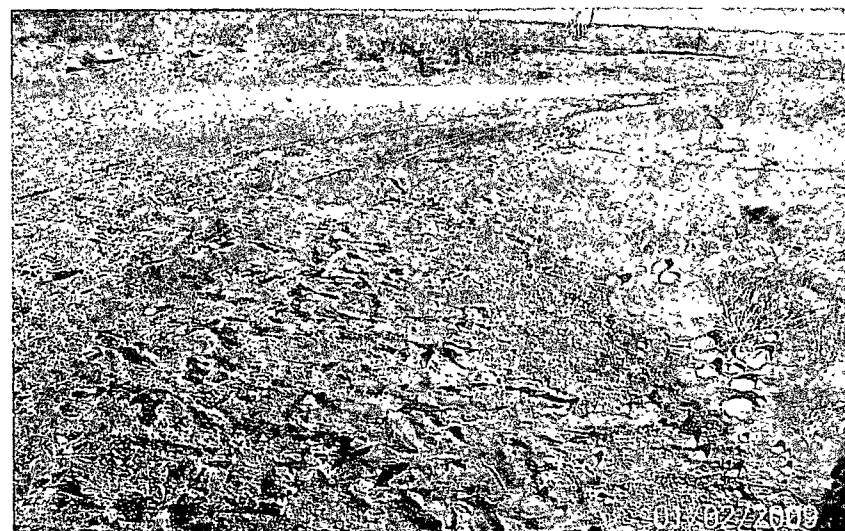
Photo #6 Beginning View of Spill Site (Road)

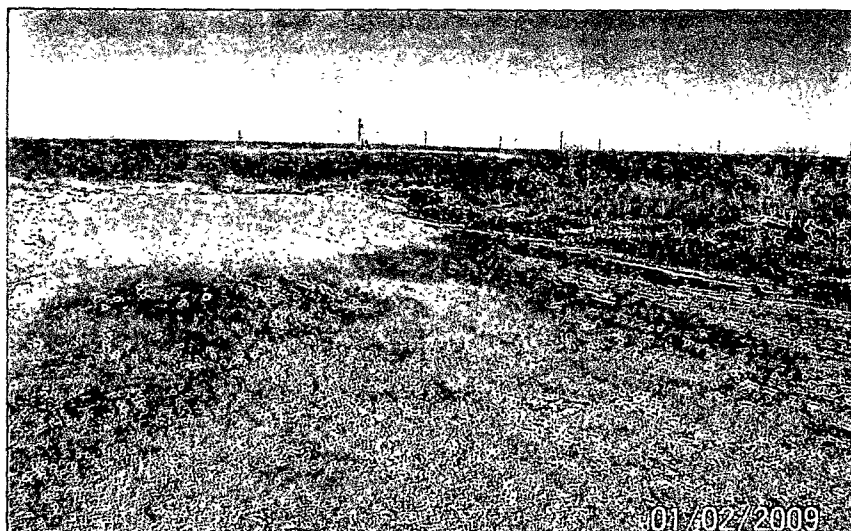
Photo #7 Beginning View of Spill Site (Location)

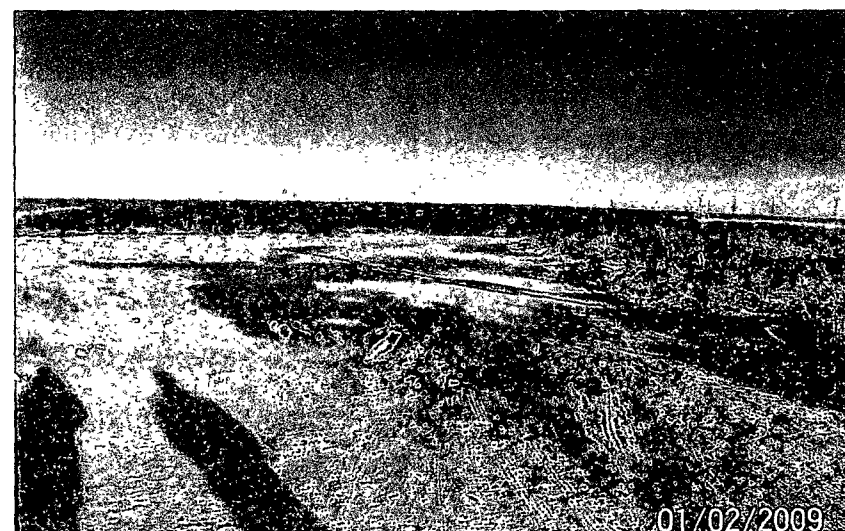
Photo #8 Beginning View of Spill Site (Location and Road)
